91 Navigation, Bluetooth, smartphone interface, voice recognition, drive select, ACC or cruise control is not available.

91 19 16 2042506/8 December 6, 2019. Supersedes Technical Service Bulletin Group 91 number 19-06 dated October 30, 2019 for reasons listed below.

Model(s)	Year	VIN Range	Vehicle-Specific Equipment
А3	2015 - 2020	All	Not Applicable
TT	2016 - 2020	All	Not Applicable
A5, Q5	2018 - 2020	All	Not Applicable
A4, Q7, and R8	2017 - 2020	All	Not Applicable
A6, A7	2016 - 2018	All	Not Applicable

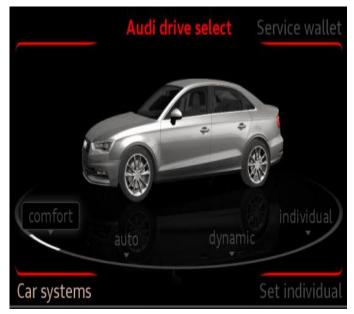
- Audi drive select functions cannot be selected (Figure 1).
- Cruise control does not work (except for A6 and A7) and DTC P164700 (ECM incorrect coding) is stored in the engine control module (address word 0001 (ECM), etc.).
- Navigation is not activated (Figure 2 and Figure 3).
- Bluetooth is unavailable.
- Audi smartphone interface, including CarPlay or Android Auto, is not available.
- Voice recognition is unavailable (in all cars except A3 Cabriolet. For A3 Cabriolet, see TSB 2038136: 91 Voice recognition is not available or not enabled).

Figure 1. Audi drive select functions unavailable and greyed out

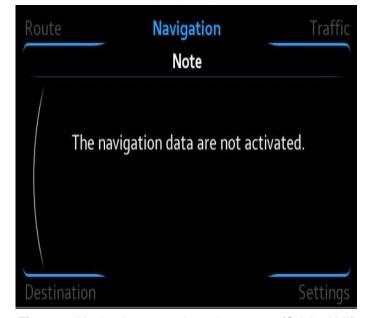
Figure 2. Navigation not activated message (Original MIB HMI).

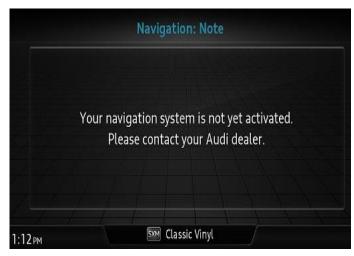
Figure 3. Navigation not activated message (New MIB2 HMI).

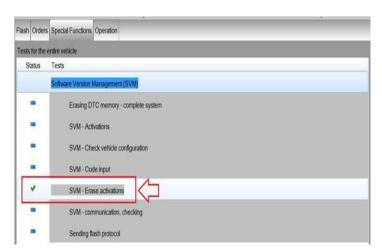
Figure 5. SVM - Erase activations.

There is a known issue with the activations keys stored in the MMI where they can become corrupt, thus the first step will be to delete the activation keys in the MMI. Delete the activations of the affected system using the ODIS test plan DIAGNOSIS >> START DIAGNOSIS >> SPECIAL FUNCTIONS >> "SVM – Erase activations" (Figure 5).
