# Service Bulletin

Bulletin No.: 19-NA-198

**Subject: Rear of Vehicle too High from Ground Surface with OEM Wheels and Tires**

Brand:	Model:	Model Year:		VIN:		Engine:	Transmission:
		from	to	from	to		
Chevrolet	Bolt EV	2019	2019	April 1, 2019	May 10, 2019	All	All

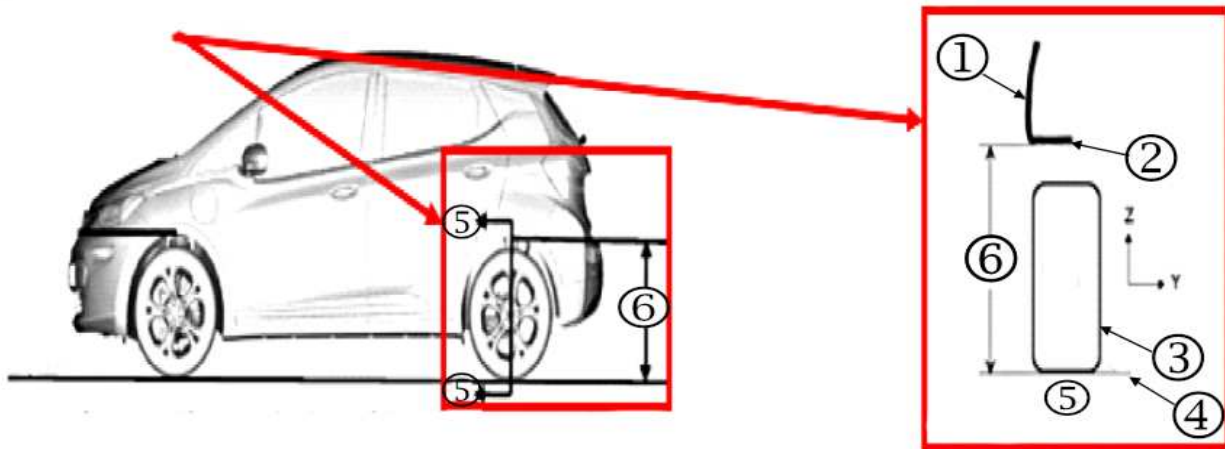
**Important:** Ensure that the inspector is measuring from the ground to the top of the wheel opening, through the centerline of the rear wheel. To ensure the most accurate measurements possible, it is recommended that the same inspector measure both sides of each vehicle.

**Note:** Key for call-outs above: (1) Quarter Panel, (2) Wheel Opening, (3) Tire (4) Ground, (5) Section, (6) Height.

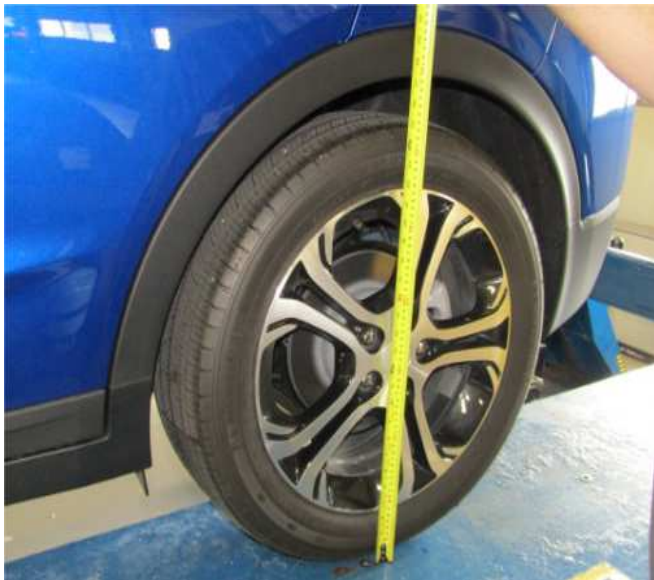
5398508

- Utilizing a metric tape measure, or yard stick, measure the height of both sides of the vehicle.

- Record the vehicle VIN, driver side, and passenger side measurements. An example is shown in the table above.
  - If the driver and passenger side heights are below 699 mm **AND** the cross-car measurements have a difference of 10 mm or less, the vehicle is within trim height specifications. No further action is required.
  - If the driver side **or** passenger side measurement is 699 mm or higher, **and/or** if the difference in cross-car measurements is greater than 10 mm, replace BOTH rear coil springs. Refer to *Rear Coil Spring Replacement* in SI.
- All reworked vehicles must go through the headlight aim process before returning to customers. Refer to the appropriate *Front Headlamp Aiming* procedure in SI.
