Technical Service Bulletin

Technical Service Bulletin: TSB101120	Released Date: 06-Nov-2019
Engine Surge - Usually With High Counts of Fault Codes 1861, 2776, and/or Fault Code 3847

Engine Surge - Usually With High Counts of Fault Codes 1861, 2776, and/or Fault Code 3847

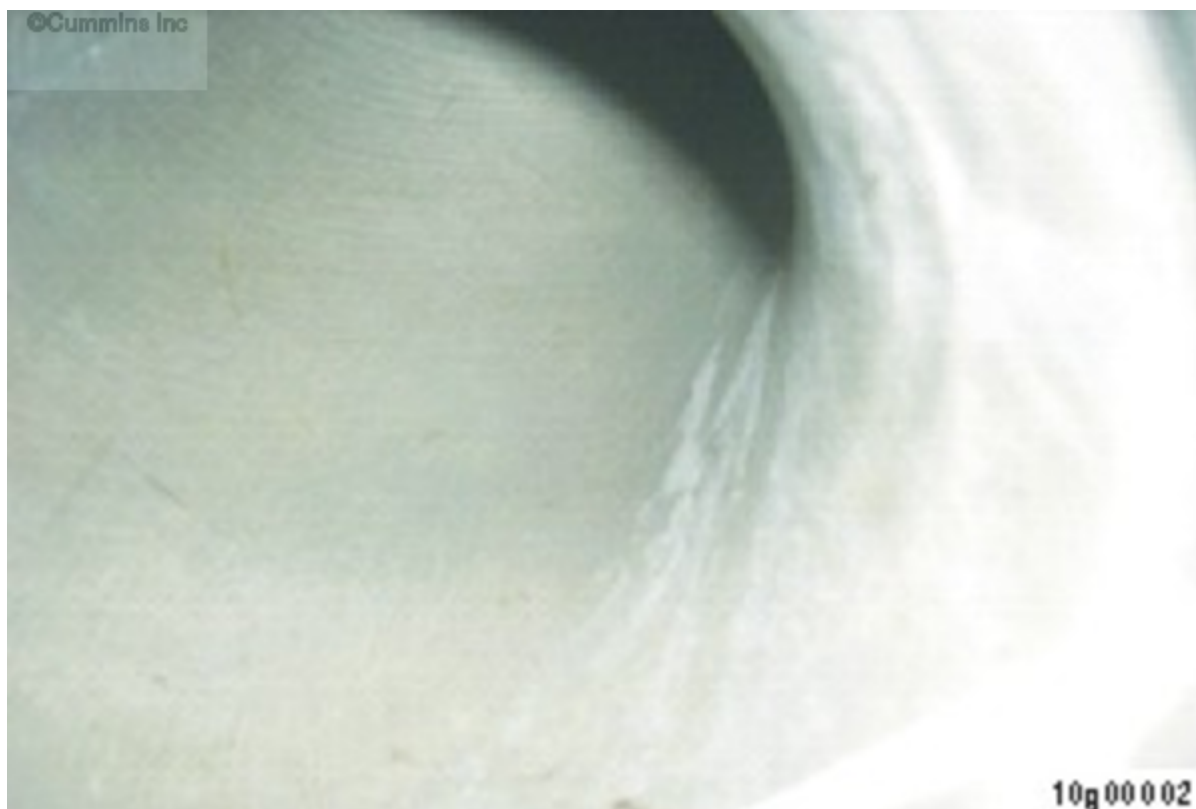
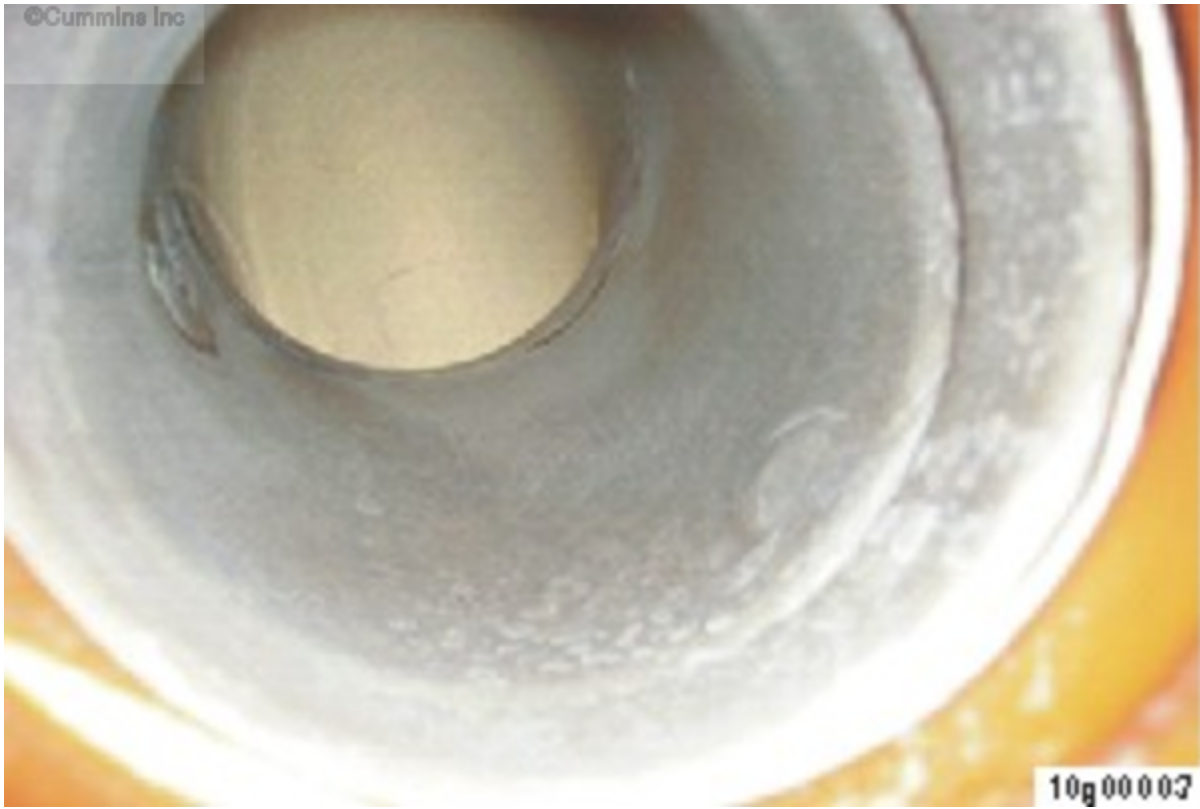
The source of the contamination is potassium fluoroaluminate flux used in the manufacture of certain charge-air coolers found in a variety of OEM installations. Flux in these coolers is carried through the intake system and deposited on the downstream components. The contaminant appears as a white, gray, or black deposit and can be mistaken for corrosion. Visual inspection of the intake piping often reveals a trail of deposited material on the downstream intake piping and

Figure 1, Air intake piping with flux deposits

Figure 2, Air intake piping with flux deposits

Air intake piping between the charge-air cooler and throttle assembly

- Remove the affected piping. Use a mild abrasive pad and water to scrub the flux from the piping, then thoroughly flush with clean water until the piping is clean.

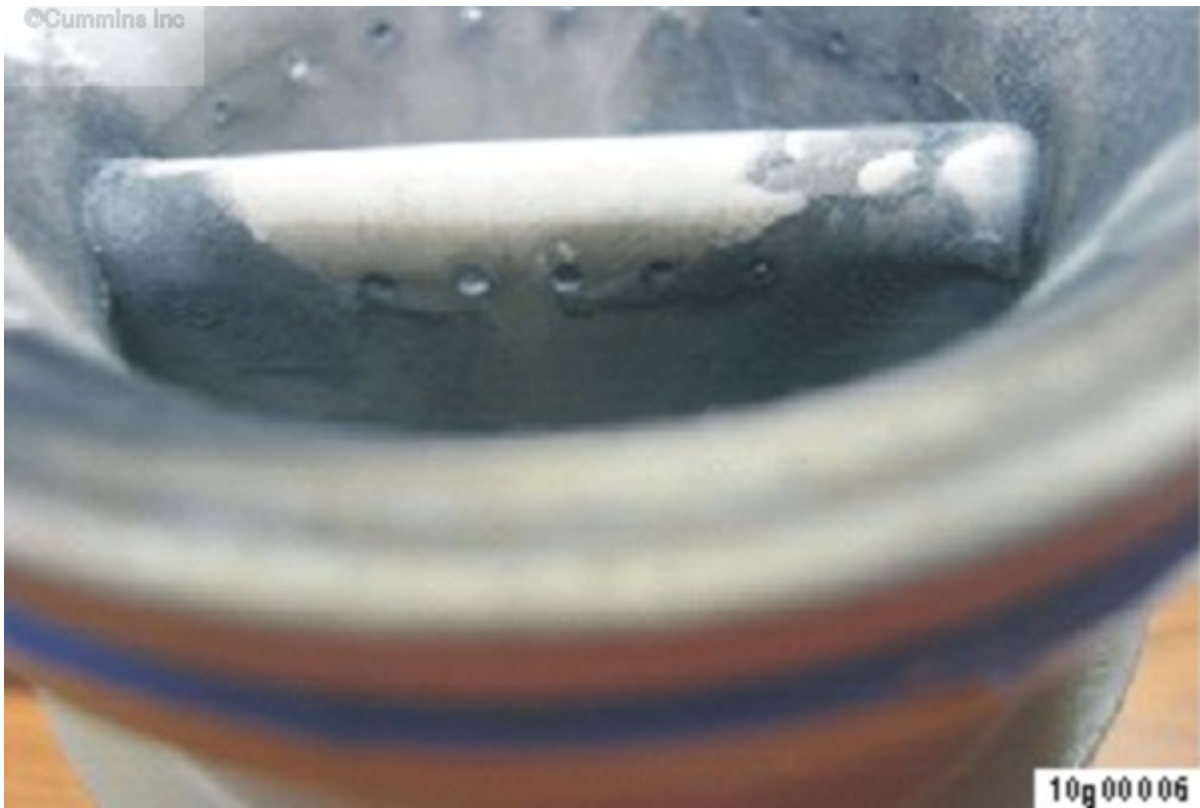
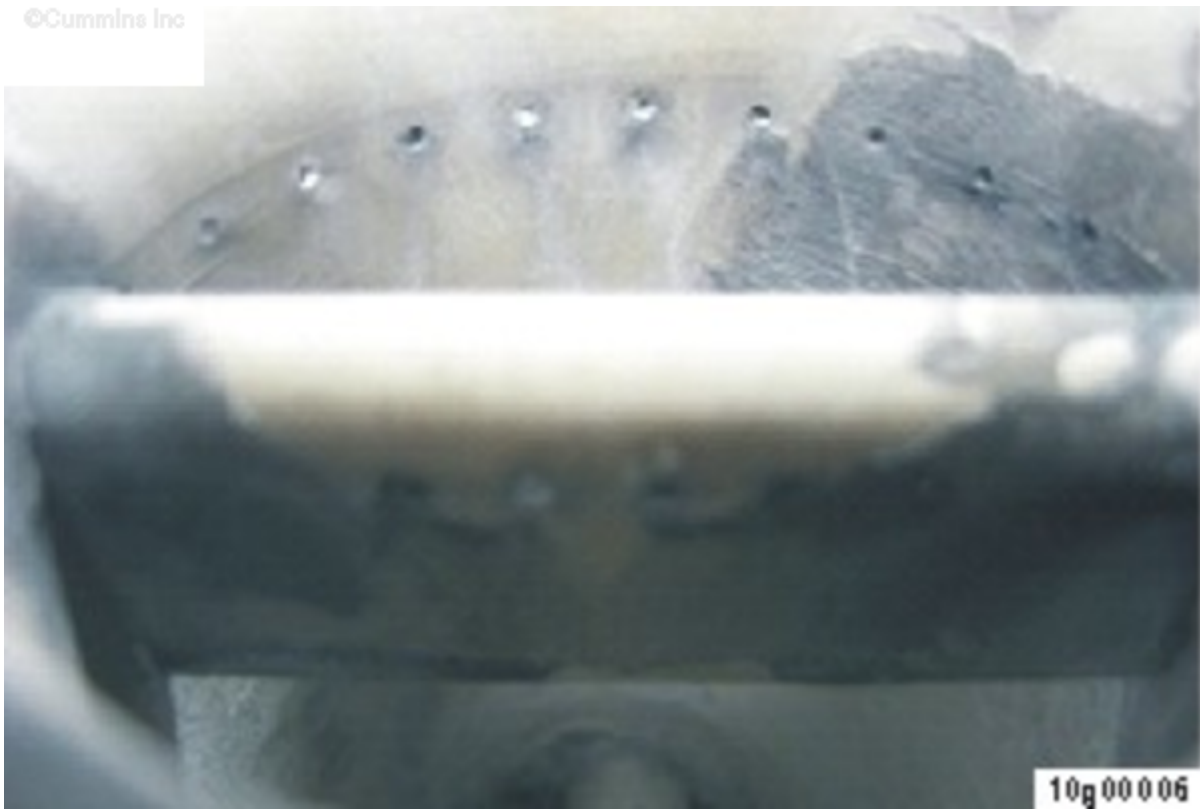
Customer complaints of engine surge, especially at idle or low RPM, usually accompanied by high counts of Fault Code 1861, 2776, and/or 3847 will prompt troubleshooting. The cause is found to be contamination of the air/fuel mixer and partial or complete blockage of the mixer's fuel ports with a gray/white, crusty substance. Further inspection may reveal similar contamination of other components in the air stream. The source of the contamination can often be traced directly back to the charge-air cooler by following a visible trail of white or grey streaks on the intake piping.

Figure 3, Air/fuel mixer with flux deposits

Figure 4, Air/fuel mixer with flux deposits

Air/fuel mixer

- Remove the air/fuel mixer from the fuel control module. See Procedure 005-003 in Section 5 of the corresponding Service Manual.
- Use a mild abrasive pad and water to gently scrub the flux from the surface of the mixer. Use a length of wire to carefully dislodge flux deposits from the fuel ports around the perimeter and in the venturi of the mixer.

Suitable wire sizes are as follows:

- Mixer barrel - 17 gauge
- Mixer venturi - 14 gauge

Note : Do **not** force the wire into the fuel ports. Do **not** elongate, enlarge, or otherwise affect the shape of the fuel ports. If the flux can **not** be removed from the fuel ports, or the ports are damaged during cleaning, the mixer **must** be replaced.

- After cleaning, flush the air/fuel mixer thoroughly with clean water to remove any cleaning debris prior to assembly.

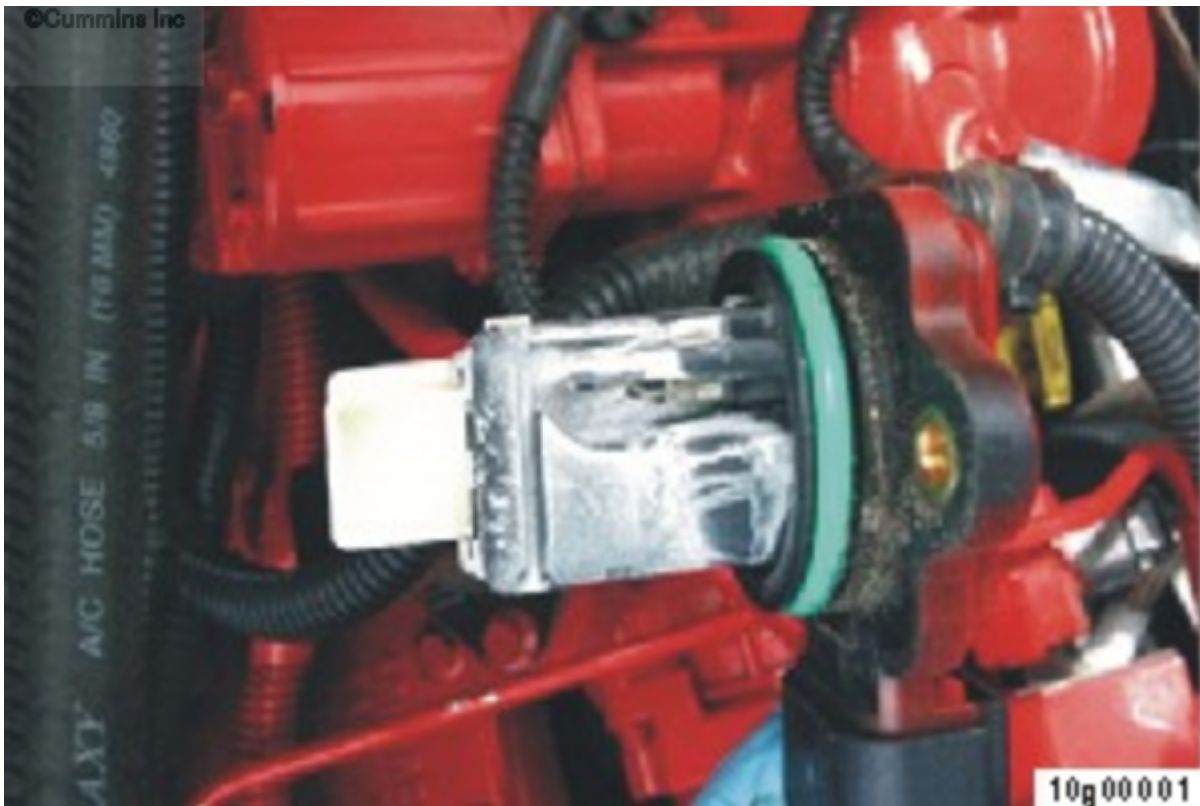
Figure 5, ISL G CM2180 Mass air flow sensor with flux deposits

- Replace the mass air flow sensor. See Procedure 019-460 in Section 19 of the corresponding Service Manual.
- Replace the turbocharger wastegate control valve. See Procedure 019-103 in Section 19 of the corresponding Service Manual.
- Replace the intake manifold pressure/temperature sensor. See Procedure 019-099 in Section 19 of the corresponding Service Manual.
- Replace the low pressure regulator. See Procedure 005-047 in Section 5 of the corresponding Service Manual.

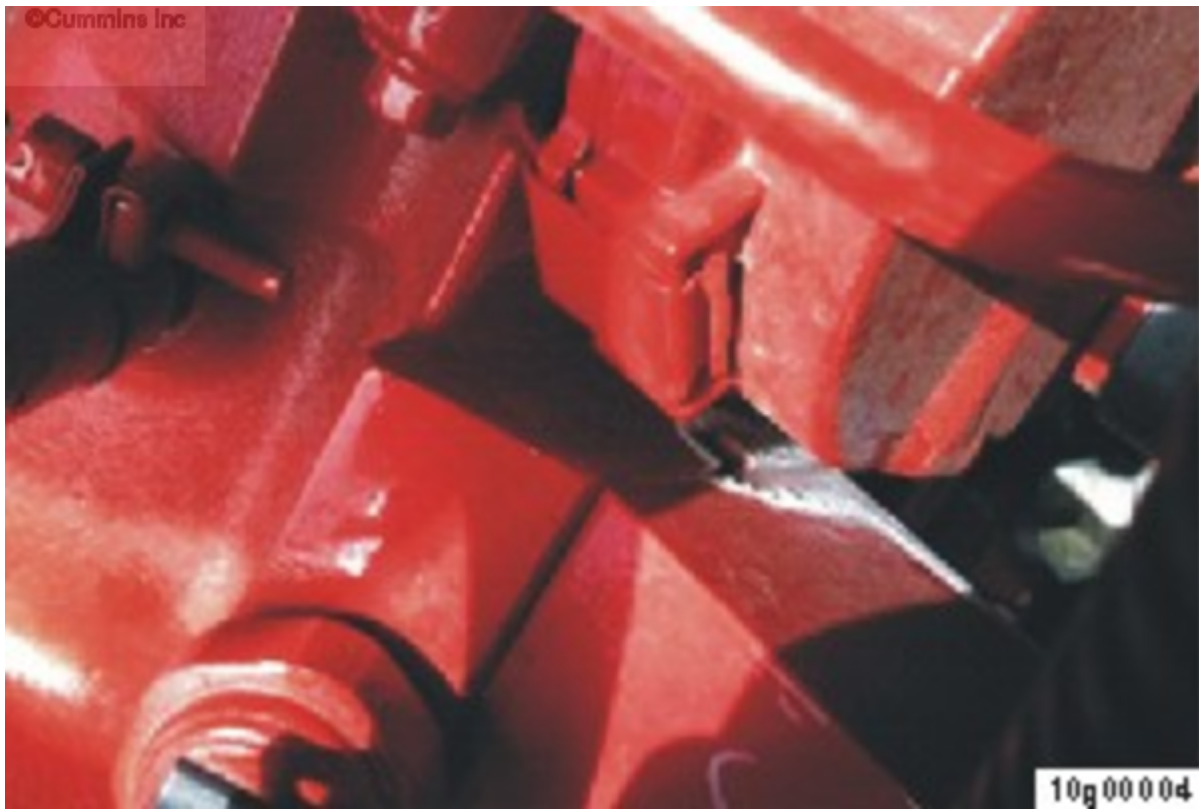
Figure 6, External deposits seeping from ISL G CM2180 fuel module near the wastegate control valve

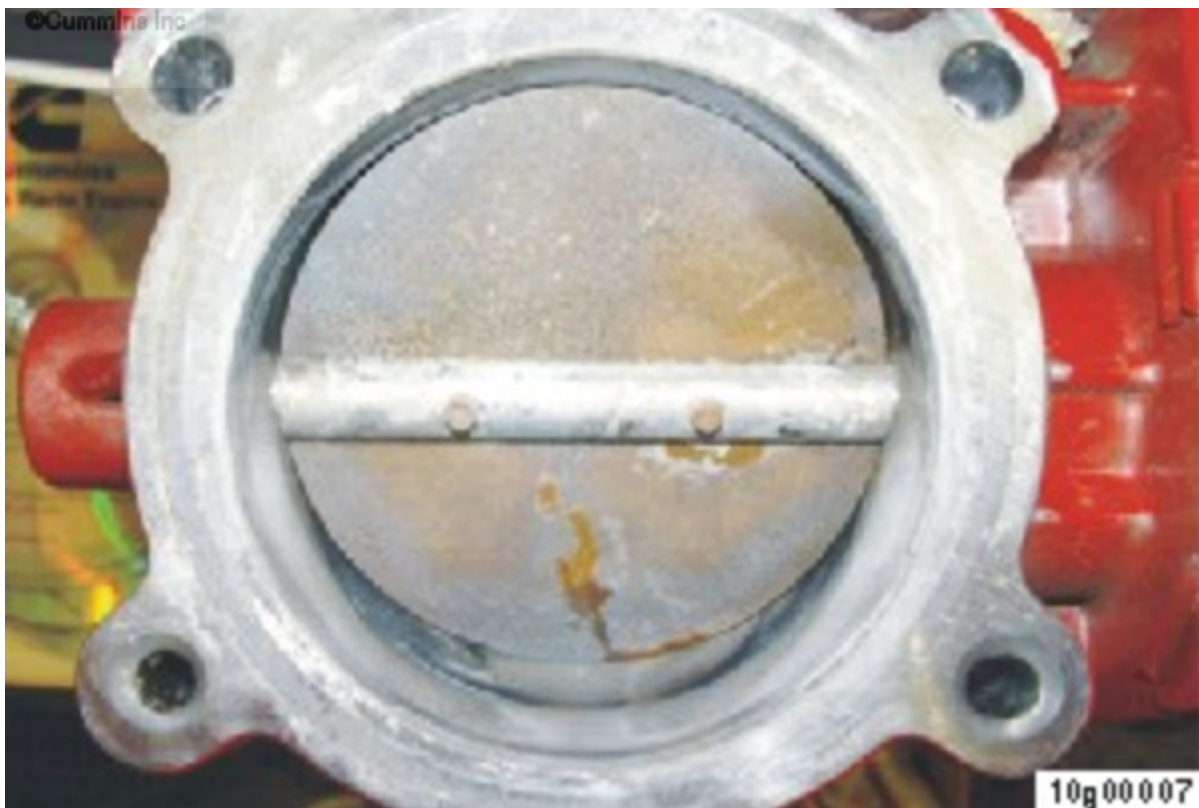
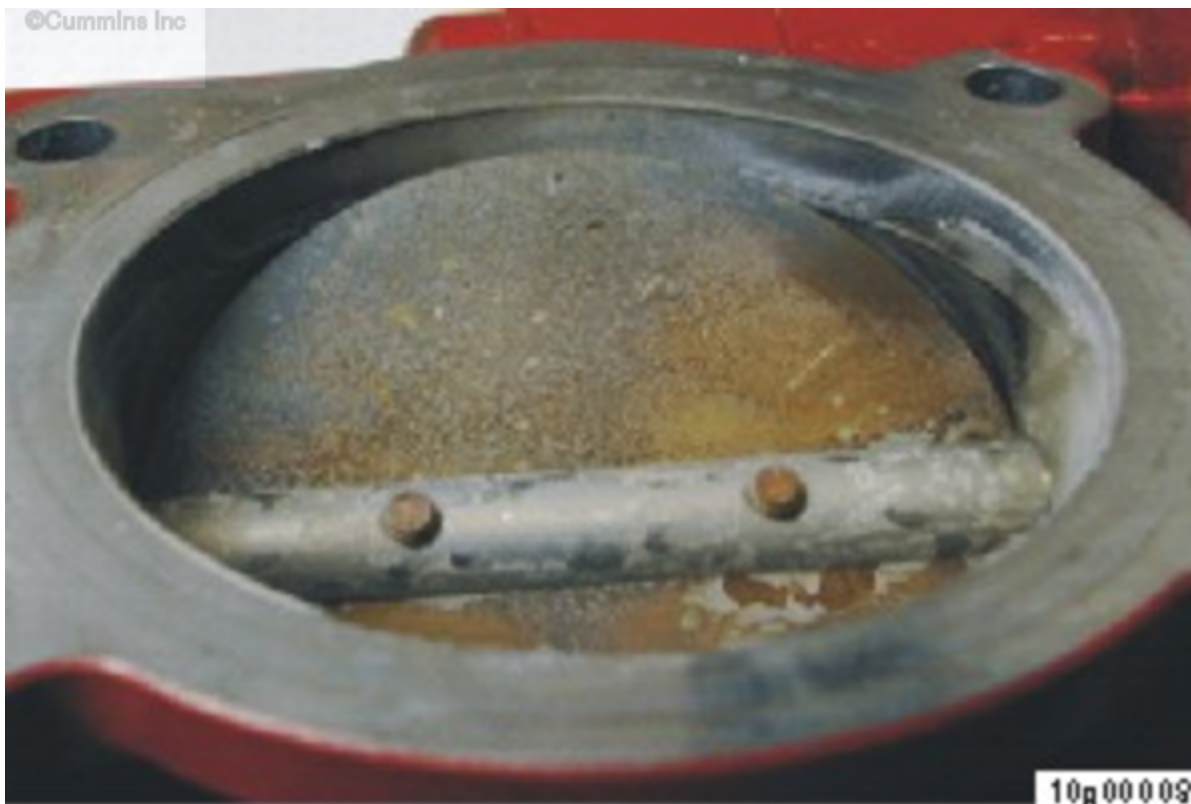
Figure 7, Throttle plate with flux deposits

Figure 8, Throttle plate with flux deposits

Throttle plate and surrounding structure

- Use a mild abrasive pad and water to gently scrub the flux from the throttle plate and throttle body. Wipe the cleaned components down to make sure that all cleaning materials and flux have been removed before reassembly.
