Technical Service Bulletin: TSB180139	Released Date: 11-Nov-2019
UL2 DEF Dosing Unit External DEF Leaks

UL2 DEF Dosing Unit External DEF Leaks

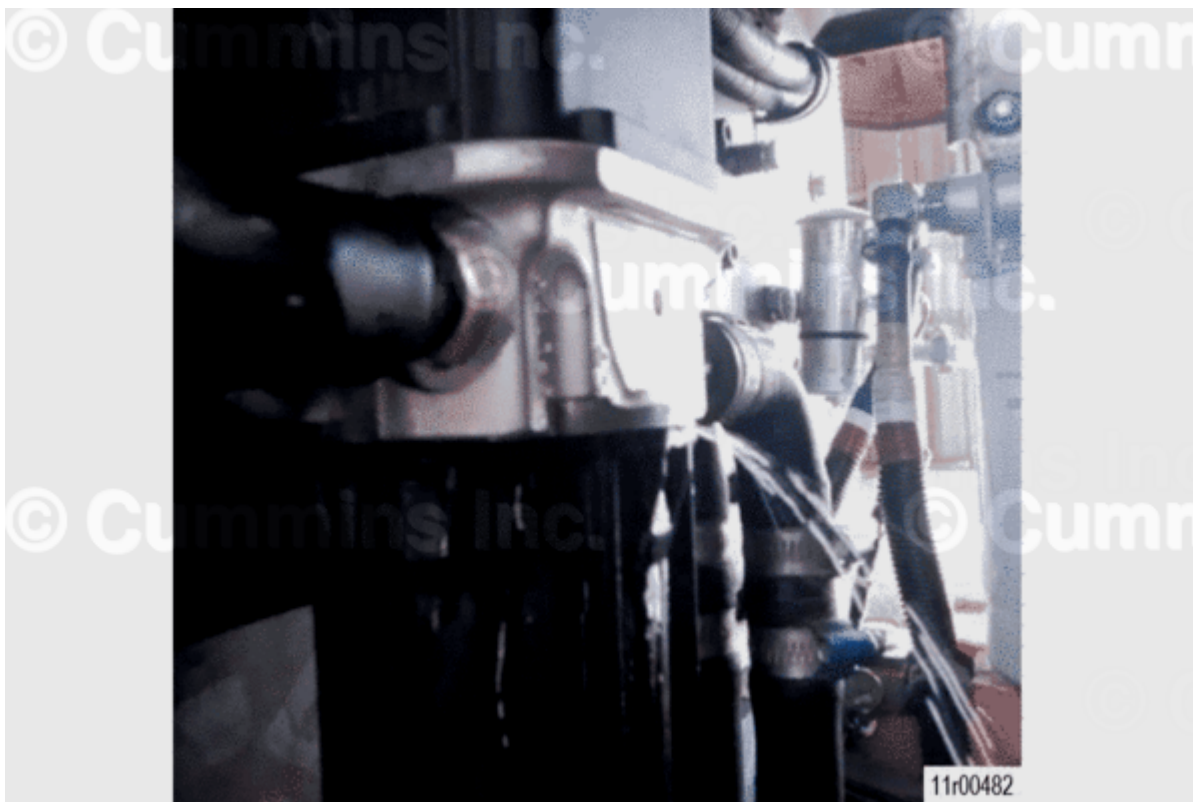
- External aftertreatment diesel exhaust fluid leak is present at aftertreatment diesel exhaust fluid dosing unit filter housing vent.
- External aftertreatment diesel exhaust fluid leak is present between the aluminum dosing unit housing and diesel exhaust fluid dosing unit filter housing.

- Some diesel exhaust fluid dosing unit filter housings have been observed to swell over time and lose clamping force required to seal DEF between the dosing unit housing and the freeze membrane.

Figure 1, Leak between Aftertreatment Diesel Exhaust Fluid Dosing Unit and Filter Housing.

- If leakage is present, remove aftertreatment diesel exhaust fluid dosing unit filter housing and freeze membrane and inspect for damage.
- If an external leak is present at aftertreatment diesel exhaust fluid dosing unit filter housing, replace the diesel exhaust fluid dosing unit filter, freeze membrane, and filter housing. See corresponding service manual. Refer to Procedure 011-060 (/qs3/pubsys2/xml/en/procedures/493/493-011-060.html) in Section 11.
- All required parts are contained in diesel exhaust fluid dosing unit filter kit, Part Number 4388378.

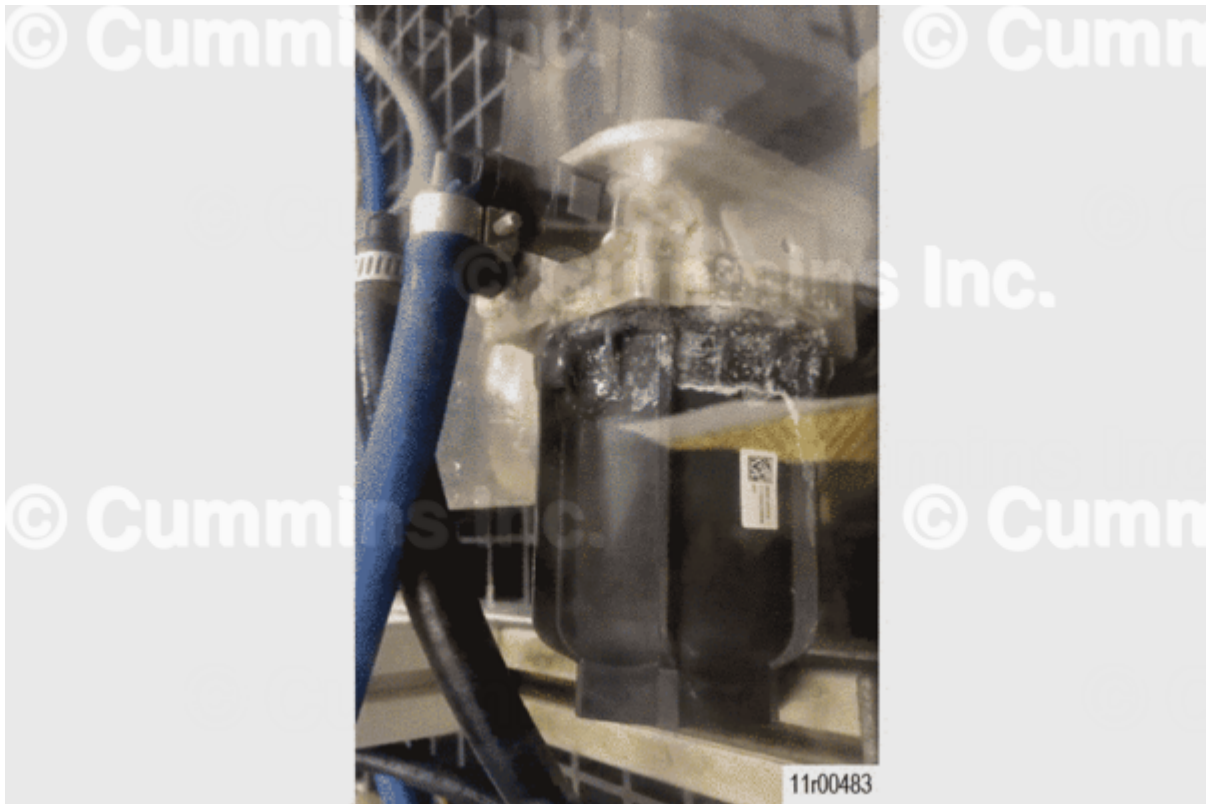
Figure 2, Signs of External DEF Leak Present on Aftertreatment Diesel Exhaust Fluid Dosing Unit.

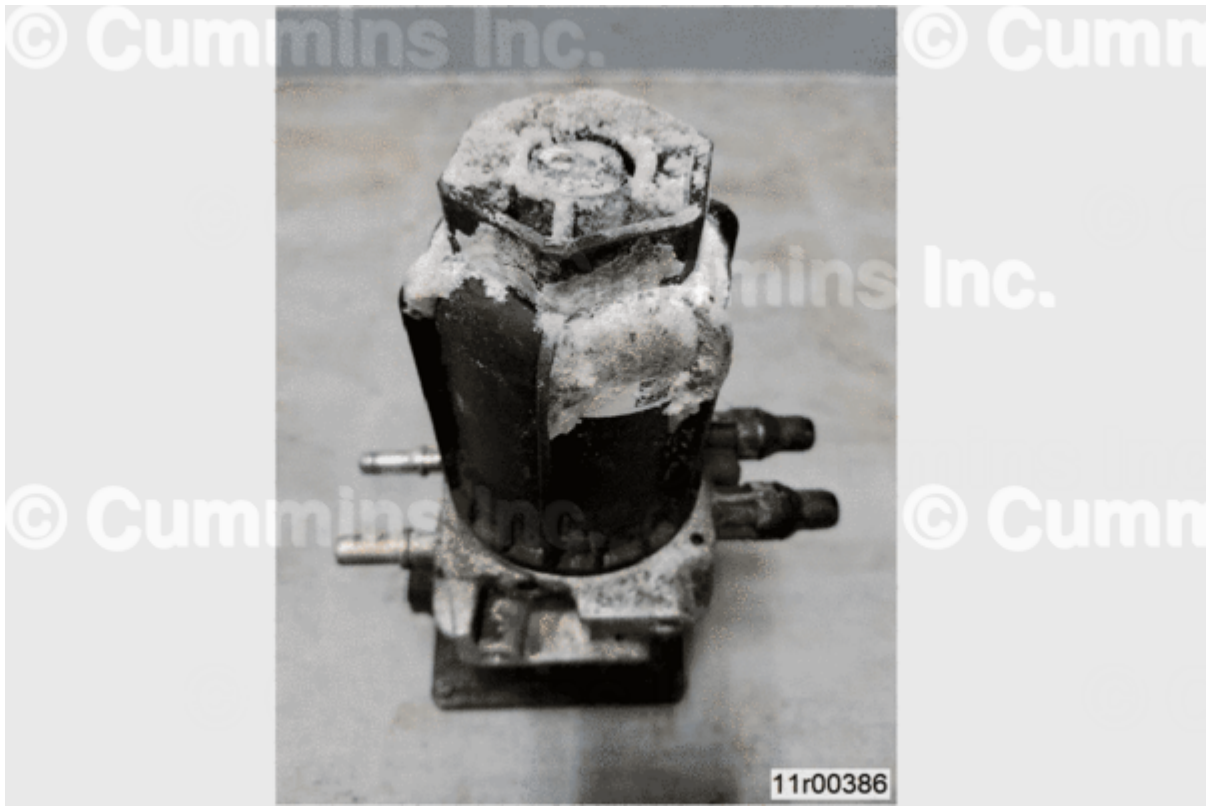
Figure 3, Aftertreatment Diesel Exhaust Fluid Dosing Unit with External Leak

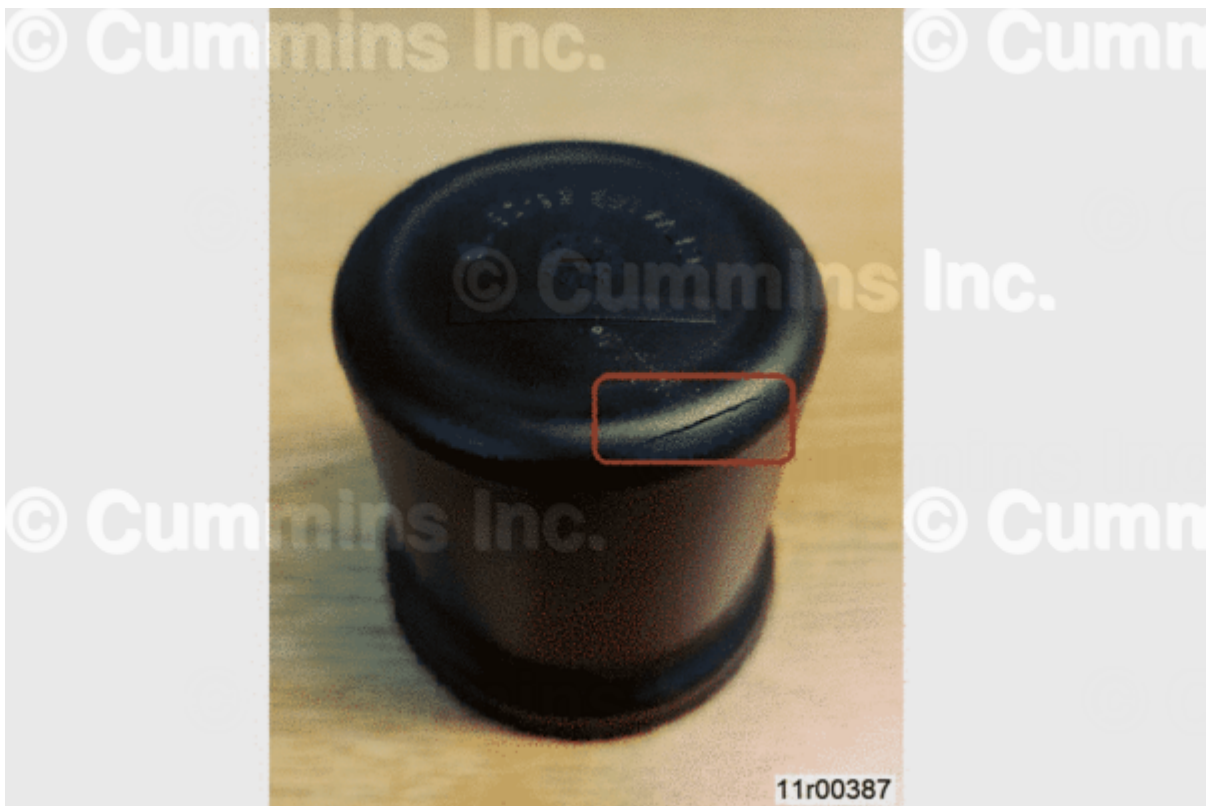
- A hard interference between the diesel exhaust fluid dosing unit filter, freeze membrane, and filter housing can cause the freeze membrane to tear and allow aftertreatment diesel exhaust

fluid to leak into the filter housing and leak out the filter housing vent.

Figure 4, Damaged Aftertreatment Diesel Exhaust Fluid Dosing Unit Freeze Membrane
