Technical Service Bulletin: TSB190181

Exhaust Gas Recirculation (EGR) System Differential Pressure Sensor Incorrect Installation: Fault Codes 3361, 3389, 3382 and 3383

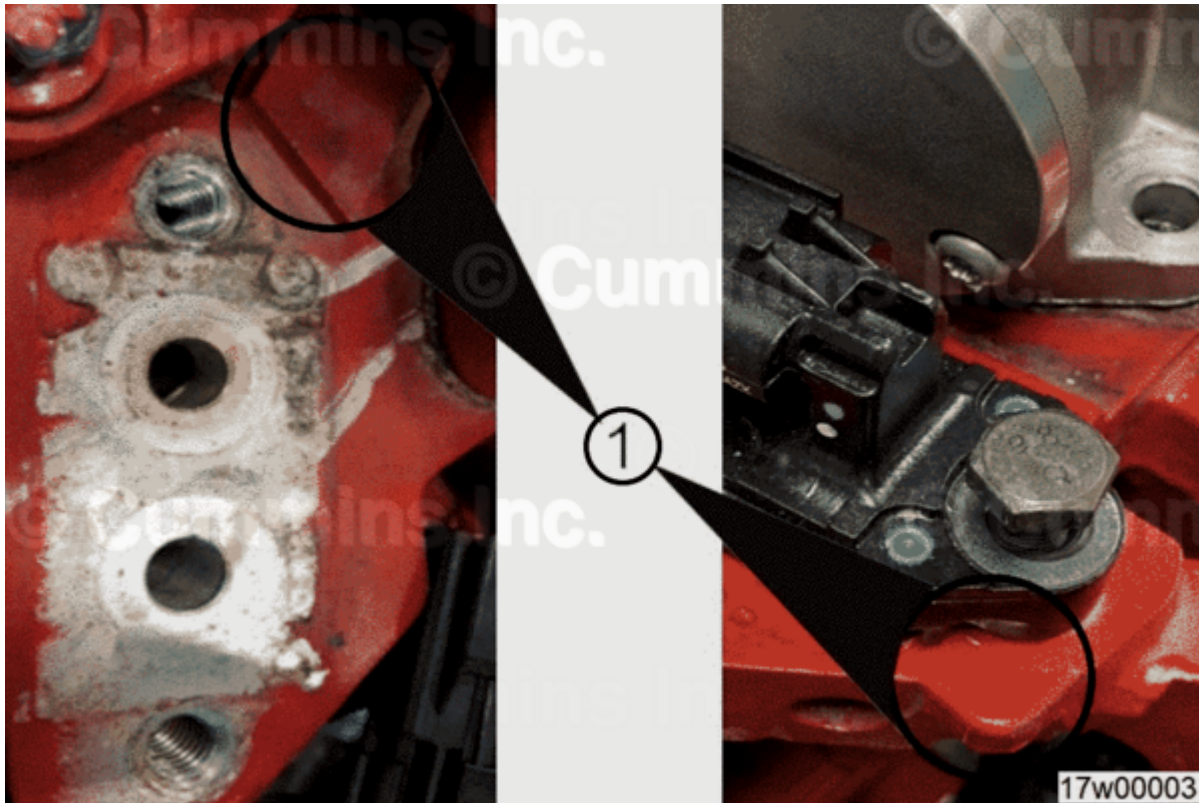
Figure 1, Examples Of Air Intake Connection Lips. Left: L9 Right: B6.7.

Air intake connection lips (1) look different when comparing two engines.

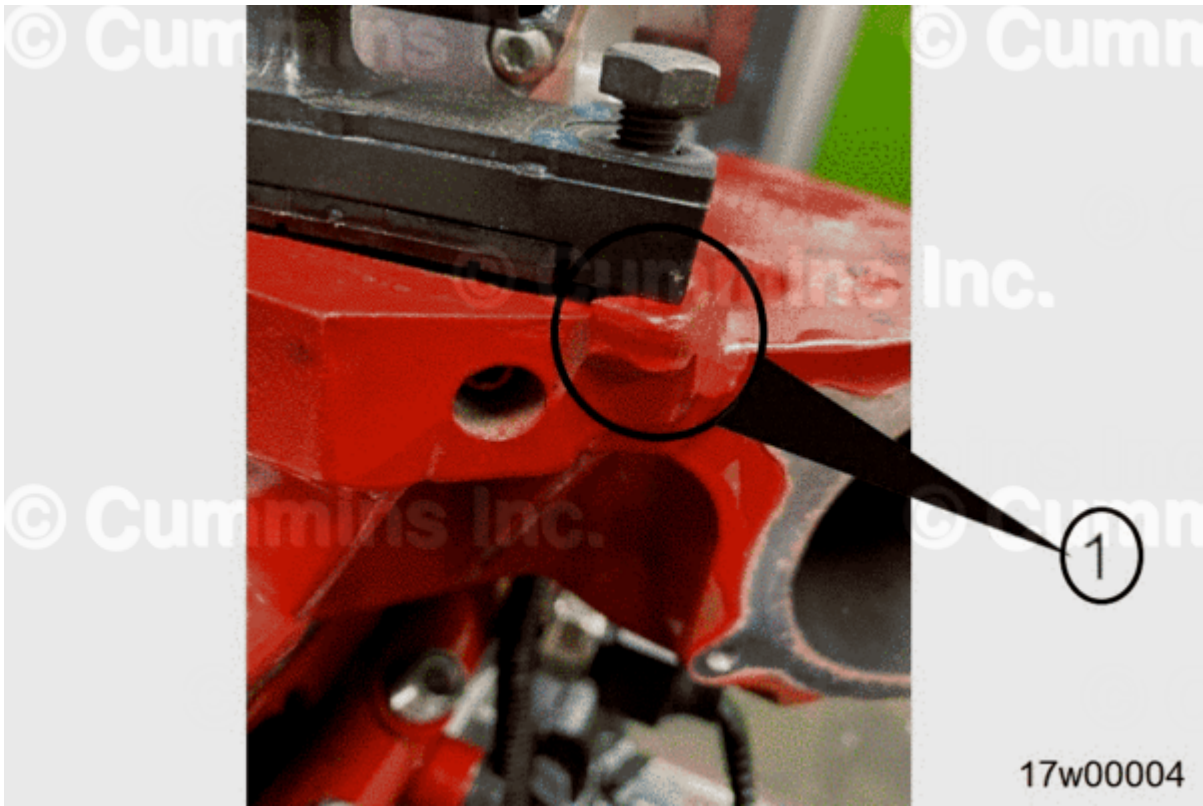
Figure 2, Incorrectly Installed Differential Pressure Sensor.

- Installing the differential pressure sensor 180 degrees off original orientation.
- Differential pressure sensor will read negative pressure if mounted incorrectly and will cause inaccurately controlled flow into the air intake manifold.

This interference (1) is proof that the differential pressure sensor is installed incorrectly.

- Locate the air intake connection lip. Differential pressure sensor 90 degree cornered side **must** be on the opposite side of the air intake connection lip.

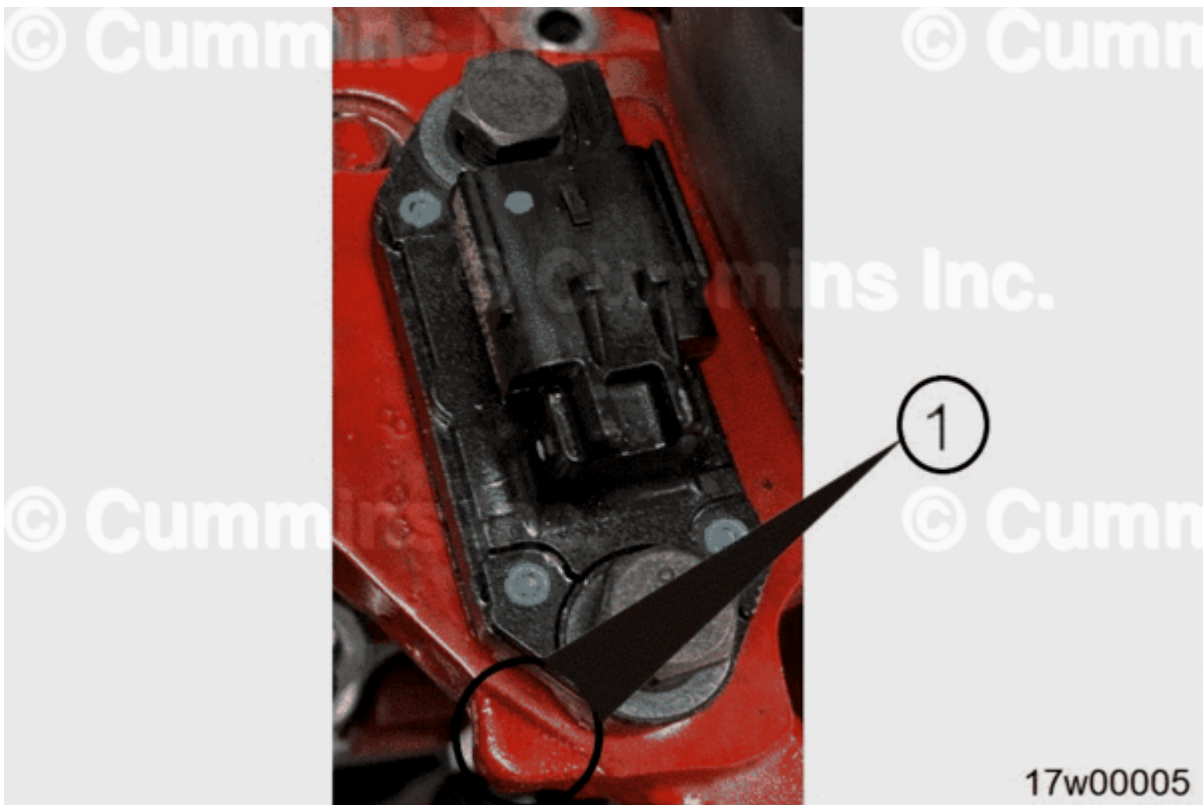
Figure 3, Correctly Installed Differential Pressure Sensor.

There is no interference (1) when the differential pressure sensor is installed correctly.

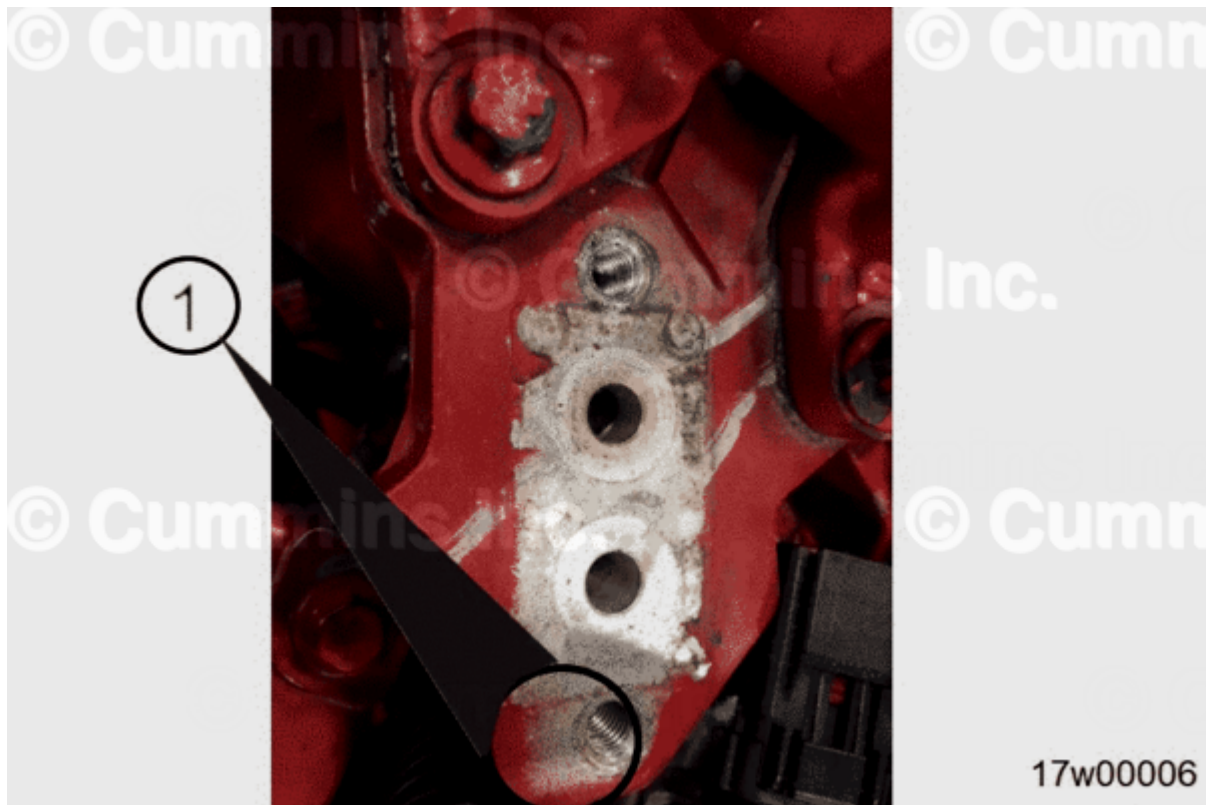
Figure 4, Differential Pressure Sensor Location Without Sensor Installed.

- Some engines are painted after assembly with differential pressure sensor installed. If any unpainted surface can be seen on engines after installation, this indicates the differential pressure sensor was installed incorrectly. An example can be seen in Figure 4 below.

If installed incorrectly, this unpainted surface (1) would be visible.

- Verify no unpainted surfaces are visible at the location as shown in Figure 4 above.

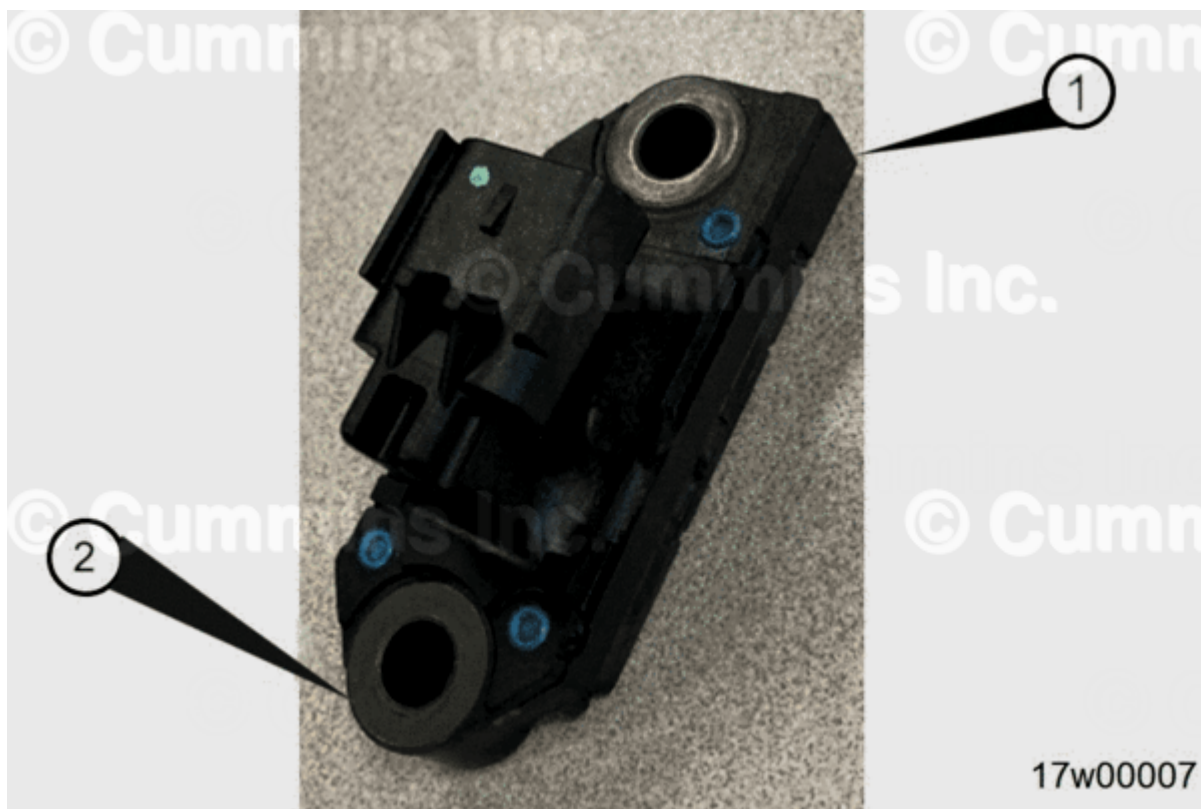
Figure 5, Differential Pressure Sensor With Sides Marked.

The two sides of the differential pressure sensor are the cornered side (1) and the side that **must** be connected to the opposite side of the air intake connection lip (2).

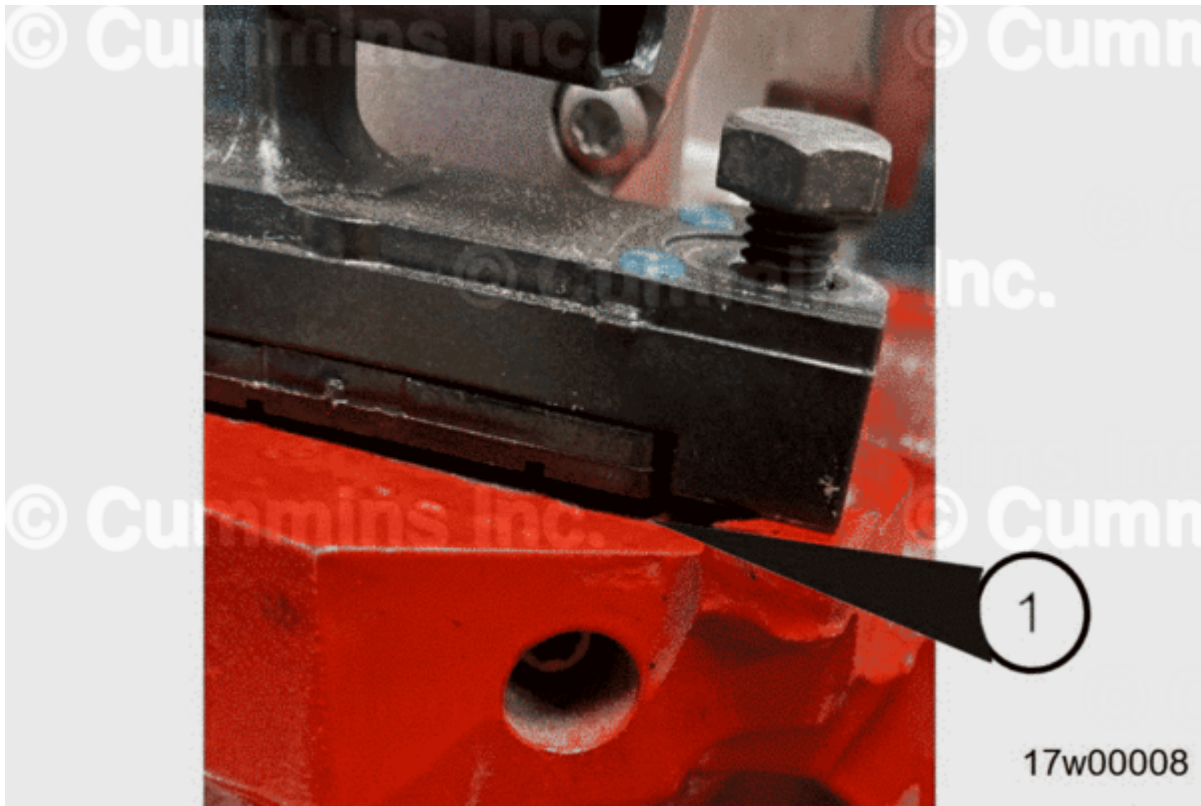
Figure 6, Incorrectly Installed Differential Pressure Sensor Sitting Unevenly On The Air Intake Connection Lip.

If the differential pressure sensor is installed incorrectly, the differential pressure sensor will lay unevenly on the air intake connection lip (1).

- Verify differential pressure sensor is completely flat before tightening capscrews. If installed incorrectly, the air intake connection lip would make differential pressure sensor uneven on the surface. See Figure 6 below.
