Service Bulletin

Bulletin No.: 17-NA-143

Subject: Clicking Noise from Front On Acceleration and Deceleration at Low Speeds

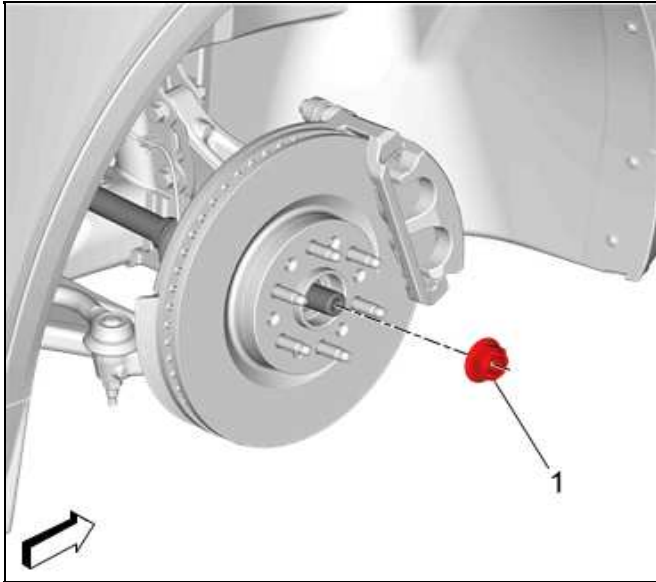
4296858

Caution: **DO NOT** use air tools to remove the wheel drive shaft nut. Damage to the wheel drive shaft threads could occur. Use hand tools only.

2. Remove the wheel drive shaft nut (1) and **DISCARD** the nut.
3. Separate the steering linkage outer tie rod from the steering knuckle.
