Service Bulletin

Bulletin No.: 17-NA-216

Subject: Convertible Top Back Glass Separation from Top Cover Material

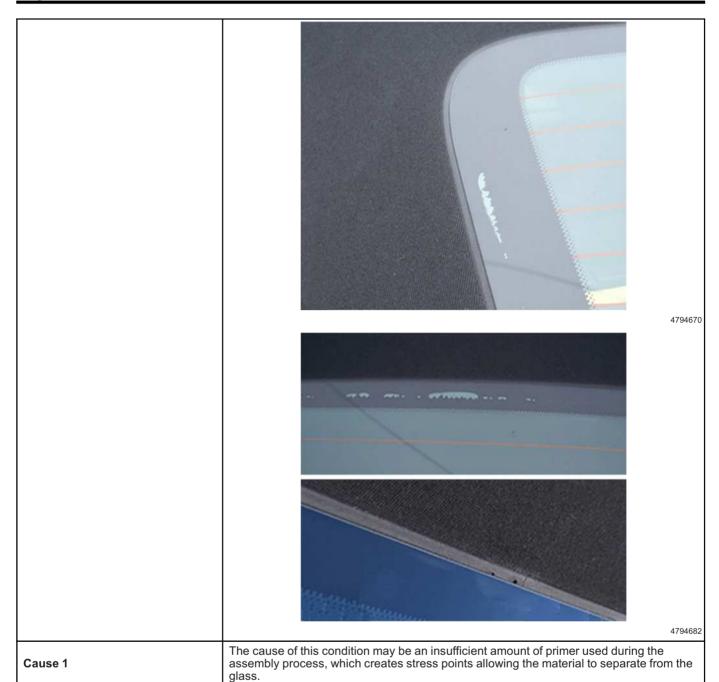
Involved Region or Country	North America, Europe, Middle East, Israel, South America, Japan
	Some customers may comment on seeing the back glass separating from the convertible top cover material. Several examples of the separation are shown in the graphic examples below:
Condition 1	
	479466

Condition 2 5049793 Some customers may comment that the vehicle may exhibit a condition where the back glass is separating from the top. This condition will typically start in the corner of the back glass. Cause 2 The cause of this condition may be the back glass separating from the bond. Correction 4794112 It will be necessary to replace the convertible top cover (1). Refer to Folding Top Cover Replacement in SI.
