Service Bulletin

Bulletin No.: 18-NA-020

Subject: Malfunction Indicator Lamp Illuminated with DTC P0300 and/or P0299/P2227 Set

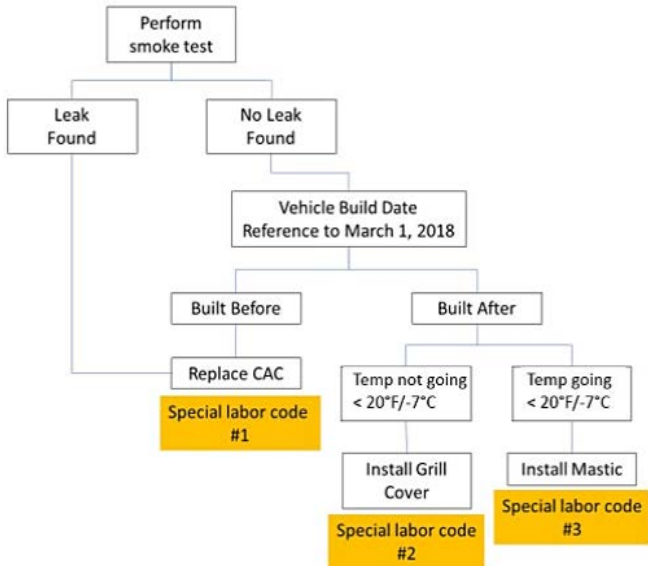
5336724

Flow Chart Based on Conditions
