# MIL ON With Misfire DTC(s) P0301, P0302, P0303, P0304, P0305, and/or P0306

## Applicability

YEAR(S)	MODEL(S)	ADDITIONAL INFORMATION
2016 - 2019	RX450H

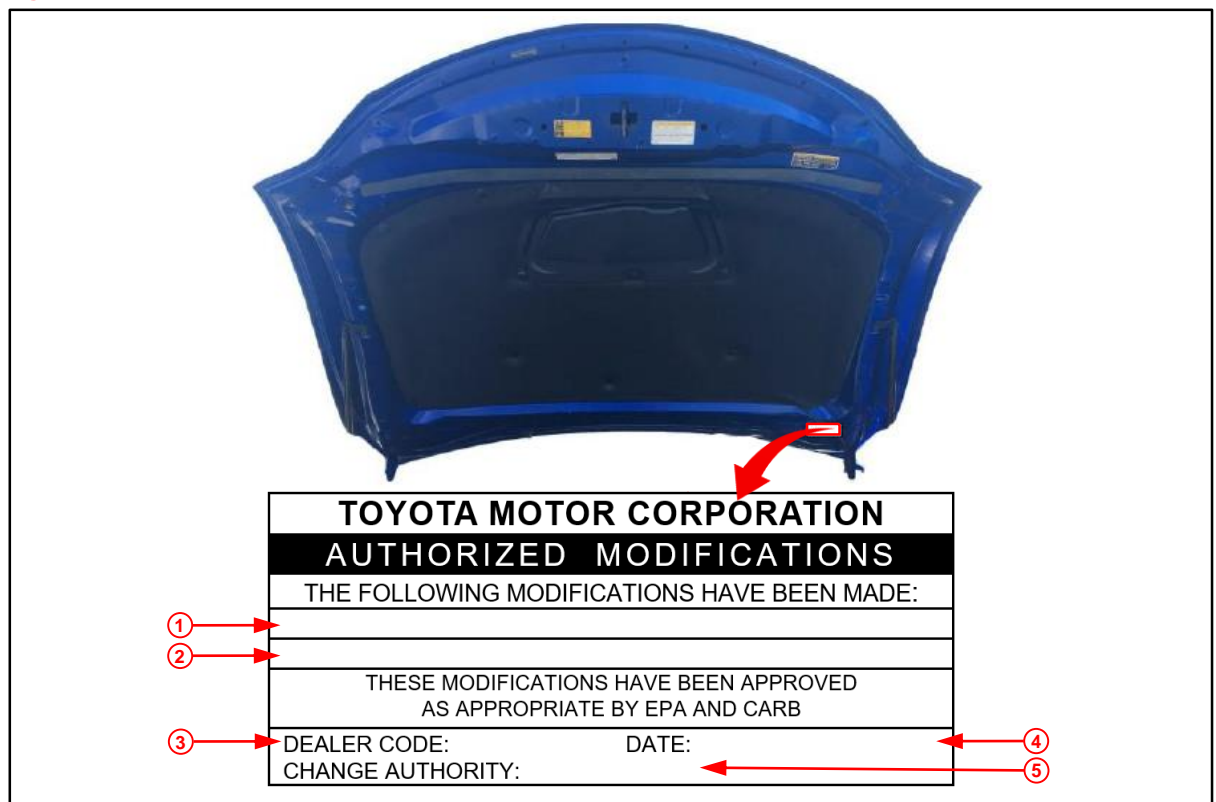
**Figure 1. Location of Authorized Modifications Label on 2016 – 2019 RX450h and 2018 – 2019 RX450hL**

- Use Techstream to confirm if the ECM (PCM) calibration has been updated and check for the Authorized Modifications Label affixed to the vehicle in the location shown below.

<b>1</b>	Replacement ECM (PCM) Part Number (e.g., 90919-02280)
<b>2</b>	New Calibration ID (e.g., 348Q4400)
<b>3</b>	Dealer Code

<b>4</b>	Date Completed
<b>5</b>	This SB Number

- B. Install the Authorized Modifications Label onto the vehicle at the location shown in Figure 1. The Authorized Modifications Label is available through the MDC, P/N 00451-00001-LBL.
