Service Bulletin

Bulletin No.: 19-NA-270

Subject: Phone Ringer Volume Turned Down or Too Quiet

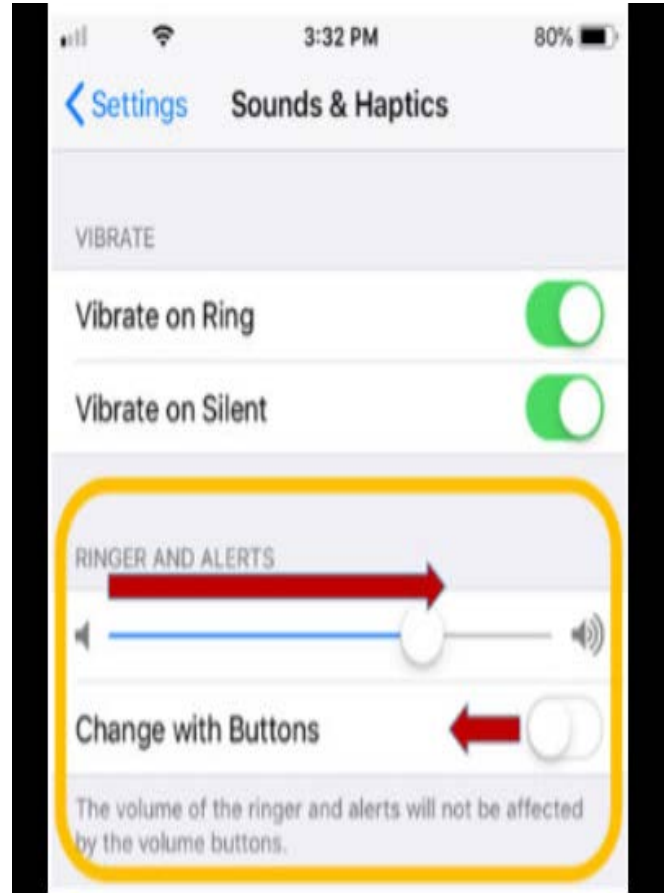
5441750

Condition 1):

1. On the customer's Apple iPhone, enter phone *Settings*.
2. Select *Sounds & Haptics*.
3. Disable *Change with Buttons*.
4. Turn the *Ringer and Alerts* volume back up to the desired level.
