Abnormal Buzz/Groan Noise at 20 – 30 mph From Front Transfer Case

Service Category Drivetrain

Section Transfer/4wd/Awd

YEAR(S)	MODEL(S)	ADDITIONAL INFORMATION
2019	RAV4

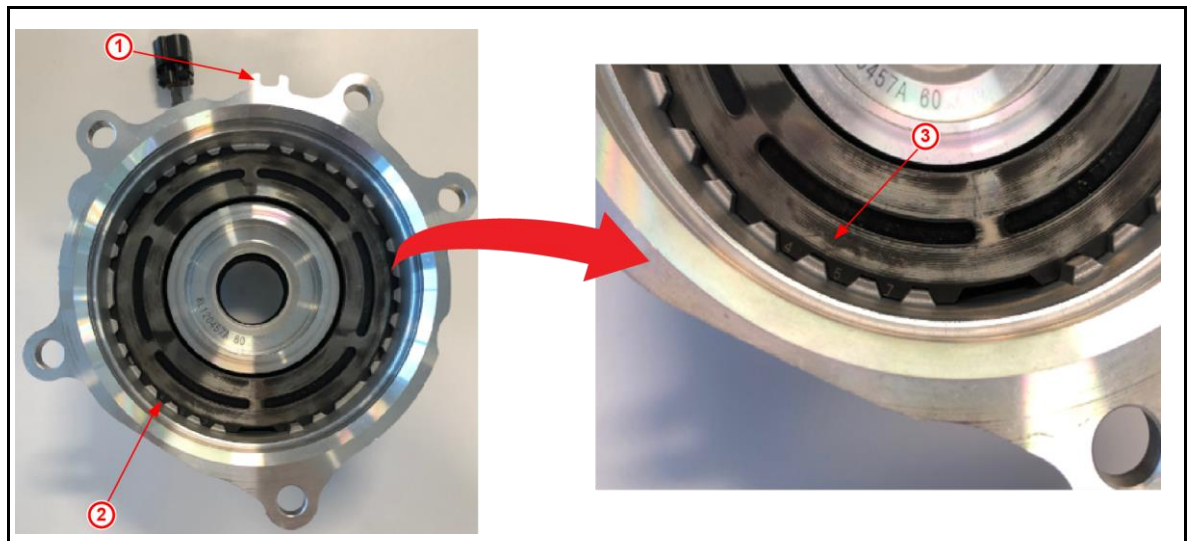
Figure 6.

- Engraved markings **MUST** be visible.
When installed, engraved markings (numbers) will face inward toward the front transfer case/transaxle.
- Outer plate is clocked correctly out of the box as NEW part (it is important to NOT remove the outer plate from the EMC cover).
The reason for NOT removing the outer plate is because it can be easily bent/damaged (no reason to handle outside of the cover).

1. Install the NEW front transfer case electro-magnetic clutch.
 - A. Make sure the outer plate is securely installed to the NEW front transfer case electro-magnetic clutch cover.

- Do NOT exchange ANY component of the NEW front transfer case electro-magnetic clutch, in which shim adjustment has been made, with ANY other kit component.
- Do NOT disassemble the outer plate from the cover of the NEW electro-magnetic clutch.

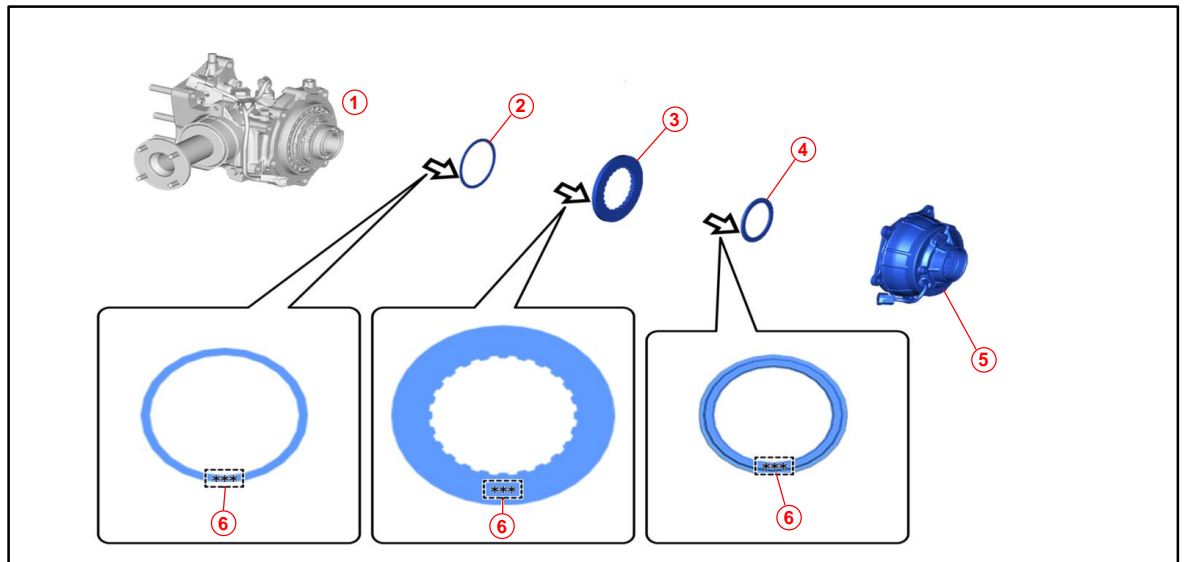
Figure 8.

A NEW shim, armature plate, and thrust roller bearing MUST be installed to the front transfer case with the engraved mark surfaces facing the vehicle inner side (automatic transaxle side). If engraved markings are visible AFTER installation of either shim, armature, and/or needle bearing, the customer may experience the same buzz/groan noise concern AFTER repair. Ensure engraved markings are NOT visible when installing these three components.

1	Engraved Marks Facing Toward Vehicle Inner Side (Automatic Transaxle Side)
2	Shim
3	Armature Plate

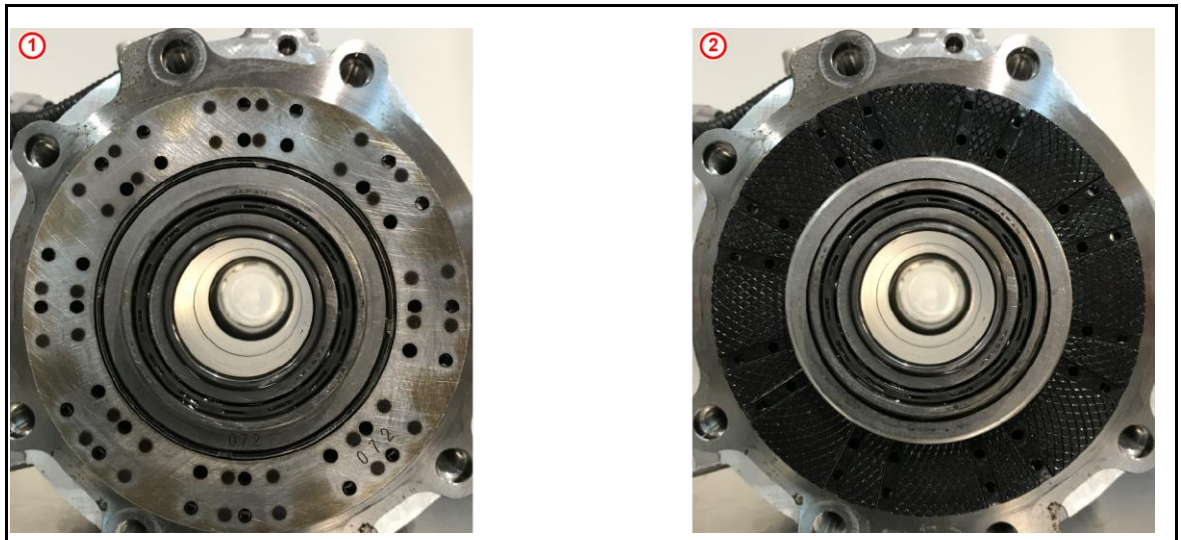
Figure 12. No Good vs OK Condition

NOTE

1	No Good Condition
2	OK Condition

- E. Install the NEW thrust roller bearing to the front transfer case with its engraved mark surface facing the vehicle inner side (automatic transaxle side).
