# Technical Service Bulletin

## 91 SOS Emergency call function deactivated message in the cluster, DTC U153E00 stored in the telematics module

91 19 19 2055945/4 December 16, 2019. Supersedes Technical Service Bulletin Group 91 number 19-96 dated October 2, 2019 for reasons listed below.

Model(s)	Year	VIN Range	Vehicle-Specific Equipment
A4, A5	2019	All	With ConBox Low
A6, A7, A8, Q5, Q7, Q8, and Audi e-tron quattro	2019 - 2020	All	With ConBox Low

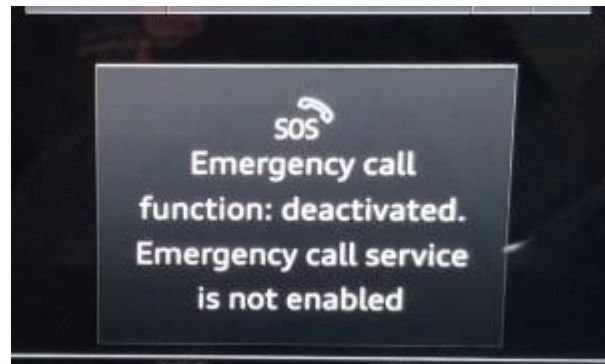
- The warning message “SOS Emergency call function deactivated” is seen in the instrument cluster (Figure 1 or 2).

*Figure 1. SOS warning in the instrument cluster.*

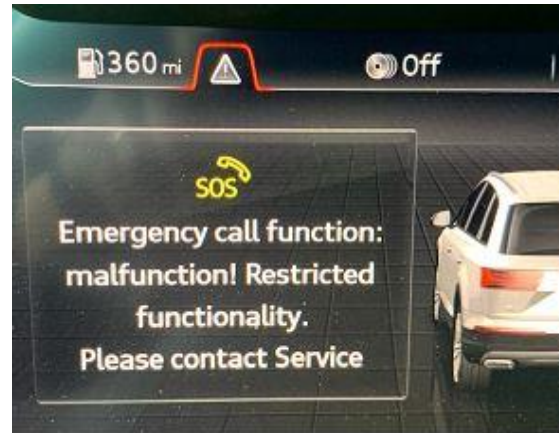
*Figure 2. SOS warning in the instrument cluster.*
