Technical Service Bulletin

20 MIL on or difficulty refueling, DTC P045100, P044100, P202500, and/or P045300 stored in the ECM

20 19 24 2050276/4 December 18, 2019. Supersedes Technical Service Bulletin Group 20 number 19-23 dated November 15, 2019 for reasons listed below.

Model(s)	Year	VIN Range	Vehicle-Specific Equipment
A6, A7	2016 - 2018	All	3.0T

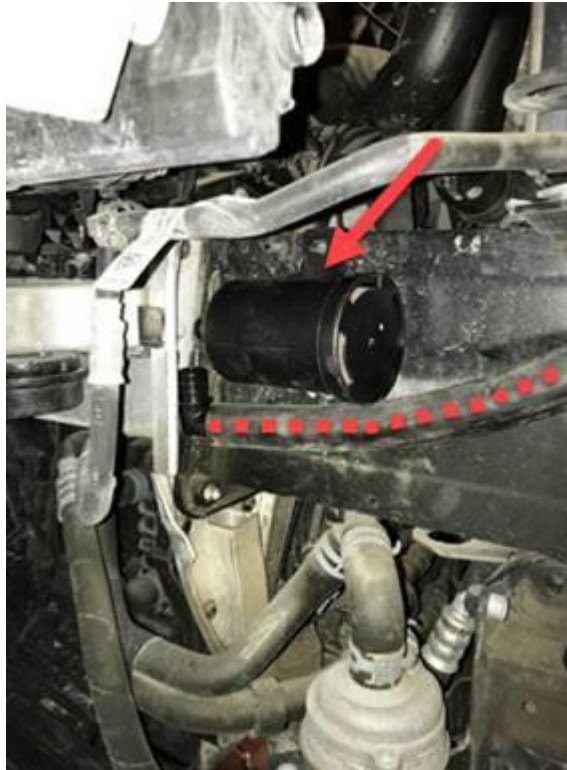
Figure 3. Installing the new NLVD filter.

If updated wheel liner has already been installed at previous repair or in the factory, the NVLD filter needs to be relocated into the engine compartment to prevent moisture entering the EVAP system, under extreme customer use conditions.

1. Replace the EVAP canister only if weight is greater than 2650 grams.
 - Install a new J909.
 - Install the NVLD filter (new part number, Version 2) in the engine compartment on the left frame rail just in front of the ABS module, secure with M6 nut. (Figure 3).

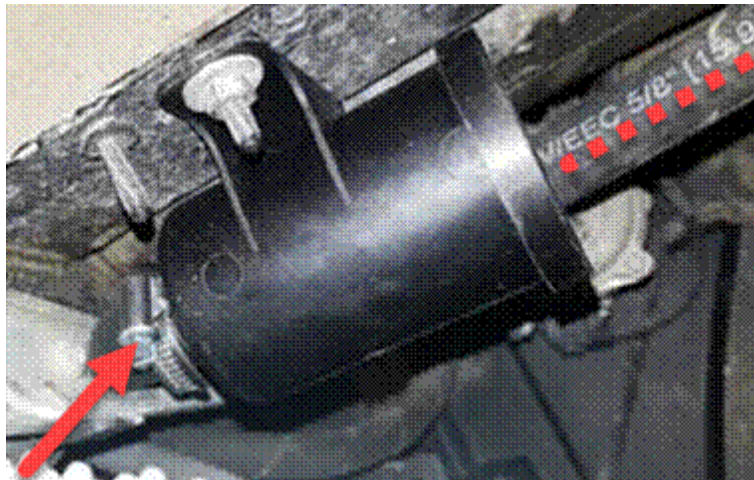
Figure 4. Connecting the NLVD filter.

2. Connect the filter to the 5/8" ID rubber hose via 1x plastic elbow and 1x rubber elbow (Figure 4).

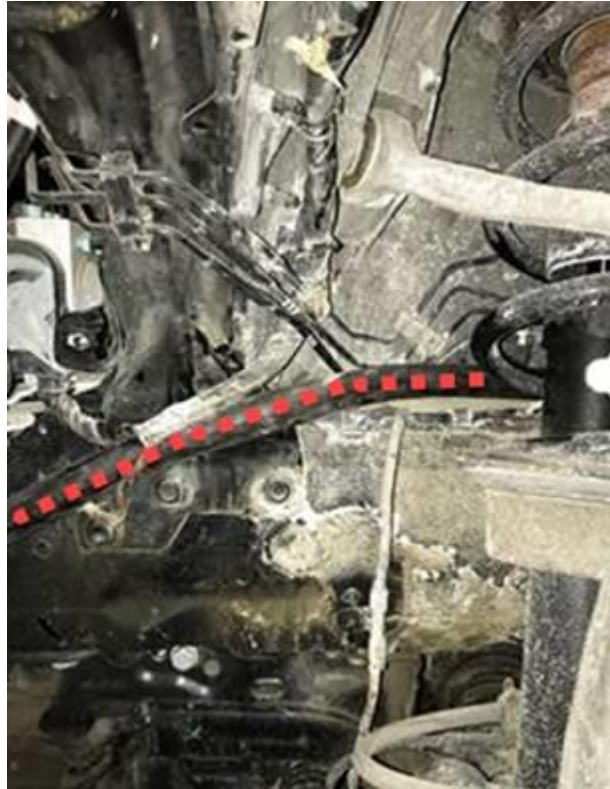
Figure 5. Route the 5/8" ID rubber hose from new filter position to the J909.

3. Route the 5/8" ID rubber hose behind the strut and brake lines from new filter position to the J909, along the orange battery cable (Figure 5 and 6). Then secure with zip ties.

5/8" ID rubber hose needs to be routed in a way that there are no sharp bends to prevent kinking.

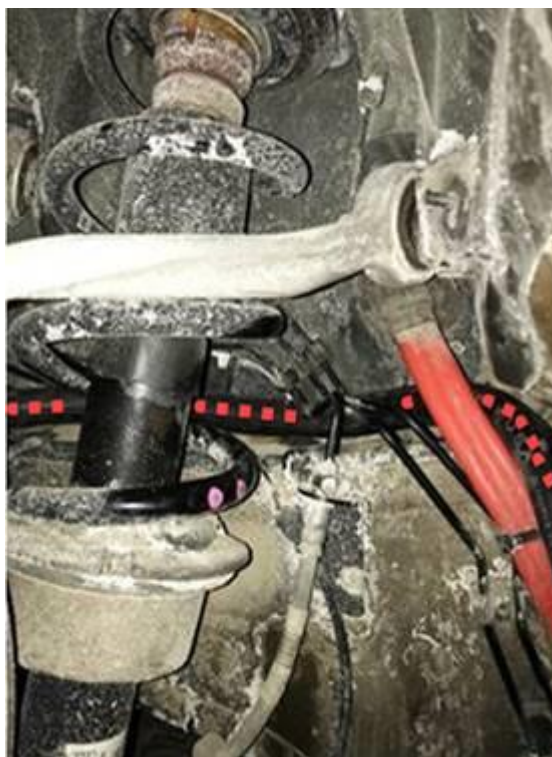
Figure 6. Routing the rubber hose.
