## MBUX multimedia system: Various problems (NTG6)

Topic number	LI82.85-N-070395
Version	2
Function group	82.85 Navigation and Communication system (CNS, ICS, COMAND, FleetBoard)
Date	11-14-2019
Validity	Model 907 with code E1C (AUDIO 25)/ EJ9 (COMAND Online)
Reason for change	Remedy updated
Reason for block

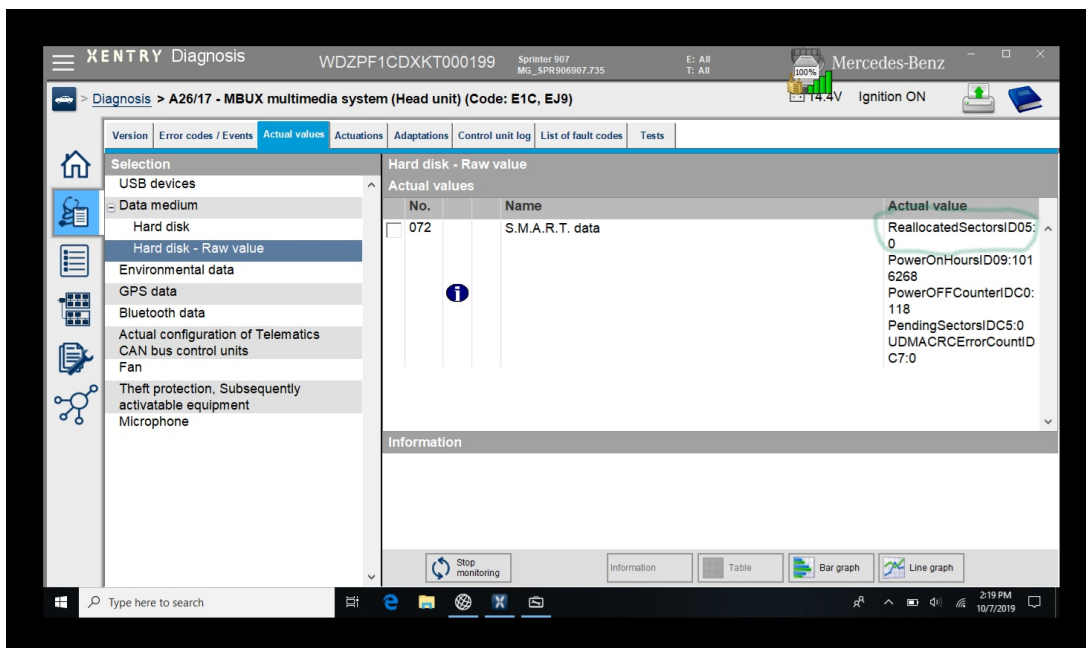
S.M.A.R.T. data.jpg:

Possible internal damage to the hard drive of the MBUX multimedia system (A26/17).

To confirm this, please read out the S.M.A.R.T. data from the MBUX multimedia system (A26/17) under 'Actual values' and check the values. (See attachment)

1. ReallocatedSectorsID05
2. PendingSectorsIDC5

If one or both of these values is greater than zero, the MBUX multimedia system (A26/17) must be replaced.
