Technical Service Bulletin

91 Voice recognition is not available or not enabled

91 19 22 2038136/4 December 20, 2019. Supersedes Technical Service Bulletin Group 91 number 19-46 dated March 12, 2019 for reasons listed below.

Model(s)	Year	VIN Range	Vehicle-Specific Equipment
A3 Cabriolet	2015 - 2018	All	MIB MMI
A5 Cabriolet	2010 - 2017	All	MMI3G or 3G+

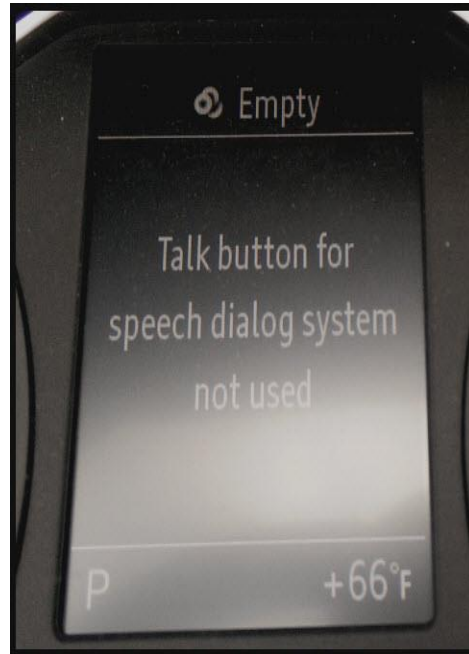
- The message “Talk button for speech dialog system not used” appears in the DIS (driver information system) for A3 Cabriolet vehicles (Figure 1).
- The message “Not available” appears in the DIS for A5 Cabriolet vehicles (Figure 2).

Figure 1. Message for A3 Cabriolet.

If the customer requests to have the VR feature enabled, it can be done through a change to the coding of the information control module 1, J794 (address word 005F). The labor to perform this change is not covered by warranty.

Coding change A3 Cabriolet (MY2015-2016) with MIB1 High & (MY2017) with MIB2 High: Byte 24 of the information control module 1, J794 (address word 005F) long coding controls the activation of the VR/SDS system. Additionally, you can use the free text search in ODIS to search for “Speech” or “SDS” and select “SDS activated” within the coding function.

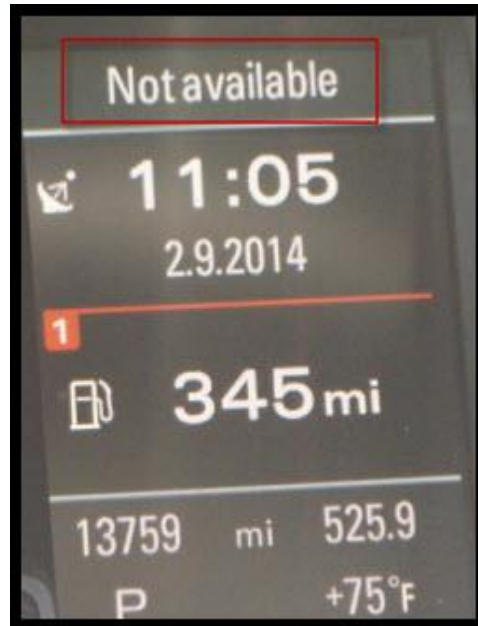
Figure 2. Message for A5 Cabriolet.

Coding change for A5 Cabriolet vehicles with MMI3G/MMI3G+: Byte 16 of the information control module 1, J794 (address word 005F) long coding controls the activation of the VR/SDS system. Note that this is byte 16 when counting in decimal, i.e., 1, 2, 3,...9, 10, 11, 12, 13, 14, 15, 16. Some aftermarket diagnostic tools number the coding bytes using HEX, i.e., 1, 2, 3,...9, A, B, C, D, E, F, 10, 11.

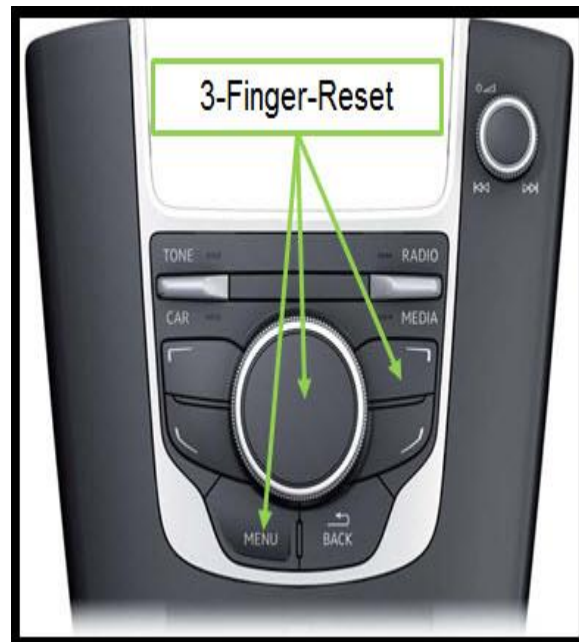
Figure 6. Three-finger reset for MIB1.

6. Hit “Apply” in the pop-up window, then hit “Apply” at the bottom of the main window.
7. Perform a three-finger reset of the main unit using the MMI control panel (Figure 6-9).

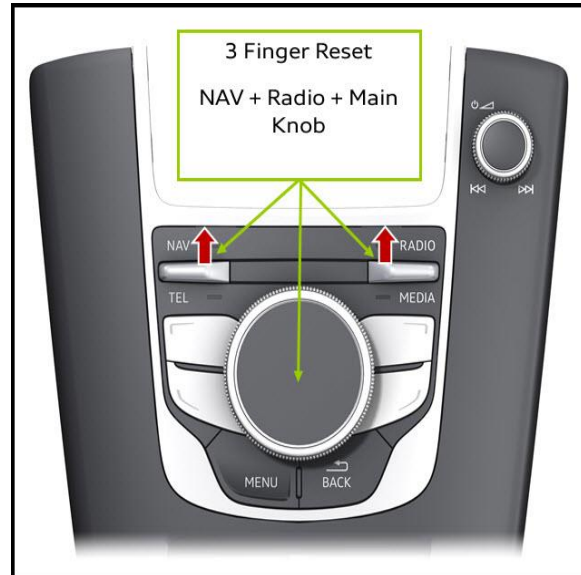
Figure 7. Three-finger reset for MIB2.

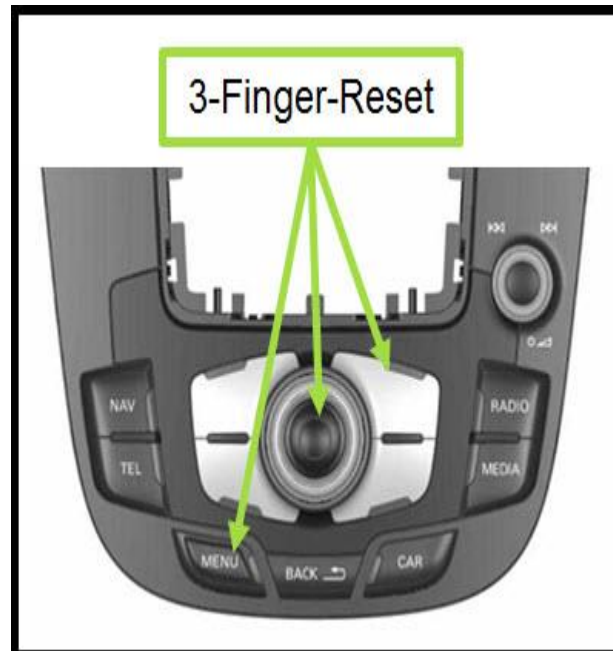
Figure 8. Three-finger reset for MMI3G+.

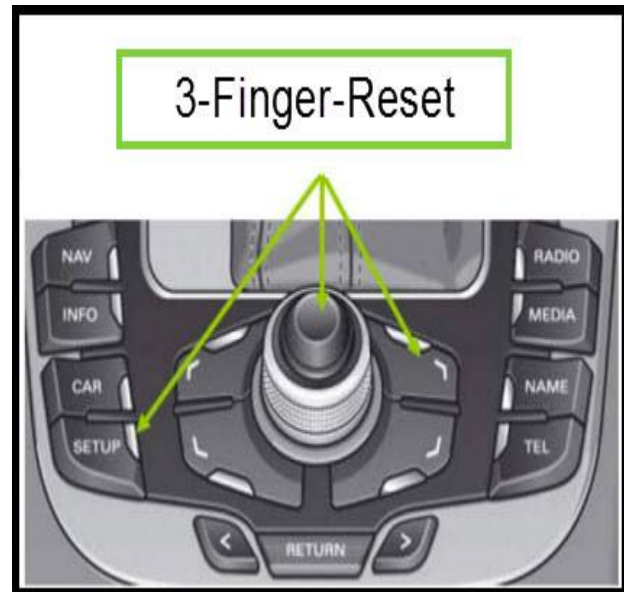
Figure 9. Three-finger reset for MMI3G.

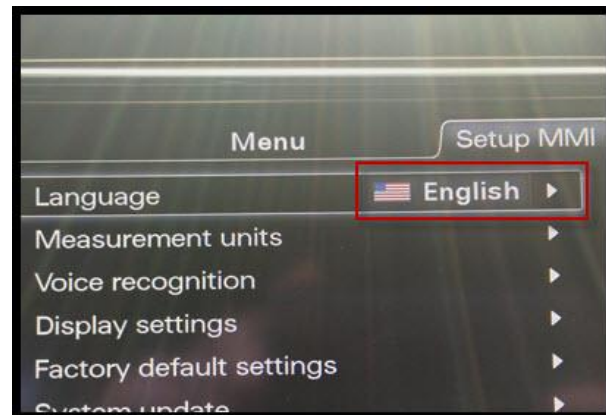
Figure 8. System language setting.

8. Test the system to verify all functionality. If the VR/SDS system does not fully function, or if it is in a different language, go to *Menu >> Setup MMI >> Language* (Figure 8) and change the language to any language other than English (either Spanish or French). Perform a three-finger reset, then set the language back to English and test the system again.
