# Technical Service Bulletin

## 92 Washer solvent level warning is on

92 19 24 2038151/11 December 20, 2019. Supersedes Technical Service Bulletin Group 92 number 19-23 dated November 12, 2019 for reasons listed below.

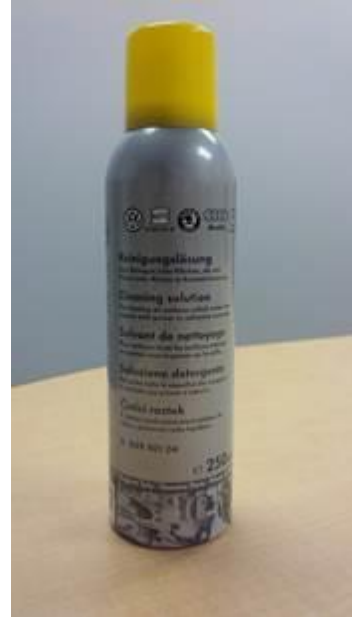
*Figure 1. D 009 401 04 all-purpose cleaner.*

1. Empty the reservoir and for all vehicles *except* A3 Sedan and A3 Cabriolet, remove the level sensor. Clean the sensor probes using all-purpose cleaner **D 009 401 04** (Figure 1) or, as an alternative, isopropyl alcohol. Reinstall the level sensor.

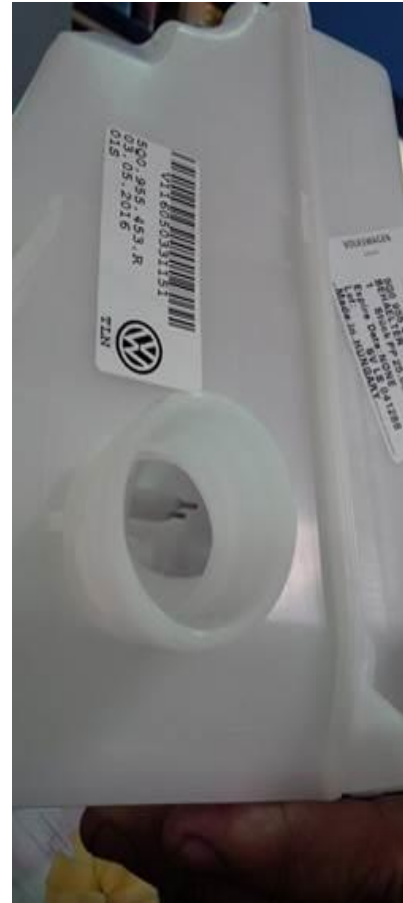
**Figure 2.** Windshield washer level sensor probes as viewed through the tank opening.

2. For Audi A3 Sedan and A3 Cabriolet where the washer solvent level sensor is not removable the sensor probes can be cleaned by removing the reservoir, removing the filler neck from the reservoir and gaining access to the sensor probes (Figure 2).

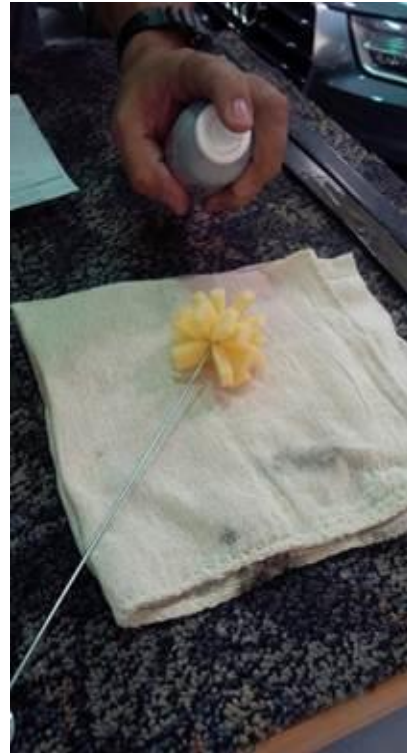
*Figure 3. Applying all-purpose cleaner **D 009 401 04** to the tip of a humming bird feeder cleaning brush. The cleaning brush can alternatively be saturated with isopropyl alcohol.*

3. Saturate the tip of a cleaning brush with a rigid stem and long enough to reach the probes (approximately 10") with all-purpose cleaner **D 009 401 04** or isopropyl alcohol. A humming bird feeder cleaning brush is shown in the illustration but any suitable cleaning brush with a tip constructed of the appropriate material will function well for this purpose (Figure 3).

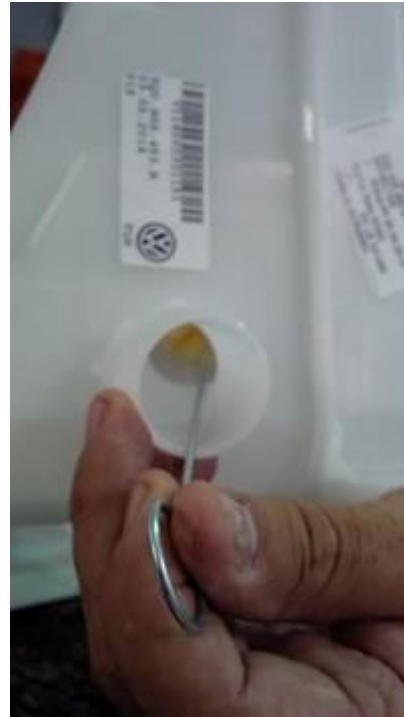
*Figure 4. Cleaning the sensor probes.*

4. Thoroughly clean the sensor probes (Figure 4).

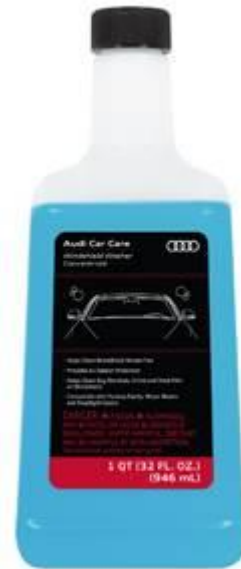
*Figure 5. ZAW 096 311 B windshield washer fluid concentrate.*

5. Refill the reservoir with the correct type and concentration of solvent. Windshield washer fluids found in the Audi Top Service Supplies and Touch Up Paint eStore with a 35% pre-mix are suitable for temperatures down to -30 °C (-22° F) and contain no rain repellents. For freeze protection below this temperature range Windshield Washer Fluid Concentrate **ZAW 096 311 B** can be used and mixed according to the table below (Figure 5). This solvent can be adjusted for freeze protection to -32° C (-25° F), prevents washer jet contamination particularly on the “fan” type of washer jet, and is highly effective in removing residues and insects from the windshield.

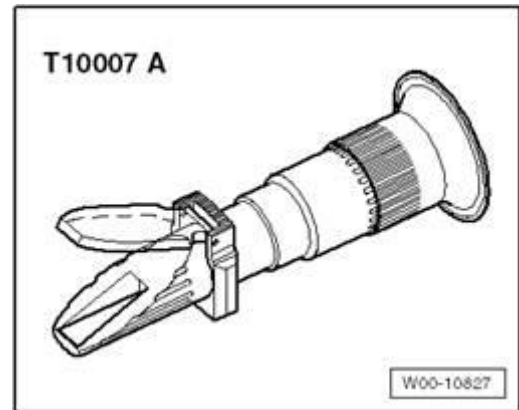
Figure 6. T10007A refractometer.

- The concentration and freeze point can be checked using the T10007A refractometer (Figure 6).

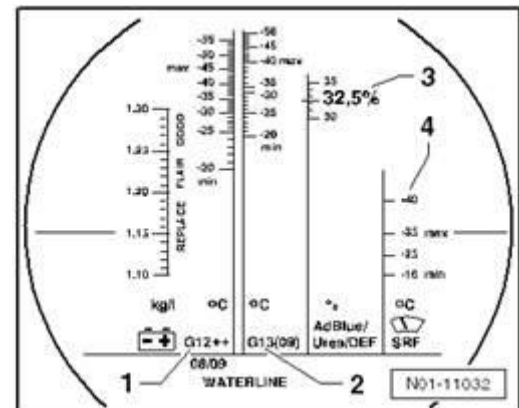
Figure 7. Scale in the view of the T10007A refractometer.

- Put a drop of washer fluid with the pipette on the glass of the refractometer. When viewing the refractometer, a light-dark border can be clearly recognized. Using the scale to the right (Figure 7), adjust the concentration of the solvent to accommodate the current weather conditions.
