**Complaint - Cylinder Head Cover Near the Injector Holes Leaking: Subsequent work on cylinder head (180/18)**

Revision: **This bulletin replaces bulletin Group 1, #180/18, dated March 7, 2019.**  
This revision includes additional vehicle types.

Vehicle Types: **Cayenne (9YA)/Cayenne E-Hybrid (9YA)/Cayenne S (9YA)**

Subject: **Cylinder head cover**

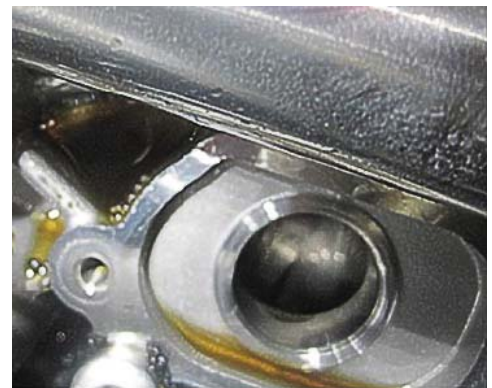
- 1.5 Look and see whether there is a large quantity of oil under the valve lift adjustment solenoid hydraulic valve, see ⇒ *Fault type 1: Valve lift adjustment solenoid hydraulic valve leaking*.

**If so:**
      - O-ring on valve lift adjustment solenoid hydraulic valve is responsible for the leak(s).
      - Clean the engine compartment and replace the affected solenoid hydraulic valve(s) with O-rings.

*Fault type 1: Valve lift adjustment solenoid hydraulic valve leaking*

- If the insulation on the top of the cylinder head cover is already soaked with oil, this must be replaced too.
      - With ⇒ 3 continue.**If not:**

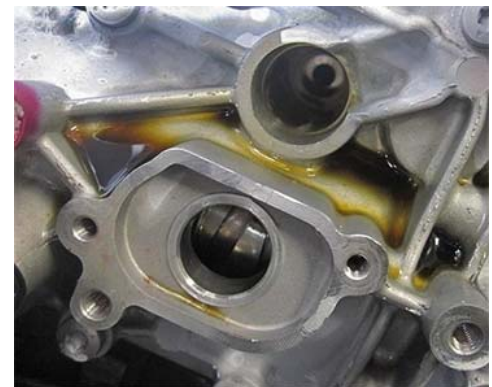
2.3.1 Oil must have collected in the vicinity of the injector of the affected cylinder and the insulation on the bottom of the cylinder head cover should be fully soaked.

*Fault type 2: Cylinder head cover leaking*

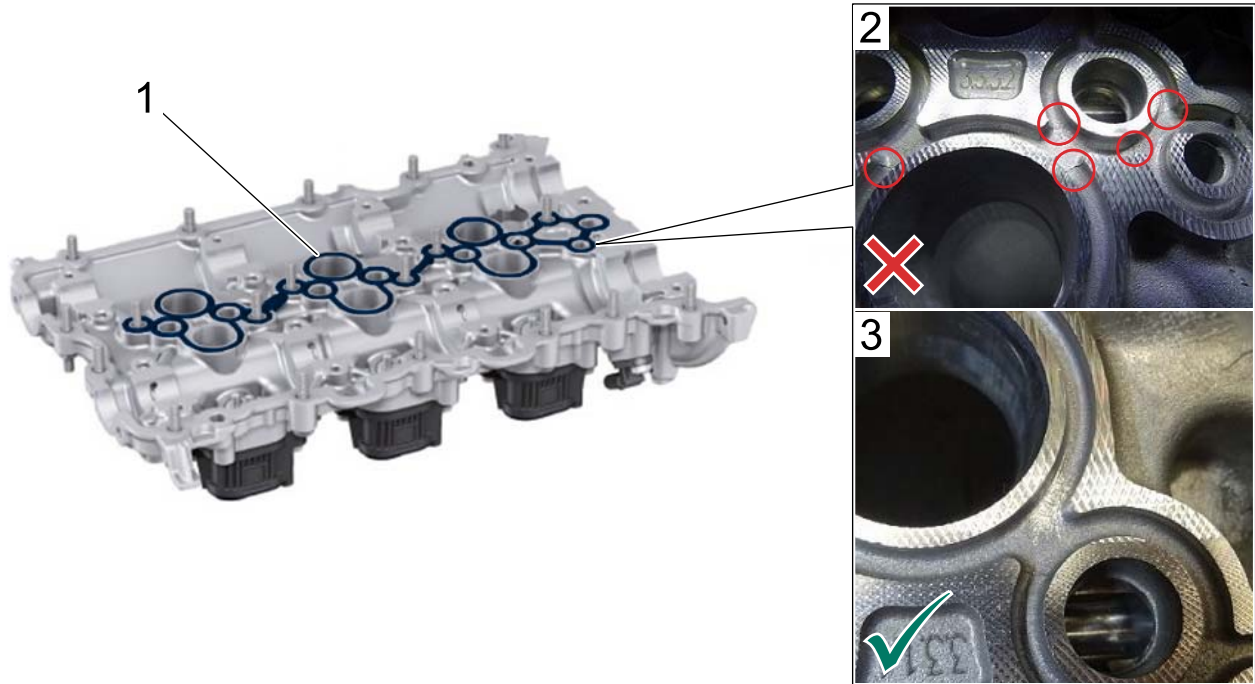
- Due to a batch error in the casting procedure there may be cast residue in the cylinder head cover sealing groove.
- This cast residue may cause the injector holes to leak.

2.6 Check the sealing groove (⇒ *Cylinder head cover sealing groove -1-*) of the cylinder head cover visually. Be particularly meticulous when doing this especially in the vicinity of the affected cylinder.

*Cylinder head cover sealing groove*

2.7 Carefully remove any cast residue (⇒ *Cylinder head cover sealing groove -2-*) using a small flat screwdriver, ensuring that the sealing groove is not damaged. There must be no more cast residue in the sealing groove after machining (⇒ *Cylinder head cover sealing groove -3-*).
