Symptom - Engine - Engine is Sluggish When Revving Up/Maximum Speed is Not Reached: Checking Part Number of Throttle-housing Cover (SY 104/19)

Vehicle Type: **911 GT3**

Model Year: **As of 2018 up to 2019**

Subject: **Throttle-housing cover**

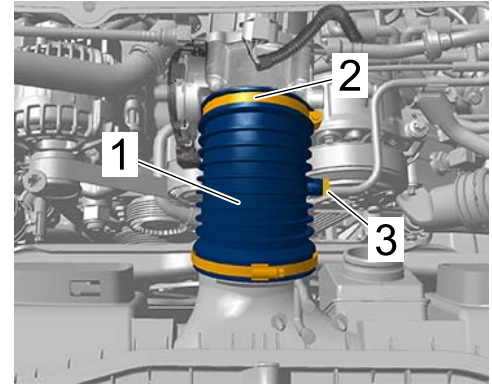
Throttle-housing cover

Cause: The cover between the air cleaner housing and throttle housing can become deformed due to insufficient material hardness while driving.

Work Procedure: 1 Check part number ⇒ *Throttle-housing cover -1-*.

- 1.1 Replace throttle-housing cover with Part No. **99111027091**, see ⇒ *Workshop Manual '242519 Removing and installing air cleaner housing'*.
