Technical Service Bulletin

PSS 91 Audi Smartphone Interface (ASI): Apple CarPlay or Android Auto display screen intermittently goes blank in FPK

91 19 25 2056232/2 December 20, 2019. Supersedes Technical Service Bulletin Group 91 number 19-97 dated October 2, 2019 for reasons listed below.

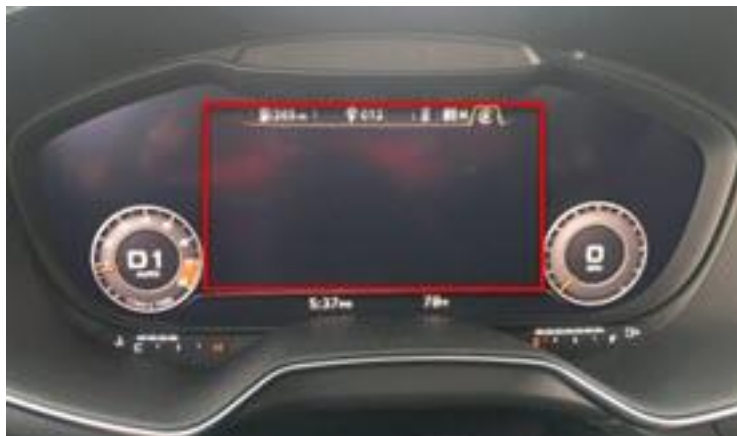
- The FPK (Free-Programmable Kombi/Cluster) screen goes blank intermittently when viewing the Audi Smartphone Interface (ASI) screen (Figure 1). This can occur while using Apple CarPlay or Android Auto.

Figure 1. FPK screen is blank.

This condition is caused by an MMI software configuration issue. Currently, as solution is being developed. Model Year 2019-2020 vehicles can have this issue with the factory-installed MMI software. Additionally, Model Year 2018 vehicles that received a recent MMI software update could also experience this issue. It's important to note that the issue is intermittent and does not always occur during a drive based on driving conditions. However, for some customers, this issue can occur during each trip each day.

Please inform the customer that the issue can occur when the vehicle speed drops below 20mph. Add the customer's information into the Pending Service Solution (PSS) system (*AccessAudi.com >> App Links >> Service >> Pending Service Solution (PSS) or <http://www.accessaudi.com/pssjct>*).

Additionally, inform the customer about the following temporary workaround.
