Technical product information

Topic	Bentayga Auxilary/cabin heating not working as expected - W12 engine derivative only
Market area	Bentley: worldwide (2WBE),Hongkong-Macau (5HK)
Brand	Bentley
Transaction No.	2057865/1
Level	EH
Status	Approval
Release date

Bentayga Fitted with Auxilary heater - W12 engine derivative

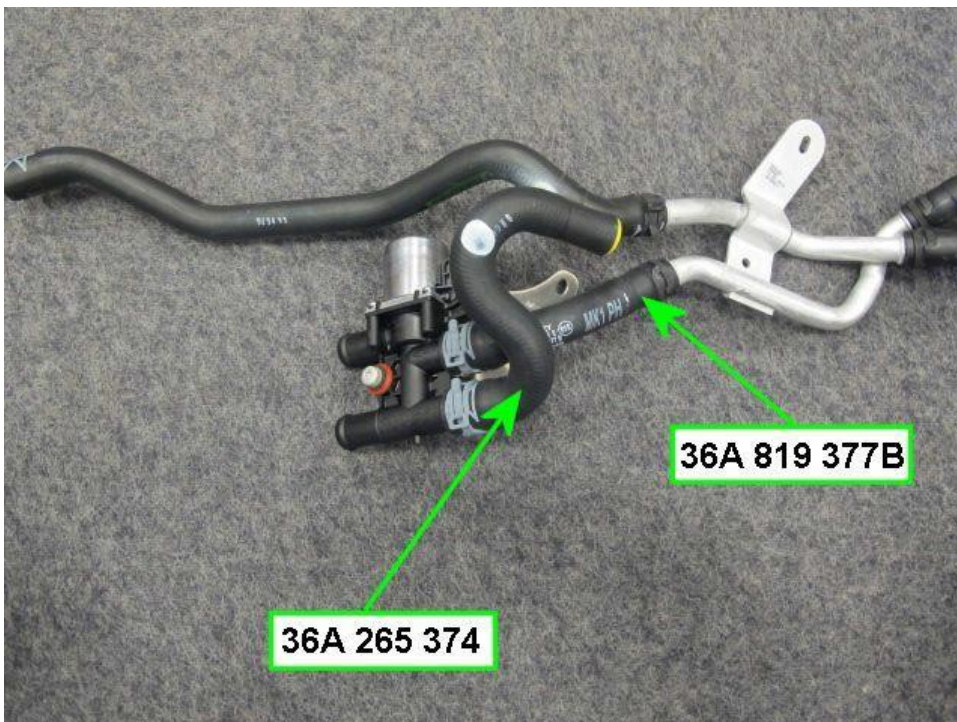
1) Referring to Figure 1 check the orientation of the auxiliary heater hoses NOTE: The hoses shown in Figure 1 are fitted/located correctly

In the event the hoses are found to be incorrectly connected carry out the following instructions

5) Swap the hoses to the correct orientation as shown in Figure 1 NOTE: For this procedure ensure the clips are replaced
