**SERVICE PROGRAM BULLETIN**

**APPLICABILITY:** 2015-2018MY Forester 2.0L Turbo  
2016-2018MY WRX 2.0L Turbo

**NUMBER:** WUK-96

**SUBJECT:** DIT Exhaust Pipe Front (EPF) Nut Torque

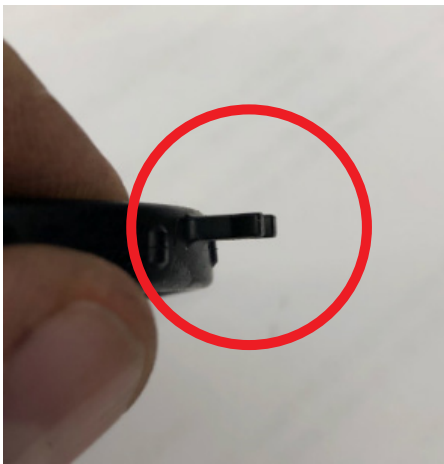
Locating Tab Is Offset  
(not centered).

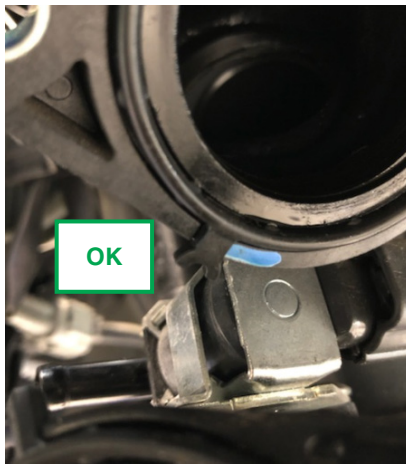
Locating Tab Is Installed  
Toward Turbo, O-Ring Is OK.

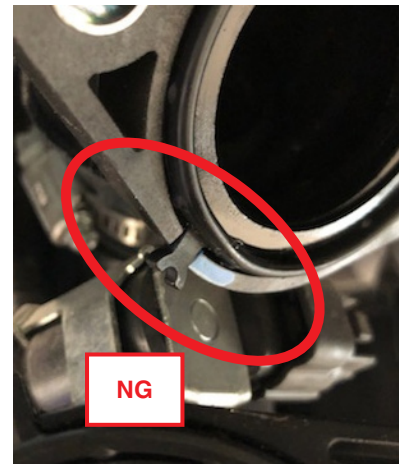
Tab Is Installed Toward Meter,  
O-Ring is Distorted.

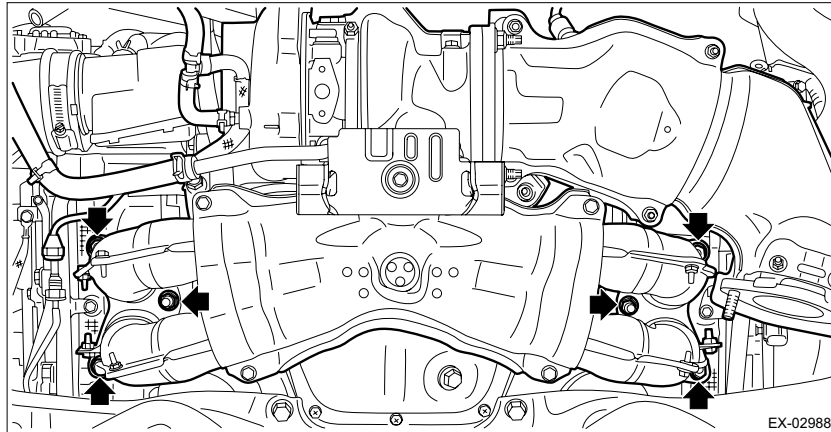
- Are any of the 6 EPF nuts shown in the figure below missing?
- Is there any trace of exhaust gas leakage (soot deposits) around the EPF mounting flanges at the cylinder heads? **IMPORTANT:** Always check for exhaust gas leakage even if all the EPF nuts are in place.

When all 6 of the EPF nuts are in place or, if there is no trace of exhaust gas leakage, proceed to **Step 2:** and inspect the 6 EPF nuts for proper torque.

When any of the 6 EPF nuts are missing or, if there is exhaust gas leakage: proceed to **Step 3:** and replace the EPF assembly.

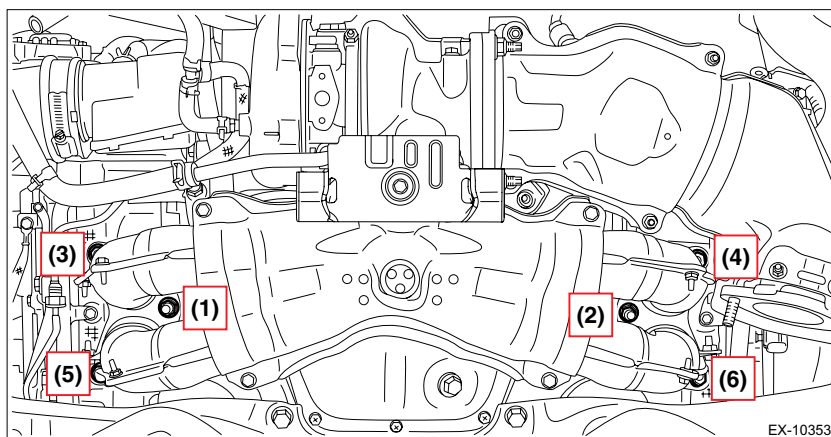
**Step 2:** Tighten the 6 EPF nuts to 45.5 Nm (4.6 kgf-m, 33.5 ft-lb) in the order shown below to check if any of them turn.

If none of the 6 EPF nuts turn: reinstall the front engine under cover to complete the procedure.

If any of the 6 EPF nuts turn: proceed to **Step 3:** and replace the EPF assembly.

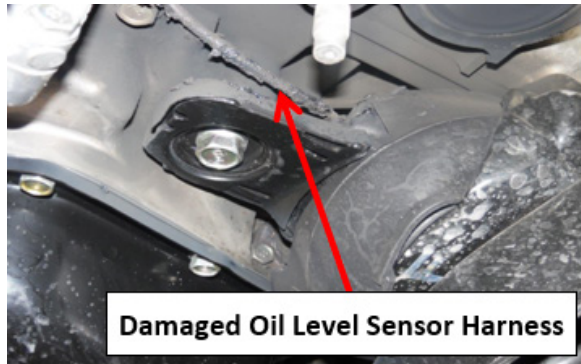
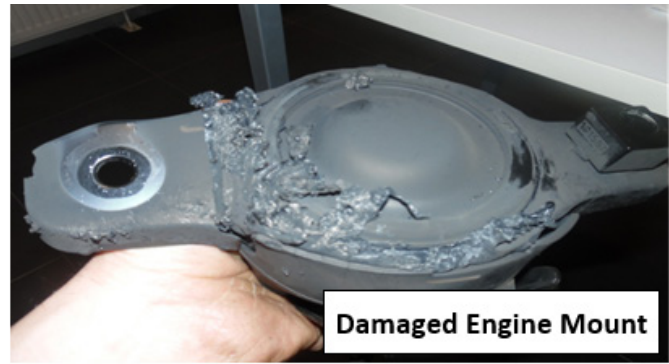
**Step 3:** When inspections during **Step 1)** or **Step 2)** dictate the EPF needs to be replaced, replace it following the procedure in the applicable Service Manual. During EPF replacement, inspect the peripheral parts (engine mount, oil level switch / harness, etc.) for any heat damage from leaking exhaust.

If none of the peripheral parts near the EPF are damaged, replace the EPF assembly to complete the procedure.

If any peripheral parts near the EPF are damaged, replace them as needed along with the EPF assembly following the procedures outlined in the applicable Service Manual.
