Technical Service Bulletin

Topic	Service info: body/equipment: front exterior lighting steamed up/leaks
Market area	Bentley: worldwide (2WBE),Hongkong-Macau (5HK)
Brand	Bentley
Transaction No.	2050542/4
Level	EH
Status	Released for publishing
Release date	Dec 16, 2019

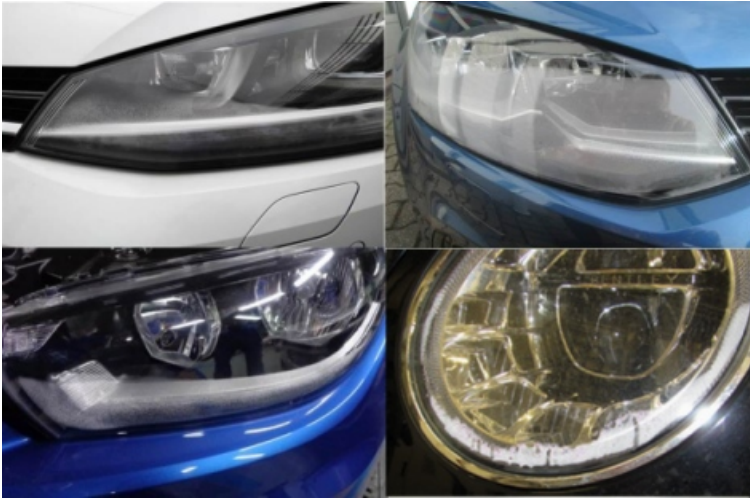
Illustration 1a (example for headlights)

1. The lenses of the headlights (illustration 1a) /front fog lamps (illustration 1b) are steamed up/damp from the inside with minor drips.

Customer statement for 1 (illustration 1a/1b): The lenses of the headlights/front fog lamps are steamed up/damp from the inside with minor drips.

1. Damp air settles on the inner lens of the headlights/fog lamps, with recognisable misting in certain weather conditions (comparable with the steaming up of spectacle lenses when entering a warm room in winter or of the bathroom mirror after a shower).
2. Leak on the headlights/front fog lamps. For example through open covers, a damaged seal of the cap or similar.

1. In case of a headlight complaint the light emission surface on the lens (illustration 3, point 2) must be clear after a journey of 5-10 minutes with sufficient ventilation (for example country road/motorway) and switched-on dipped beam. It is no problem if the remaining surfaces of the inner lens (illustration 3, point 1) are steamed-up after a journey. But the time for the clearing process depends on the outside temperature, the vehicle speed (at higher speeds the ventilation of the headlights is better) and the relative air humidity.

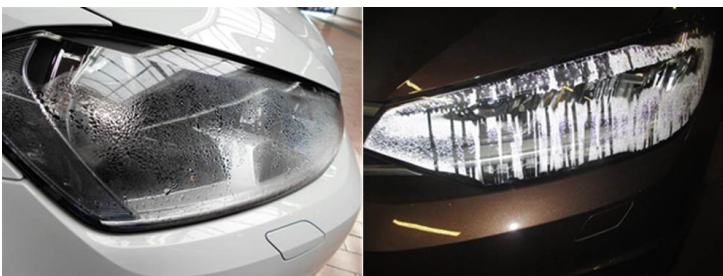
Illustration 2a (example for headlights)

2. Water is in the headlight (illustration 2a) / front fog lamp (illustration 2b), big drips.

Customer statement for 2 (illustration 2a/2b): Water is in the headlights/fog lamps, big drips on the complete lens. Leak on the headlights/front fog lamp.

2. In case of an obvious water ingress/leak (a lot of drips on the inside of the lens, illustration 2) check first the cover and the seals on the headlight/front fog lamp. In case of water ingress (damaged seal, lens and so on) perform the appropriate repairs according to the repair manual/parts catalogue.

Ask the customer to keep an eye on the situation. If despite the above repair the customer complains again about leaking headlights/front fog lamps and water ingress or lots of drips can still be recognised after the checks, replace the headlights/front fog lamps according to the repair manual/parts catalogue.

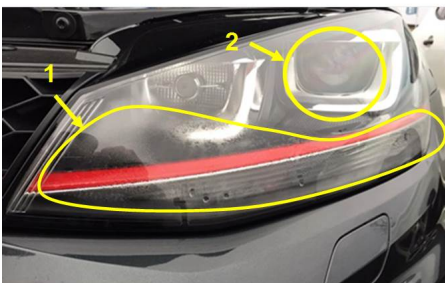
Illustration 3

1 = steaming-up in the headlight

2 = light emission surface

In this case use the argumentation aid (physical situation) under Customer information. **In this case a replacement of the headlights would not fix the problem and lead to a repeat repair.**
