SERVICE BULLETIN

Classification: FA19-003	Reference: NTB19-117	Date: December 12, 2019
-----------------------------	-------------------------	----------------------------

2020 MAXIMA; CREAKING SOUND FROM FRONT SUSPENSION WHILE TURNING

APPLIED VEHICLES: 2020 Maxima (A36)
APPLIED VIN AND DATE: Built before 1N4AA6(*)V(*)LC 365651 / October 9, 2019

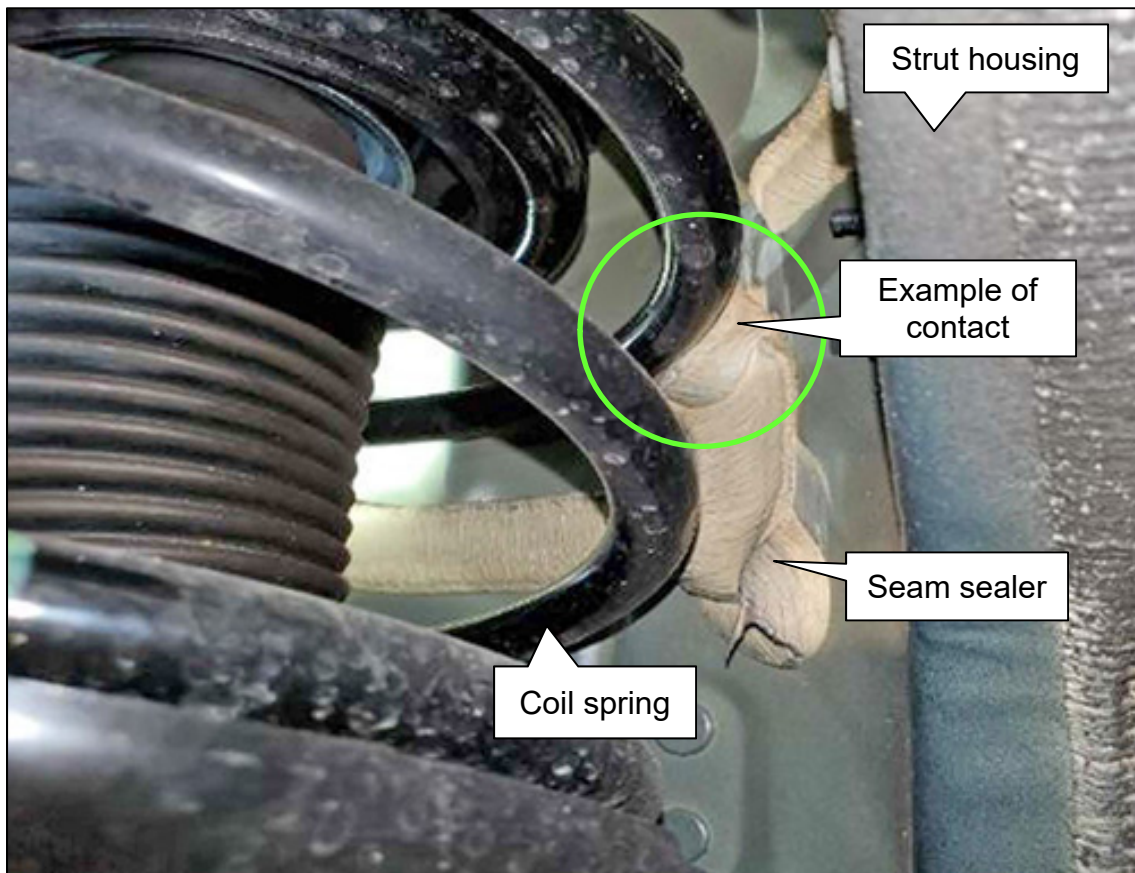
Figure 2

1. While slowly turning the steering wheel from lock to lock, inspect for contact between the coil spring and the seam sealer of the strut housing (see Figure 2).
 - Step 1 must be performed with the full weight of the vehicle resting on the tires.

2. If there is contact between the coil spring and the seam sealer, remove the excessive seam sealer with an appropriate tool.
 - Carefully remove only enough seam sealer to stop contact with the coil spring.

- Take care to not remove paint from the strut housing. If bare metal is exposed it must be repaired with self-etching primer.
- Do not remove the seam sealer to the point that it no longer covers the seam. If the seam is exposed it must be repaired with the appropriate seam sealer.
