TECH TALK

Volume 196, April, 2013

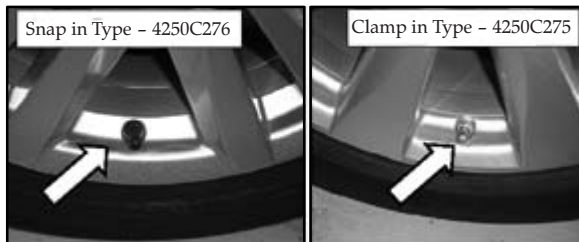
Due to a supply issue with the “snap-in” type Tire Pressure Monitoring System (TPMS) sensor, subject vehicles are temporarily being built using the 2012 “clamp in” type sensor. This change will affect production and service parts until the supply issue is resolved. An owner’s manual addendum card reflecting this change has been placed in the glove box of affected vehicles.

The TPMS sensor type can be easily identified by the valve stem.

4250B975 in the service parts system. Once p/n 4250C276 becomes available, the supersession will be broken, allowing supply of both part numbers. If a replacement sensor is required, install p/n 4250B975. If a customer comments about the cosmetic difference, advise them the original specification sensor can be installed, at no cost to them, when inventory becomes available.

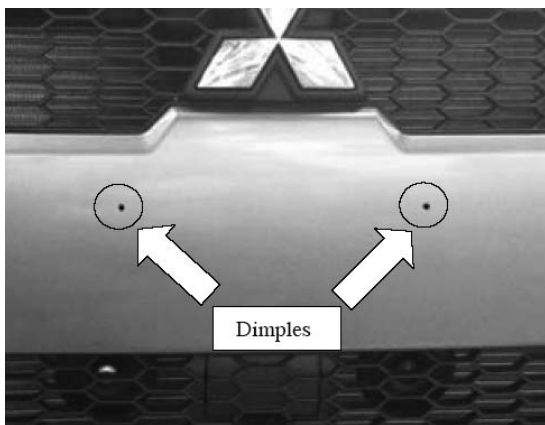
Affected vehicles are no longer shipped with front license plate hardware (rubber nut and bolt package). Dealers are asked to use self-tapping screws for mounting the front license plate. License plates should be installed in the locations indicated by dimples in the front fascia. Dealers should use locally sourced, non-corroding, M6 fasteners, 20mm to 25 mm long. **Fasteners should be installed using hand tools only.**

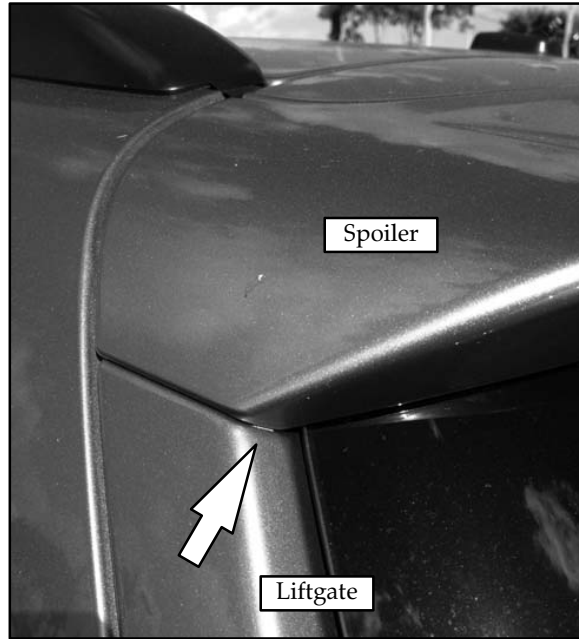
REAR SPOILER/TAILGATE RUB MARKS — 2011 to 2013 Outlander Sport/RVR w/factory installed rear spoiler. MMNA is investigating the cause of rub marks in the paint at the contact point between the factory installed rear spoiler and tailgate.

Do not replace the spoiler for this condition. Look for an upcoming publication to address this concern. In the meantime you can contact Techline for the latest information.

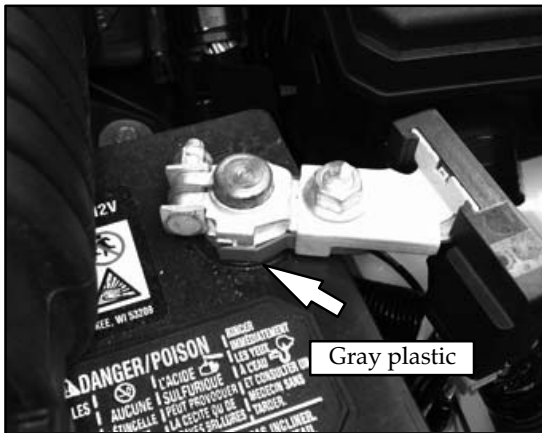
2011-2013 Outlander Sport/RVR. When connecting a battery charger or using test equipment that connects to the battery, make sure that you connect to the metal portion of the negative (—) battery post or cable. If you connect to the gray plastic support under the cable connection, you may cause improper test results or incomplete battery charging.
