2014 Mirage

TECH TALK

Volume 199, August, 2013

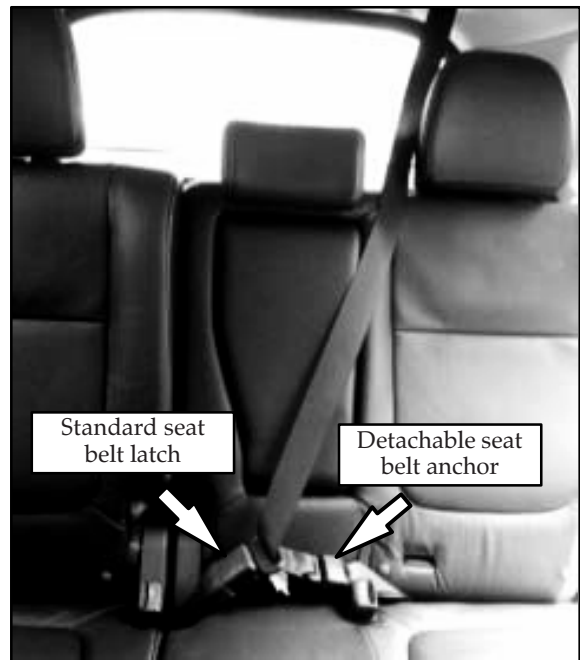
In order to make it easier for customers to identify the proper configuration of the second row center lap and shoulder seat belt, during PDI, please latch the second row

detachable anchor, then latch the seat belt plate to the standard seat belt latch, with the result looking like the photograph. Please ensure the seat belt is not twisted.

!! IMPORTANT !! When the left side of the second row seat is folded forward, the standard seat belt latch for the center seat will retract between the seats. This is normal.

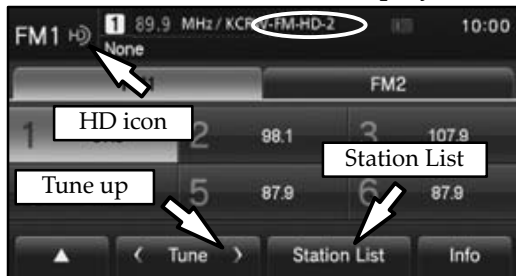
- For touch screen radio - Press the “Tune” up (>) arrow. HD Sub-channel tuning is confirmed in the channel display (circled).

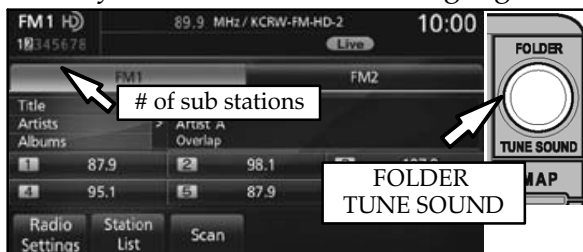
- For MMCS Navigation - Turn the FOLDER/TUNE SOUND knob clockwise. Each increment changes up one sub channel. The number of available sub-channels is highlighted immediately underneath the HD icon (1-8 as shown). Only those available will be highlighted.

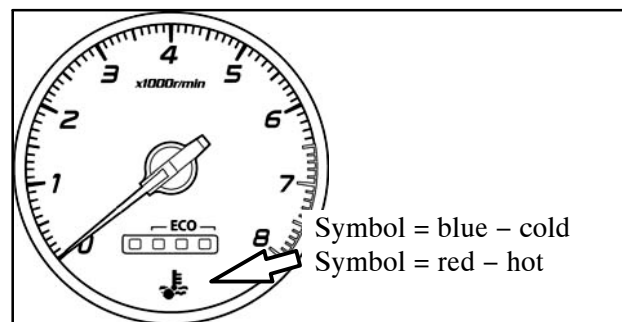
2014 Outlander with the Type 2 instrument cluster on ES models is not equipped with a temperature gauge display in the MID. In its place, a two-color indicator, located bottom center of the tachometer (RPM gauge), is used to indicate engine coolant temperature. This is shown on page 5-165 of the owner’s manual.

- If there is no indicator displayed, engine coolant temperature is in the “normal operating temperature” range.
- If the indicator is blue, engine coolant has not risen to the “normal operating temperature” range. It **does not** indicate a fault if a low coolant temperature would be expected (e.g. at cold start). Page 5-166 of the owner’s manual explains when the indicator goes out, it is a rough indication of coolant temperature being warm enough to heat the cabin.
- If the indicator is red (see illustration, below), engine coolant may have risen above the “normal operating temperature” range. Treat this as you would any other “high coolant temperature” event.

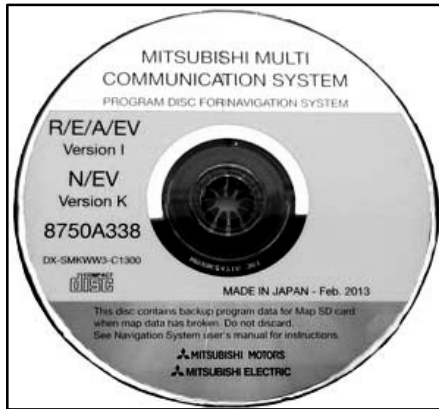
A program data backup disc is shipped in the glove box of all 2014 vehicles equipped with MMCS.

If the SD card becomes unreadable due to malfunction or damage, the MMCS will not function (including audio functions). Disabled functions (except Navigation) can be restored using this disc.

Please make sure this disc is located in the glove box during new vehicle delivery.

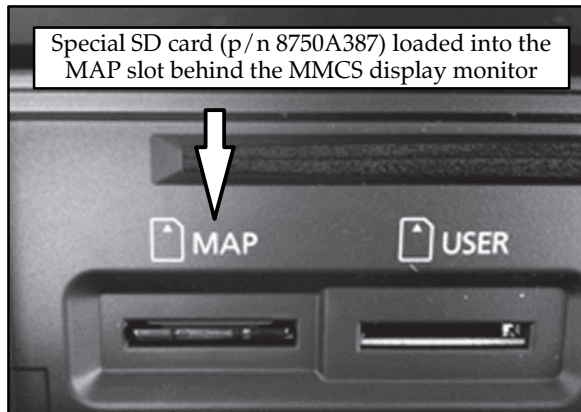
RESTORING NEW GENERATION MMCS SOFTWARE — All 2014 Models with MMCS. The new generation MMCS uses a special SD card to store system and mapping data.

The card is coded to protect against copying and prevent unauthorized use. As the card contains system function data, using an unreadable card causes the system to malfunction. This includes audio, service, and trip functions as well as navigation. If the SD card becomes unreadable due to malfunction or damage, the system does not function. If the SD card is missing, the system does not function and a message on the monitor advises the customer to insert an SD card into the slot.

Vehicles equipped with MMCS are shipped with a programming restoration disc in the glove box. This disc allows you to program a standard SD card (available locally) to restore system data, allowing all functions except navigation. To

program a “temporary” SD card, follow these instructions:
