Hendrickson Lift Axle Hardware, Retorque
VN, VHD

SP 656-001, Hendrickson Lift Axle Hardware, Retorque

(December 2019)

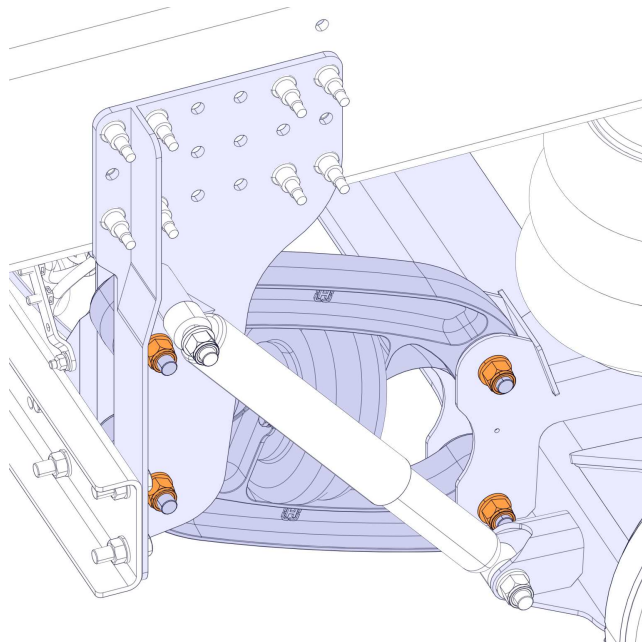
T6153407

For certain Volvo VN and VHD trucks built between 01/01/2017 and 10/02/2019, the lift arm fasteners of Hendrickson lift axle may have not been properly tightened. A new improved torque procedure has been introduced to maintain and distribute torque properly on the hardware attaching the Hendrickson Lift Axle to the brackets. Follow the repair instructions outlined in this document for retorquing the indicated fasteners.

5 Torque tighten the fasteners.

Tightening torque	
Lifting arm, fasteners	407 Nm (300 ft. lbs)
