Title Assembled Camshaft - Injector Lobe Rotation Inspection For Possible Spun Camshaft Lobe; Diagnostic Trouble Codes (DTC) P0257-00, P2A17-00, Or P2A1F-00, Possible Lack Of Power – **US17+OBD16 and Newer Emissions**

Engine family 11L Engine , 13L Engine , MP7 , MP8

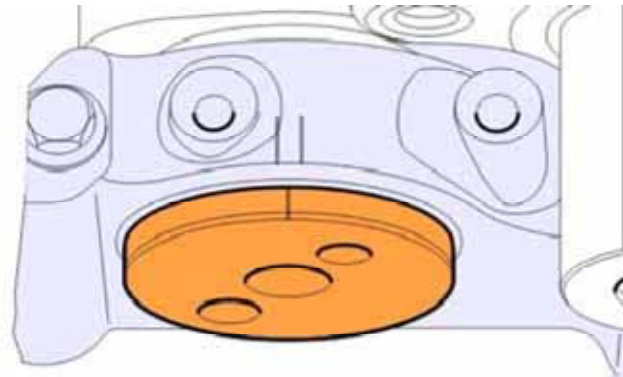
1. Rotate the engine with the turning tool in the normal direction of rotation until the timing marks are aligned for the Injector Pump(s). While the engine is being rotated, confirm each

injector lobe is rotating with the camshaft and does not slip.

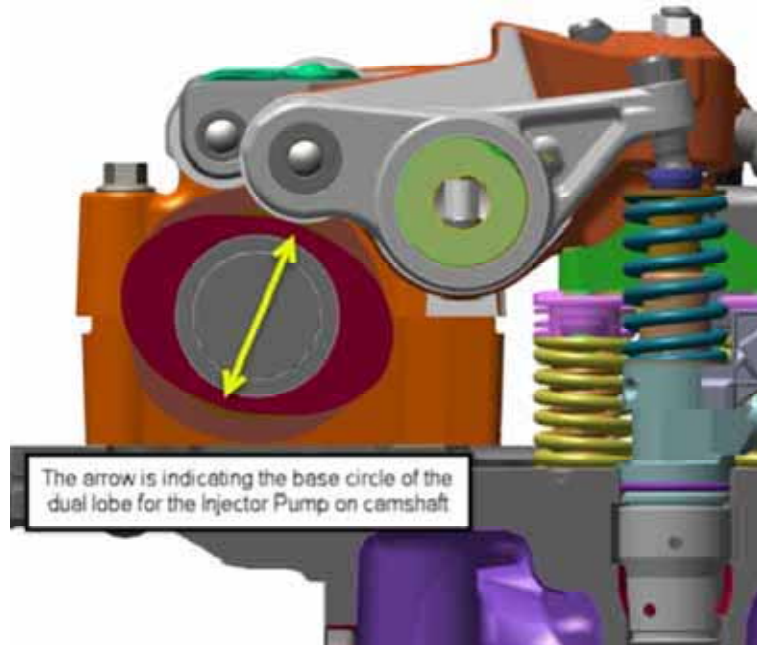
2. Once the timing marks are aligned for a specific Injector Pump, verify the injector rocker roller is on the base circle of the injector lobe. Refer to the illustration below.

Note: If an injector lobe rotates on the camshaft, the rotation is normally by 60 degrees. It takes approximately 15 degrees of rotation before potentially causing the faults codes listed previously or a fault for a pumping injector during the Common Rail Fuel System Test.
