Title Updated PM Sensor Removal Procedure - [US17+OBD16 and Newer Emissions](#)

Mack Model LR , TE - TerraPro , AN - Anthem , GR - Granite , PI - Pinnacle

Volvo Model VNL , VNR , VNX , VAH , VHD

Emission Standard US17+OBD16 , US17+OBD18 , US17+OBD19

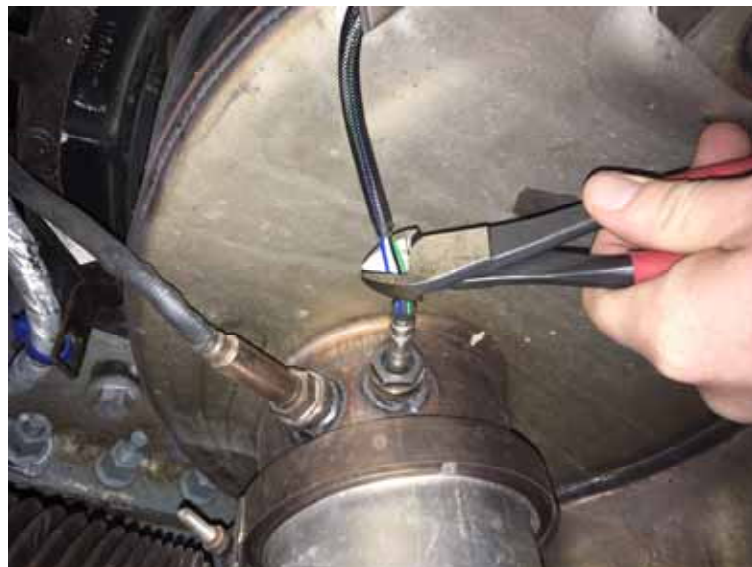
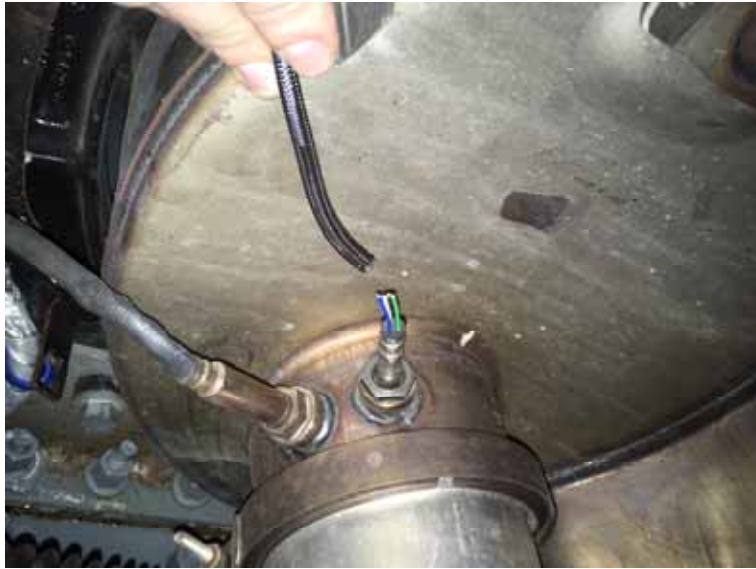
1. Cut the harness at the top of the sensor.

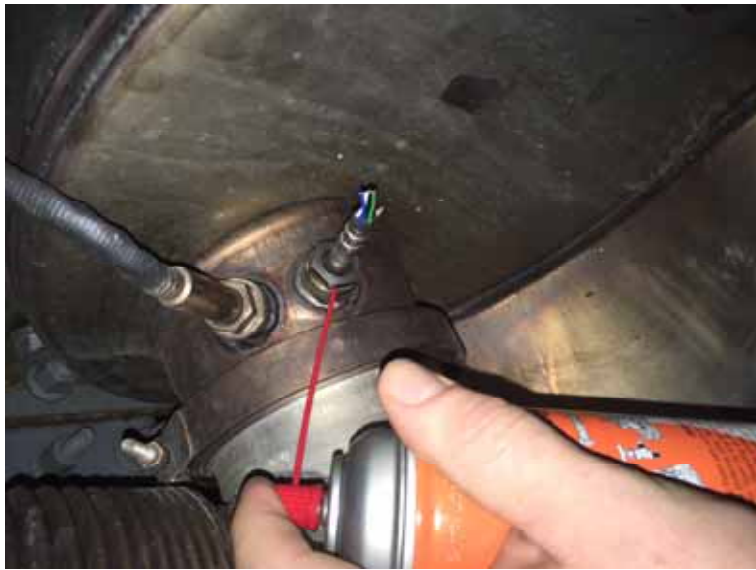
2. Spray the sensor nut with a suitable rust penetrant and let soak for approximately 5 minutes.

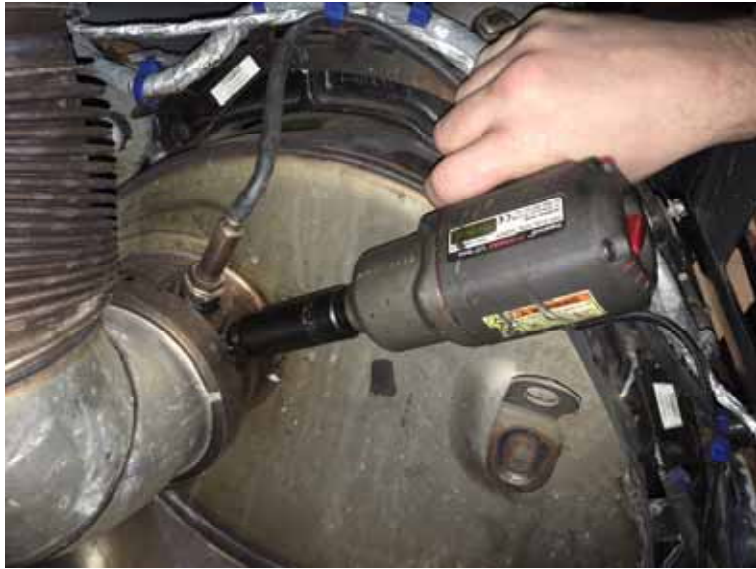
3. Remove the sensor with a 1/2" drive impact and appropriately sized deep socket.

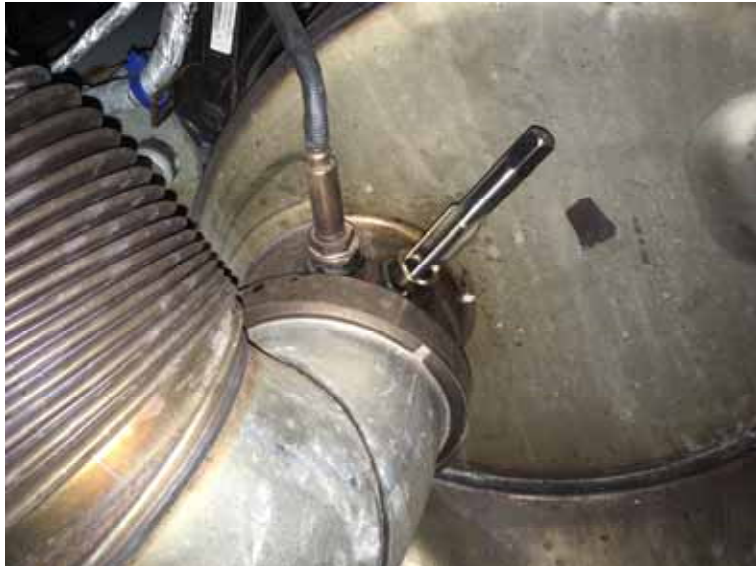
4. Use an M18 x 1.5mm **bottoming** tap to chase the SCR boss threads.

- Example bottoming tap – Grainger part # 2LWT5

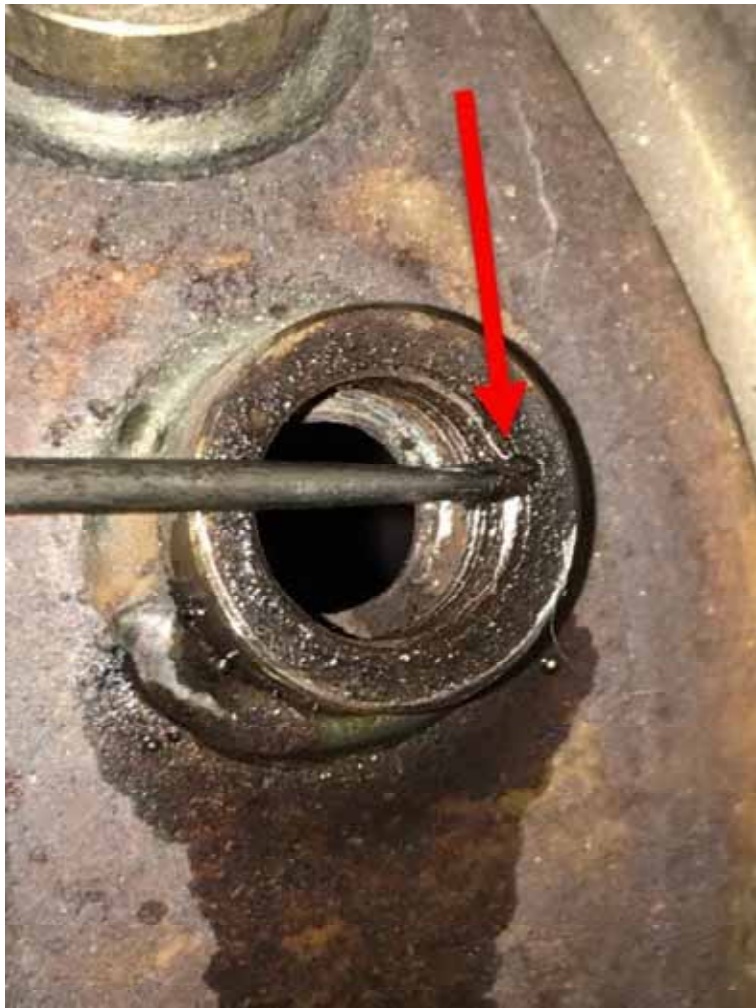
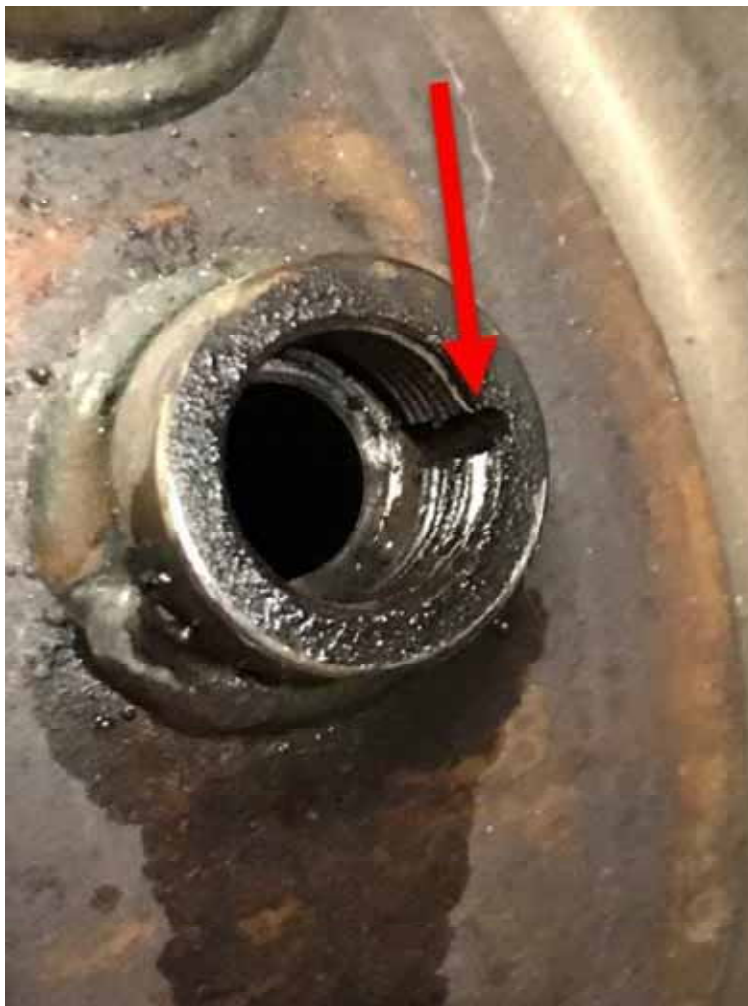
5. Inspect the boss threads and PM Sensor alignment notch for debris and clean if necessary.
