Abnormal Buzz/Groan Noise at 20 – 30 mph From Front Transfer Case

Service Category Drivetrain

Section Transfer/4wd/Awd

YEAR(S)	MODEL(S)	ADDITIONAL INFORMATION
2019	RAV4

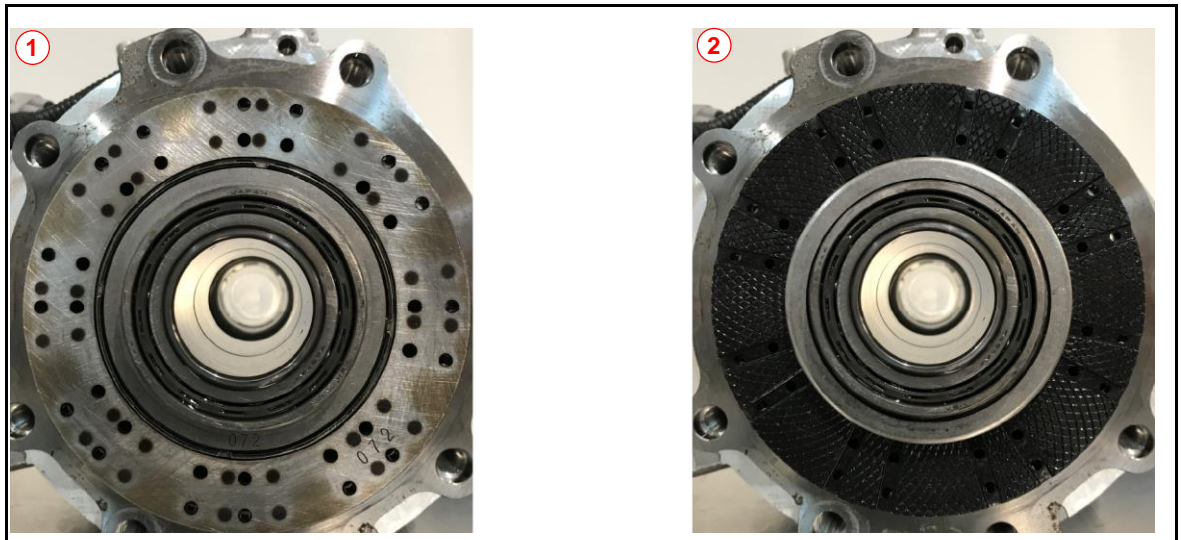
Figure 12. No Good vs OK Condition

1	No Good Condition
2	OK Condition
