Technical Service Bulletin: TSB190213	Released Date: 09-Dec-2019
New Crankcase Pressure Relief Valve: Fault Codes 555 and 556

New Crankcase Pressure Relief Valve: Fault Codes 555 and 556

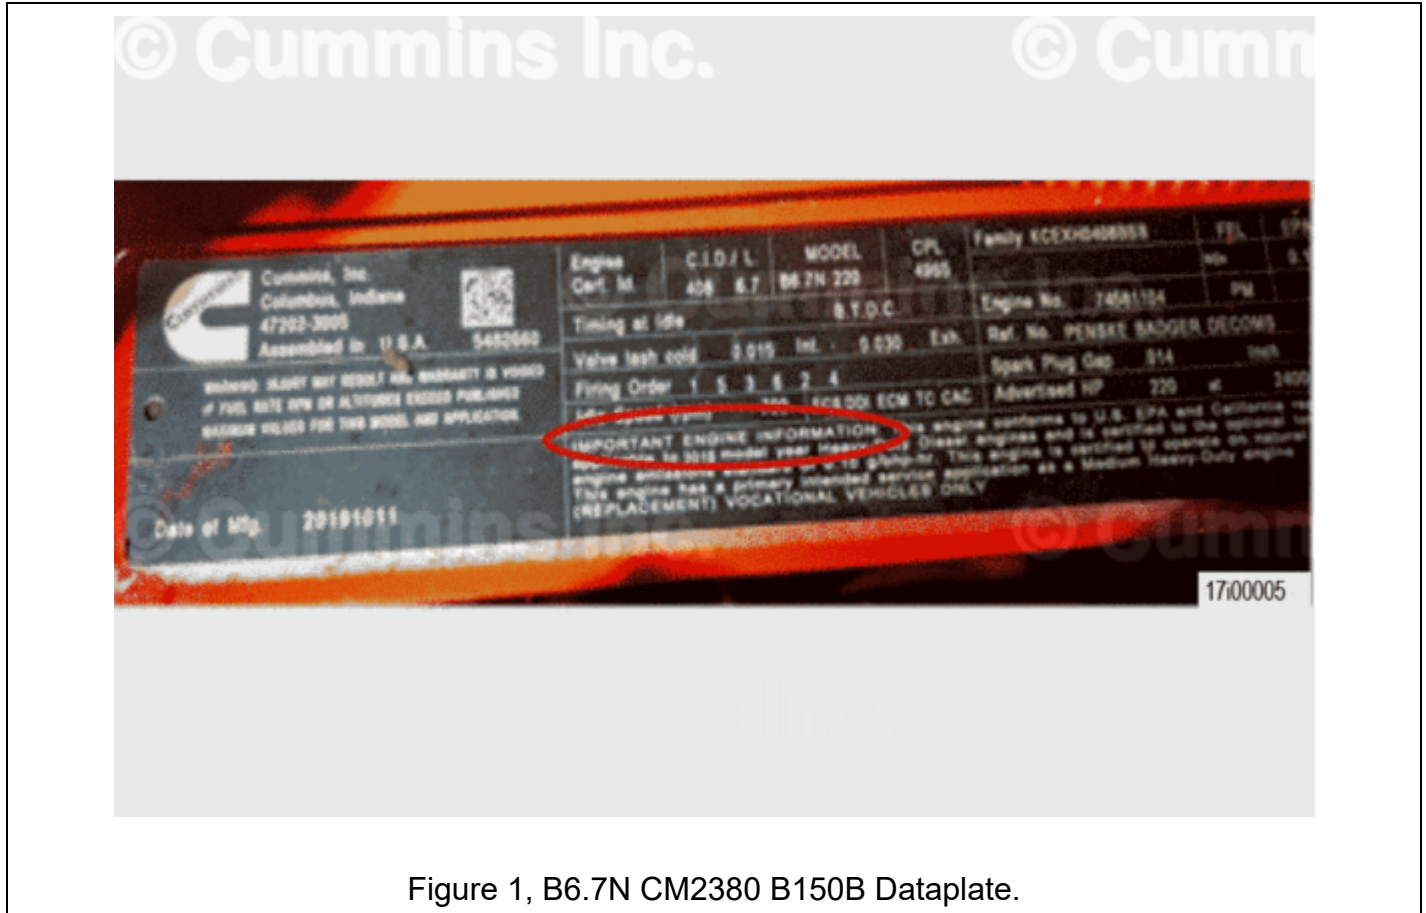
- On B6.7N CM2380 B150B engines **only**:
 - Verify that the engine is model year 2018 or 2019 by looking in at the engine dataplate.
 - Figure 1 below shows the layout of a B6.7N CM2380 B150B engine dataplate.
 - The year listed in the text of the “IMPORTANT ENGINE INFORMATION” field will indicate the model year of the engine.
 - This Technical Service Bulletin does **not** apply to B6.7N CM2380 B150B engines with a model year other than 2018 or 2019.
