Technical Bulletin 201 12.2019

Item	Subject	Model Affected
201.1	Steering Lock and Keys	Scrambler 1200 XC, Scrambler 1200 XE
201.2	Neutral Position Adaption	Street Twin from VIN 914793, Street Scrambler from VIN 914448, Thruxton TFC, Speed Twin, Scrambler 1200 XC, Scrambler 1200 XE, Street Triple S 660 cc from VIN 967907, Street Triple RS from VIN 966534, Daytona Moto2™ 765

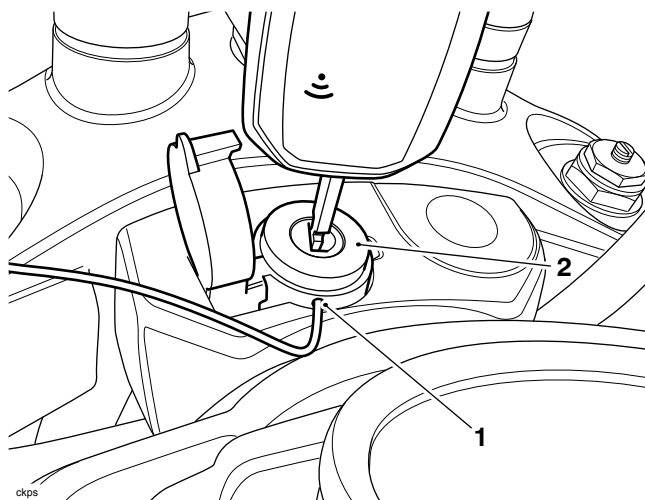
Removing an Incorrect Key from the Steering Lock

1. Key release hole
2. Steering lock

- Locate the key release hole at the front of the steering lock.
- Push a suitable tool approximately 1.5 mm diameter into the key release hole.
- Rotate the key slightly left and right to release the key from the lock.

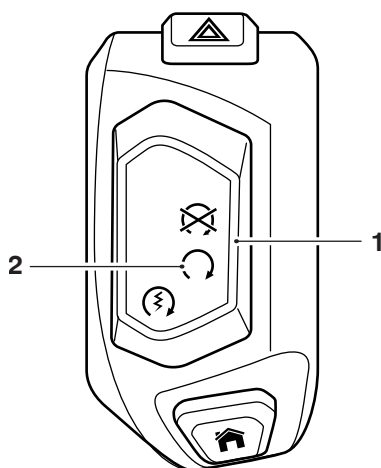
1. Engine stop switch

2. RUN (ON) position

1. Connect the Triumph diagnostic tool and turn the ignition ON.
2. Make sure the engine stop switch is in the RUN (ON) position.

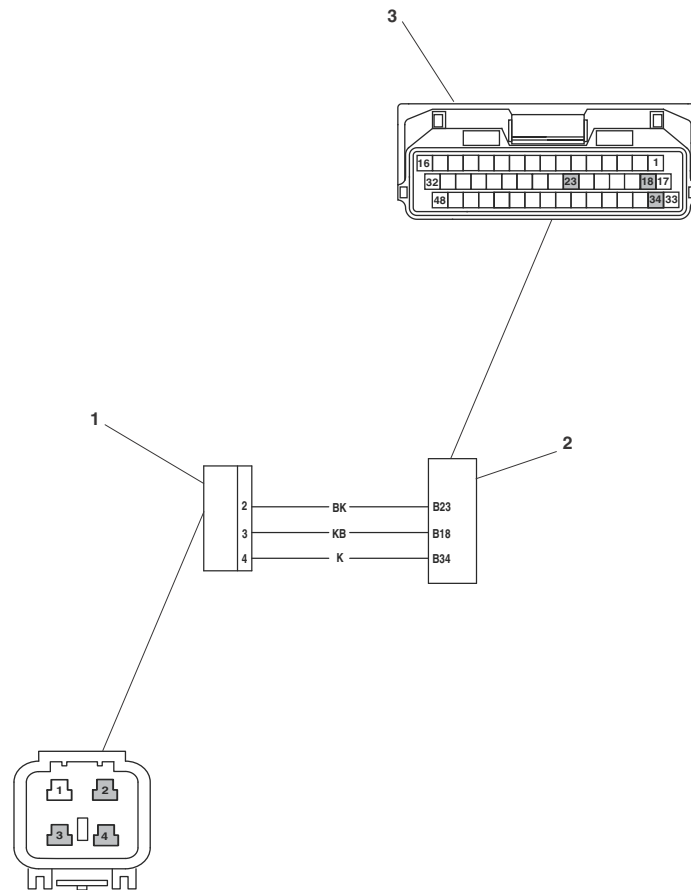
Circuit Diagram

Fault Code	Possible cause	Action
P0914	Gear position sensor short circuit to ground or open circuit	View and note 'freeze-frame' data if available.
P0917	Gear position sensor short circuit to 5 Volt sensor supply	View and note 'sensor' data. Ensure sensor connector is secure. Disconnect the engine ECM and proceed to pinpoint test 1:

1. Gear Position Sensor
2. Engine Electronic Control Module
3. Engine Electronic Control Module - Connector B

Test	Result	Action
1 Reset the neutral position adaption (see Neutral Position Adaption), clear fault code and run engine.	Fault cleared	Action complete - quit test
	Fault still present	Proceed to test 2
2 Check cable and terminal integrity: - Engine ECM pin B18 - Engine ECM pin B23 - Engine ECM pin B34	OK	Disconnect sensor and proceed to test 3
	Faulty	Rectify fault, proceed to test 6
3 Check cable for short circuit: - Engine ECM pin B23 to ground - Engine ECM pin B34 to ground	OK	Proceed to test 4
	Short circuit	Locate and rectify wiring fault, proceed to test 6
4 Check cable continuity: - Engine ECM pin B23 to sensor pin 2 - Engine ECM pin B18 to sensor pin 3 - Engine ECM pin B34 to sensor pin 4	OK	Proceed to test 5
	Open circuit	Locate and rectify wiring fault, proceed to test 6
5 Check cable for short circuit: - Engine ECM pin B23 to ECM pin B34 - Engine ECM pin B23 to ECM pin B18	OK	Renew gear position sensor and contact pin and proceed to test 6

Short circuit	Locate and rectify wiring fault, proceed to test 6
6 Reconnect harness, clear fault code and run engine.	OK	Action complete - quit test
	Fault still present	Contact Triumph service

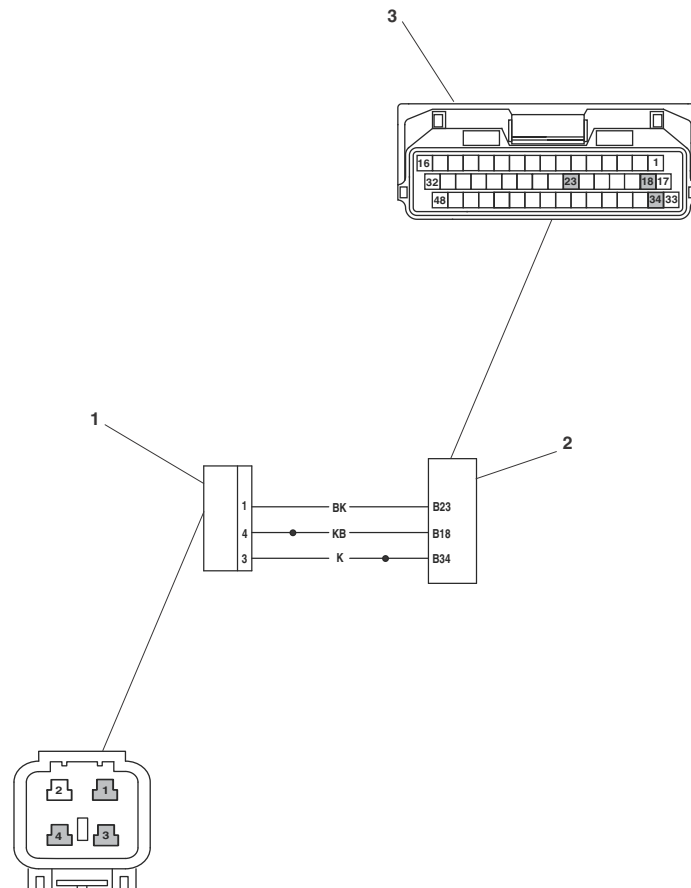
Circuit Diagram

Fault Code	Possible cause	Action
P0914	Gear position sensor short circuit to ground or open circuit	View and note 'freeze-frame' data if available.
P0917	Gear position sensor short circuit to 5 Volt sensor supply	View and note 'sensor' data. Ensure sensor connector is secure. Disconnect the engine ECM and proceed to pinpoint test 1:

1. Gear Position Sensor
2. Engine Electronic Control Module
3. Engine Electronic Control Module - Connector B

Test	Result	Action
1 Reset the neutral position adaption (see Neutral Position Adaption), clear fault code and run engine.	Fault cleared	Action complete - quit test
	Fault still present	Proceed to test 2
2 Check cable and terminal integrity: - Engine ECM pin B23 - Sensor pins 1, 3, 4	OK	Disconnect sensor and proceed to test 3
	Faulty	Rectify fault, proceed to test 6
3 Check cable for short circuit: - Engine ECM pin B23 to ground - Engine ECM pin B34 to ground	OK	Proceed to test 4
	Short circuit	Locate and rectify wiring fault, proceed to test 6
4 Check cable continuity: - Engine ECM pin B23 to sensor pin 1 - Engine ECM pin B18 to sensor pin 4 - Engine ECM pin B34 to sensor pin 3	OK	Proceed to test 5
	Open circuit	Locate and rectify wiring fault, proceed to test 6
5 Check cable for short circuit: - Engine ECM pin B23 to ECM pin B34	OK	Renew gear position sensor and contact pin and proceed to test 6

Short circuit	Locate and rectify wiring fault, proceed to test 6
6 Reconnect harness, clear fault code and run engine.	OK	Action complete - quit test
	Fault still present	Contact Triumph service

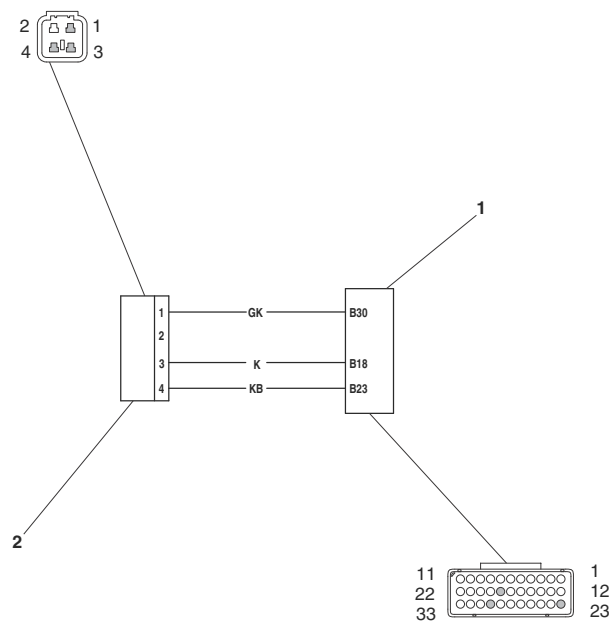
Circuit Diagram

Fault Code	Possible cause	Action
P0914	Gear position sensor short circuit to ground or open circuit	View and note 'freeze-frame' data if available.
P0915	Gear position sensor signal error - correlation error with vehicle speed	View and note 'sensor' data. Ensure sensor connector is secure.
P0917	Gear position sensor short circuit to 5 Volt sensor supply	Disconnect the engine ECM and proceed to pinpoint test 1:

- 1. Engine ECM Connector B
- 2. Gear Position Sensor

Test	Result	Action	
1	Reset the neutral position adaption (see Neutral Position Adaption), clear fault code and run engine.	Fault cleared	Action complete - quit test
		Fault still present	Proceed to test 2
2	Check cable and terminal integrity: - Engine ECM pin B30	OK	Disconnect sensor and proceed to test 3
		Faulty	Rectify fault, proceed to test 6
3	Check cable for short circuit: - Engine ECM pin B18 to ground - Engine ECM pin B30 to ground	OK	Proceed to test 4
		Short circuit	Locate and rectify wiring fault, proceed to test 6
4	Check cable continuity: - Engine ECM pin B18 to sensor pin 3 - Engine ECM pin B23 to sensor pin 4 - Engine ECM pin B30 to sensor pin 1	OK	Proceed to test 5
		Open circuit	Locate and rectify wiring fault, proceed to test 6
5	Check cable for short circuit: - Engine ECM pin B30 to Engine ECM pin B18 - Engine ECM pin B30 to Engine ECM pin B23 - Engine ECM pin B30 to Engine ECM pin A08 - Engine ECM pin B30 to Engine ECM pin A21	OK	Renew gear position sensor and contact pin and proceed to test 6

Short circuit	Locate and rectify wiring fault, proceed to test 6
6	Reconnect harness, clear fault code and run engine.	OK	Action complete - quit test
		Fault still present	Contact Triumph service

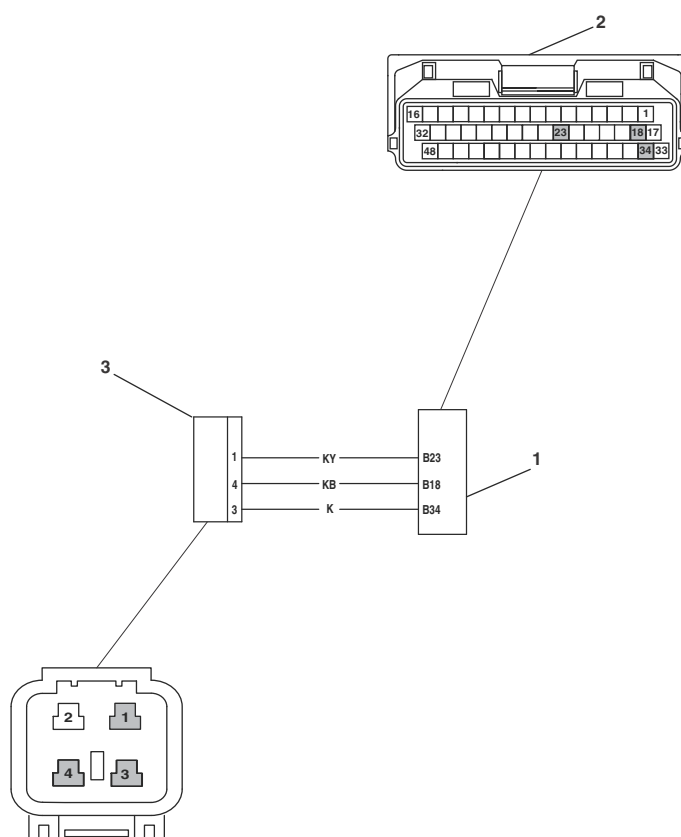
Circuit Diagram

Fault Code	Possible cause	Action
P0914	Gear position sensor short circuit to ground or open circuit	View and note 'freeze-frame' data if available.
P0917	Gear position sensor short circuit to 5 Volt sensor supply	View and note 'sensor' data. Ensure sensor connector is secure. Disconnect the engine ECM and proceed to pinpoint test 1:

1. Engine Electronic control module
2. Engine Electronic control module - Connector B
3. Gear position sensor

Test	Result	Action
1 Reset the neutral position adaption (see Neutral Position Adaption), clear fault code and run engine.	Fault cleared	Action complete - quit test
	Fault still present	Proceed to test 2
2 Check cable and terminal integrity: - ECM pin B23 Gear position sensor pin 1 Gear position sensor pin 3 Gear position sensor pin 4	OK	Disconnect sensor and proceed to test 3
	Faulty	Rectify fault, proceed to test 6
3 Check cable for short circuit: - ECM pin B23 to ground - ECM pin B34 to ground	OK	Proceed to test 4
	Short circuit	Locate and rectify wiring fault, proceed to test 6
4 Check cable continuity: - ECM pin B23 to sensor pin 1 - ECM pin B34 to sensor pin 3 - ECM pin B18 to sensor pin 4	OK	Proceed to test 5
	Open circuit	Locate and rectify wiring fault, proceed to test 6
5 Check cable for short circuit: - ECM pin B23 to ECM pin B44	OK	Renew gear position sensor and contact pin and proceed to test 6

Short circuit	Locate and rectify wiring fault, proceed to test 6
6 Reconnect harness, clear fault code and run engine.	OK	Action complete - quit test
	Fault still present	Contact Triumph service

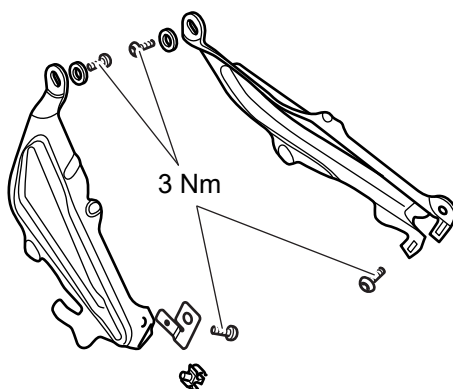
The torque figure has changed. If loosened or removed for any reason the fixing(s) must be torqued as required.

Application	Torque (Nm)	Notes
Side infill panels	3 Nm

• **Models already in service need not be re-tightened unless the fixings have been loosened or removed. Please mark your copy of the Service Manual with this information. For electronic service manuals, store this information in a readily accessible place and refer to it when working on the relevant Triumph motorcycle. This information will be included in the next service manual update.**

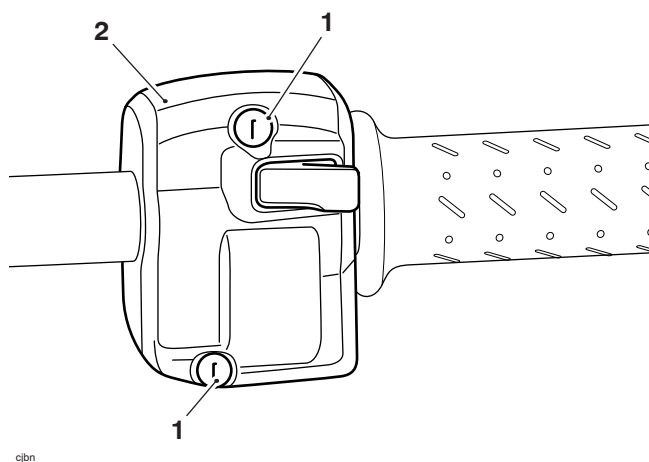
The torque figure has changed. If loosened or removed for any reason the fixing(s) must be torqued as required.

Application	Torque (Nm)	Notes
Left hand switch housing	2 Nm

1. Fixings

2. Left hand switch housing

• **Models already in service need not be re-tightened unless the fixings have been loosened or removed. Please mark your copy of the Service Manual with this information. For electronic service manuals, store this information in a readily accessible place and refer to it when working on the relevant Triumph motorcycle. This information will be included in the next service manual update.**

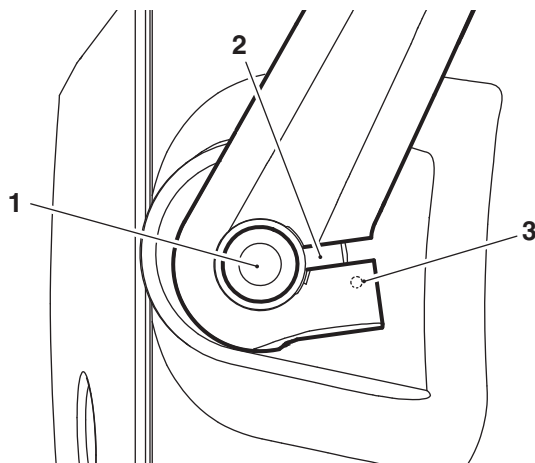
A new clutch cable was introduced to the above models from VIN 693388 and is retrofittable. Triumph parts department no longer support the original clutch cable. The difference between the original and new condition clutch cable is that the inner cable's free length at the clutch actuation lever is 18 mm longer than the original. The additional length is to allow the repositioning of the clutch actuation lever.

1. Clutch shaft
2. Clutch actuation lever split line
3. Single dot alignment mark

1. Rotate the clutch shaft clockwise until the shaft makes contact with the clutch pressure plate bearing.
2. Align the split in the clutch actuation lever to the single dot alignment mark on the clutch cover.
3. While holding the clutch shaft in position, rotate the actuation lever two splines anticlockwise then fit the arm to the shaft.

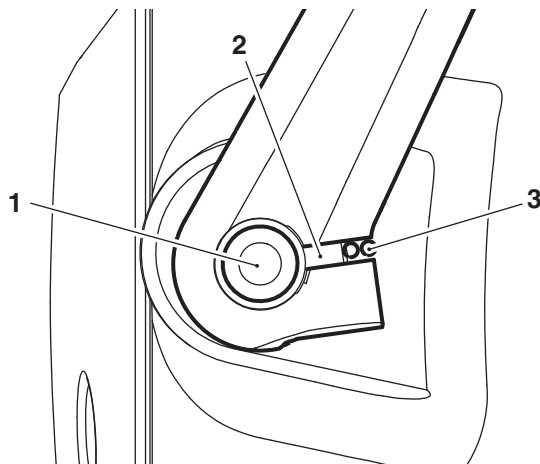
1. Clutch shaft
2. Clutch actuation lever split line
3. Double dot alignment mark

1. Rotate the clutch shaft clockwise until the shaft makes contact with the clutch pressure plate bearing.
2. Align the split in the clutch actuation lever to the double dot alignment mark on the clutch cover then fit the arm to the shaft.

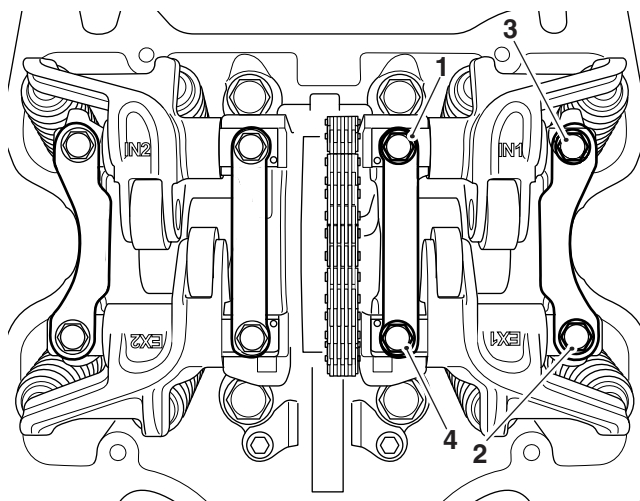
Cylinder One Camshaft Frame Tightening Sequence

New camshaft frame bolts have been introduced to the above models from Engine Number 944903 (all markets except Brazil) and from Engine Number 960154 (Brazil only) and these have a new torque tightening value of 12 Nm.

To avoid damage to the camshaft frame, always ensure as many camshaft lobes as possible are facing away from the rocker shaft. This will reduce stress on the camshaft frame during assembly. Damage to the camshaft frame will result in replacement of the cylinder head.

1. In the sequence shown below,
 - Tighten cylinder one camshaft frame fixings, until the camshaft frames are in full contact with the cylinder head. Tighten the fixings in the sequence shown below to 5 Nm.

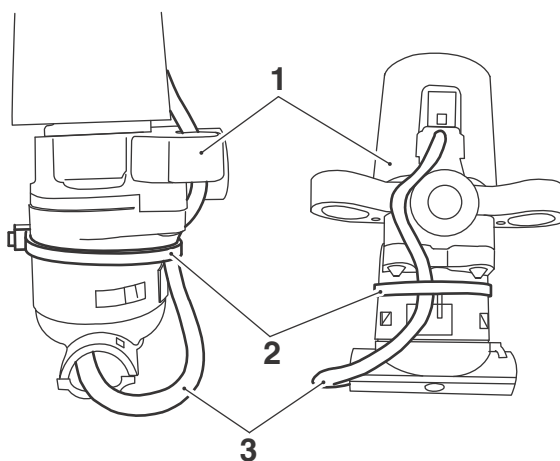
A cable tie was added to the ignition switch on the above models from VIN 888086 (all markets except Brazil and India) and from VIN 887670 (Brazil and India only) to secure the immobiliser antenna wire. If removing or replacing the ignition switch, ensure the cable tie is fitted as illustrated.

1. Ignition switch assembly
2. Cable tie
3. Immobiliser antenna wire

- **Street Triple R models and Street Triple RS:** From VIN 932416 (all markets except Brazil and India) and from VIN 933535 (Brazil and India only), the ignition switch assembly has an integral cable clip and the immobiliser antenna wire is correctly routed. Replacement spare parts will be the same.
- **Street Triple S Models:** From VIN 940087 (all markets except Brazil and India) and from VIN 960409 (Brazil and India only), the ignition switch assembly has an integral cable clip and the immobiliser antenna wire is correctly routed. Replacement spare parts will be the same.
