Topic	Battery monitor control unit – software update (SC13/21)
Market area	Worldwide Bentley (1WBE)
Brand	Bentley
Transaction No.	2035952/3
Campaign number	E798
Note	
Type	Workshop Campaign
US code

Workshop Campaign E798

Battery monitor control unit – software update (SC13/21)

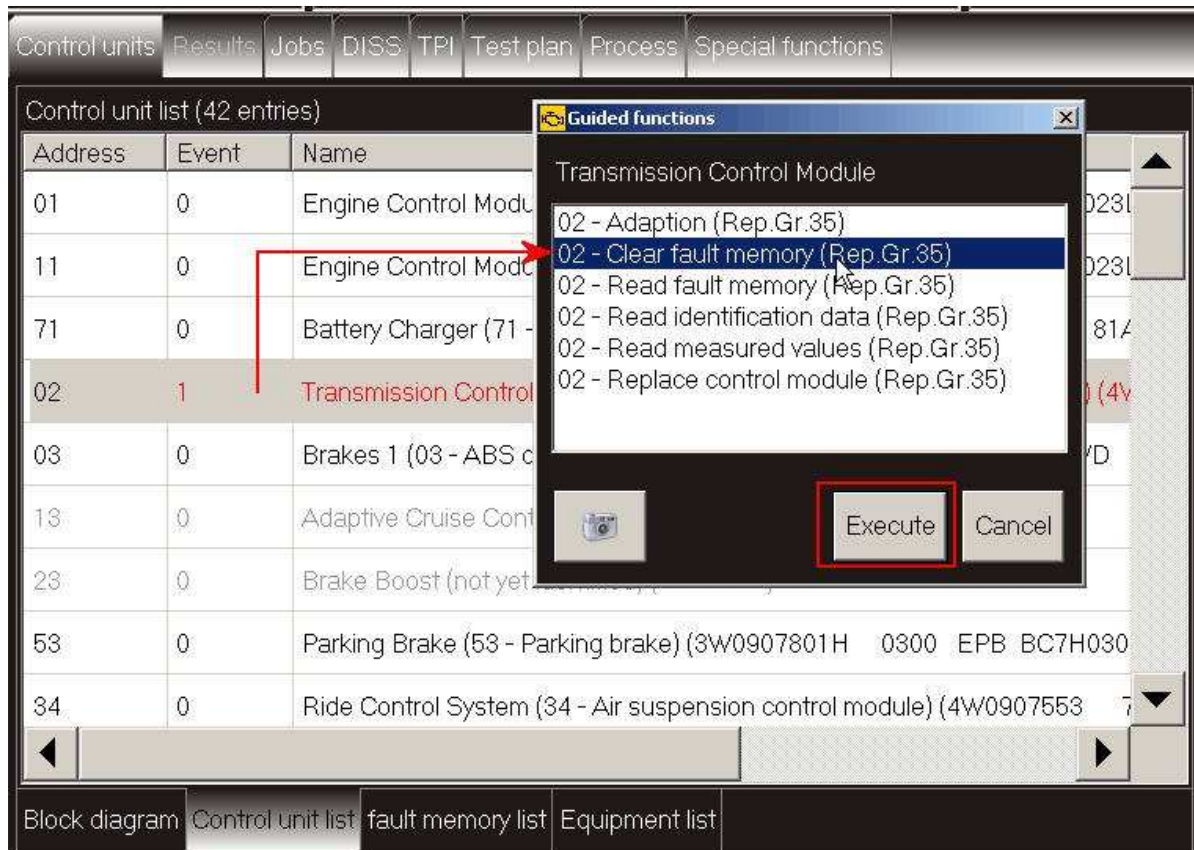
Figure 9

19. NOTE 2: It is possible that an engine or transmission fault code may require guided fault finding to be used directly in that specific control module to clear the fault code (see Figure 9)
20. On completion apply a blue campaign completion mark (see Figure 10)

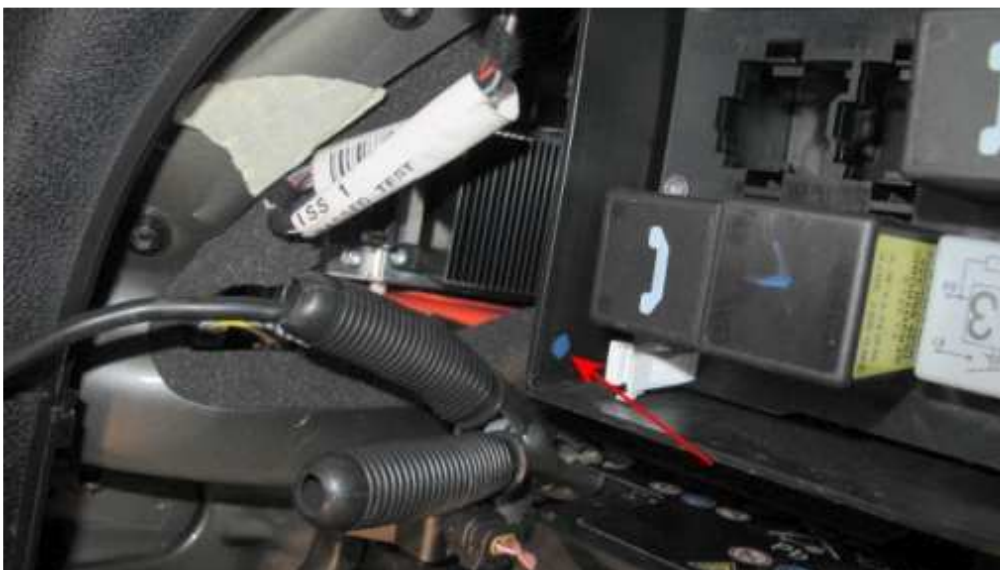
Figure 10

On completion apply a blue campaign completion mark to the boot mounted fuse box adjacent to the main system battery negative post (see Figure 10)
