Technical Service Bulletin

91 SOS Warning displayed in the instrument cluster, no communication to the telematics control module

91 20 28 2056076/6 January 14, 2020. Supersedes Technical Service Bulletin Group 91 number 19-15 dated December 4, 2019 for reasons listed below.

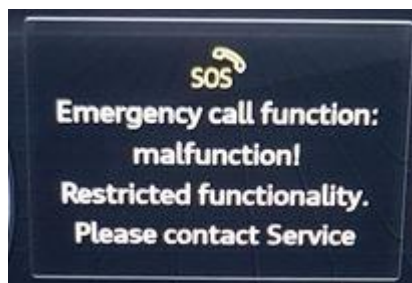
- An SOS Warning is displayed in the instrument cluster (Figure 1).

Figure 1. Emergency call malfunction warning.

A software bug can cause the control module to freeze during cold start.

1. Remove and unplug the telematics control module, J949 (address word 0075) according to the repair manual in Elsa.
2. Open the battery compartment of the telematics control module, J949 (address word 0075) and disconnect the backup battery.
