TECH TALK

Volume 206, March, 2014

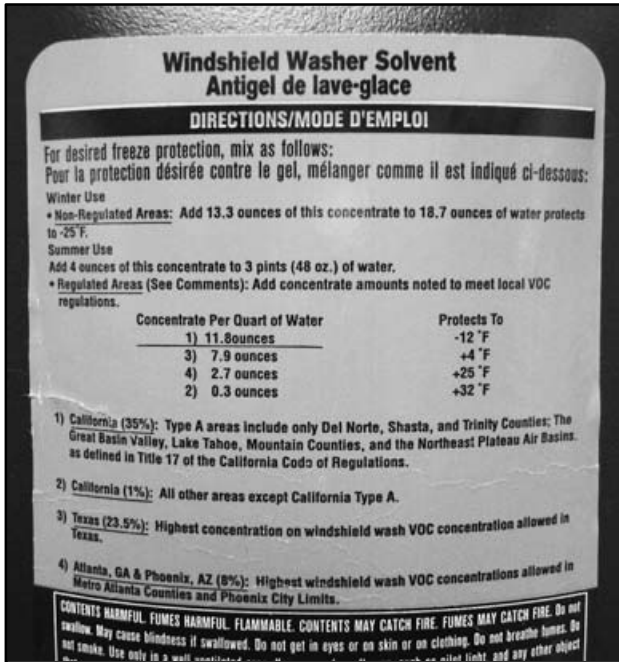
CAUTION The ACH3ZC1X07 washer fluid container advises that some municipalities regulate washer fluid concentration. Always refer to the directions on the container to determine the correct and legal concentration.

Always mix the concentration seasonally for the expected temperatures in your area and take care when mixing and filling washer fluid. Using a concentration that is too weak can lead to an inoperative washer system caused by washer fluid freezing and damaging the washer pump or breaking the reservoir.

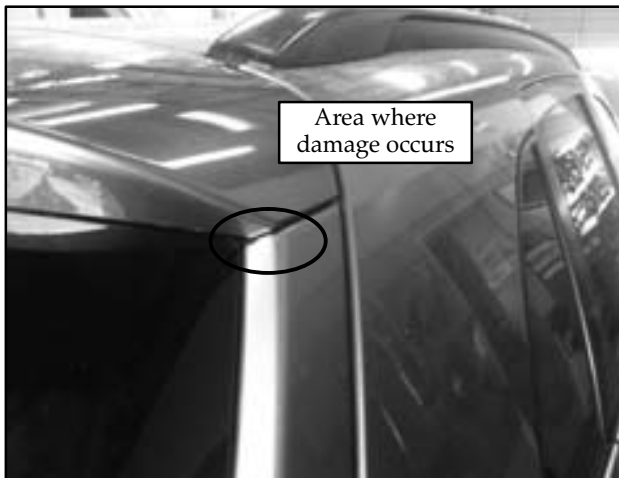
PRODUCTION COUNTERMEASURE FOR LIFTGATE PAINT PEELING AT SPOILER ENDS 2014 Outlander Sport. The spoiler has been modified beginning with vehicles built February 20, 2014, to prevent contact with the liftgate causing paint damage. TSB-13-51-003 will be revised with this information.

If you see vehicles built after the February 20, 2014 that exhibit liftgate paint peeling under either end of the spoiler, please submit a PQR.

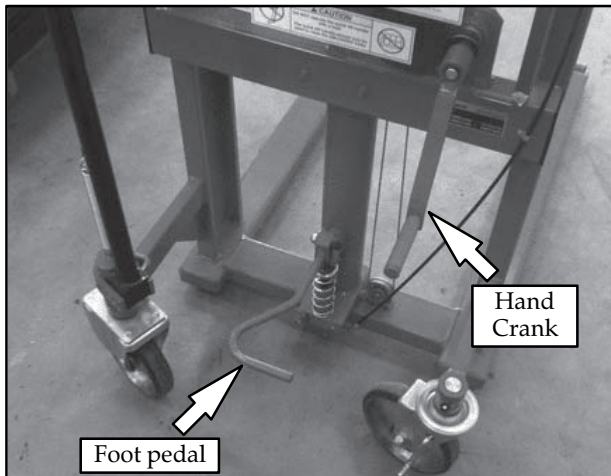
When transferring a main drive battery between the shipping container and the lift table, DO NOT use the hand crank to lift the battery’s full weight. The crank should only be used to position the forks and take up slack in the straps before the battery is lifted. The cable controlled by the crank is not designed to lift the battery’s full weight. Once the forks are positioned and the slack is taken up, use the foot pedal to raise and lower the battery by pumping it to charge the fork lift’s hydraulic system.

Using the handle for lifting the battery can lead to cable failure, subsequent battery damage and possible personal injury.
