MiEV Evolution III
2014 Pike's Peak EV Class Champion

Vehicle Technical Info

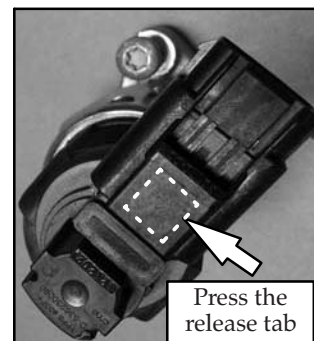
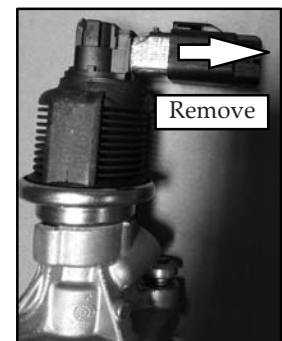
SUPERSEDED EGR VALVE WITH NEW CONNECTOR — 2006 - 09 Raider. The EGR valve for V6 Raiders has superseded a new wiring harness connector, allowing the valve to be used on other Chrysler products. In order to use it on Raider, simply remove the new connector and discard it.

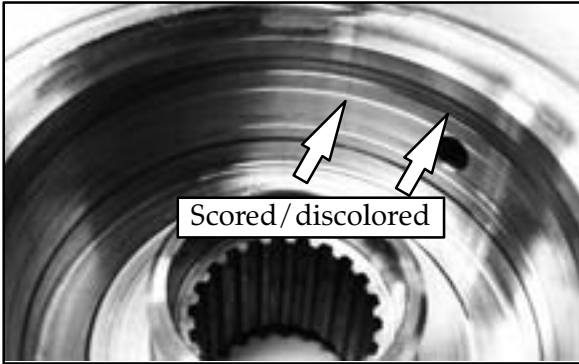
POOR 1-2 UPSHIFT AND/OR 2ND GEAR ENGAGEMENT — 2012 Galant. If a customer reports delayed engagement of 1st gear, the vehicle won’t move with the shift selector in the D position until engine speed increases, or they report poor shift quality between 1st and 2nd gears, check pressures and pay attention to the under drive clutch pressure. If it’s low at idle but improves off idle, there may be scoring of the under drive clutch retainer, causing a loss of pressure at low fluid volume.

Disassemble the transmission and look for rotational scoring on the inner retainer surface. You may also find a damaged piston or damaged clutches. If you find this type of damage during inspection, replace the under drive clutch retainer and seals, and any additional damaged under drive clutch components.

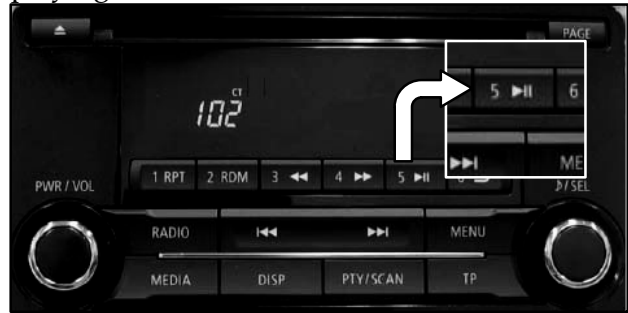
PLAY/PAUSE BUTTON DOES NOT FUNCTION WITH CD — 2014 - 15 Outlander, Lancer models, Outlander Sport. On vehicles equipped with the base radio and Bluetooth® streaming, the play (▶)/pause(⏸) feature (the number “5” preset button) only functions for audio being streamed via Bluetooth®. The radio does not have a specific play/pause control for CD. You can “pause” a CD by powering the unit OFF. When powered back ON, the CD begins

playing where it left off.

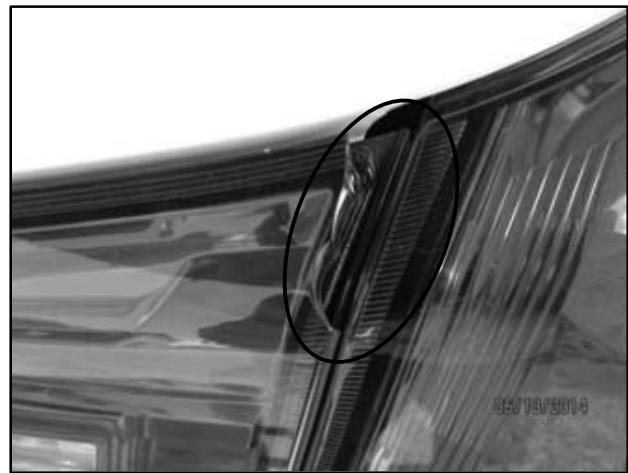
LEFT OR RIGHT LIFTGATE LIGHT ASSEMBLY CRACKED/BROKEN AT UPPER CORNER — 2013-15 Outlander Sport. Insufficient clearance between the liftgate light assembly and the combination light may cause the tailgate light lens to crack or break when the liftgate is closed. A 4mm clearance between the two components is required to prevent contact.

When replacing a broken or cracked light, follow the service manual procedure to remove the inner liftgate trim and loosen the liftgate light's fasteners. To achieve a 4mm clearance, hold the light assembly towards the inside of the tailgate and tighten the fasteners snug. Then torque them to spec.
