# Technical Service Bulletin

SUBJECT: <b>RATTLE OR TICKING NOISE FROM GLOVE BOX</b>		No: <b>TSB-12-52A-003</b>
		DATE: <b>November, 2012</b>
		MODEL: <b>2013 Outlander Sport/RVR</b>
CIRCULATE TO:	<input type="checkbox"/> GENERAL MANAGER	<input checked="" type="checkbox"/> PARTS MANAGER
<input checked="" type="checkbox"/> SERVICE ADVISOR	<input checked="" type="checkbox"/> SERVICE MANAGER	<input checked="" type="checkbox"/> TECHNICIAN
	<input type="checkbox"/> WARRANTY PROCESSOR	<input type="checkbox"/> SALES MANAGER

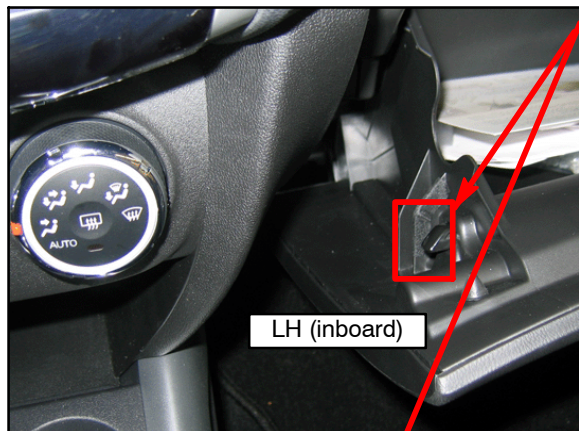
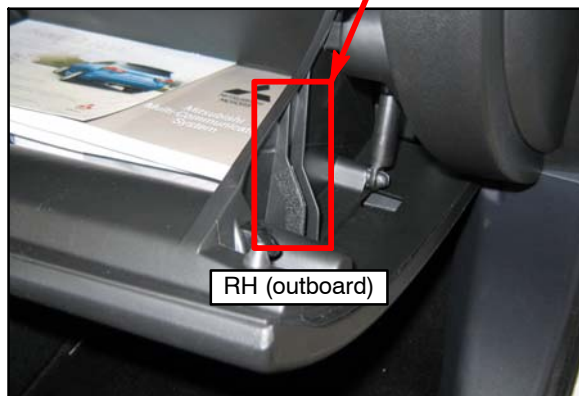
Customers of affected vehicles may report a rattle or ticking noise from the glove box area when travelling over railroad tracks, highway lane markers ("Botts dots") or rough road surfaces. This may be caused by contact between the glovebox and the dash. This TSB instructs technicians to remove the existing glovebox felt insulating strips and add a new felt strip in a different location to suppress the noise.

1. Remove existing felt strips from the indicated areas and discard them.

**NOTE:** These felt strips will not be replaced.
