# Technical Service Bulletin

SUBJECT: <b>SECURING THE OVERHEAD CONSOLE</b>		No: <b>TSB-12-52A-004</b>
		DATE: <b>December, 2012</b>
		MODEL: <b>2013 Outlander Sport/RVR</b>
CIRCULATE TO:	<input type="checkbox"/> GENERAL MANAGER	<input checked="" type="checkbox"/> PARTS MANAGER
<input checked="" type="checkbox"/> SERVICE ADVISOR	<input checked="" type="checkbox"/> SERVICE MANAGER	<input checked="" type="checkbox"/> TECHNICIAN
	<input checked="" type="checkbox"/> WARRANTY PROCESSOR	<input type="checkbox"/> SALES MANAGER

## PURPOSE

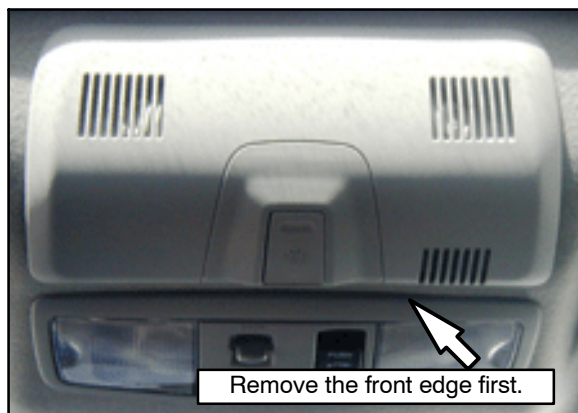
1. Grab the front edge of the overhead console with your fingers and pull rearward and down to remove it. It should come out easily.

Remove the front of the assembly, then the rear.

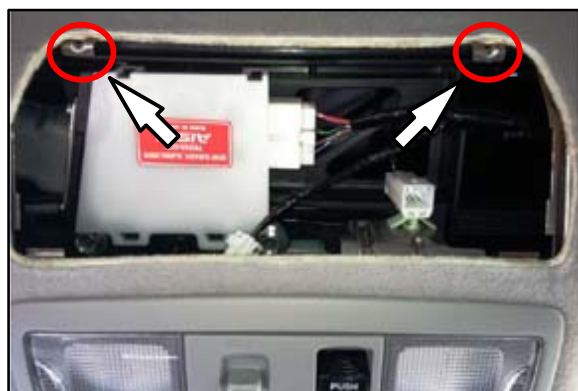
2. Check if the two tabs (circled) on the bracket are fitted with felt pads (see illustration for location).

If felt pads are present, skip to step 4.
