# Technical Service Bulletin

<b>Subject:</b>  <b>CHECK ENGINE LIGHT ON WITH DTC P2610 AND P2507</b>	<b>Bulletin No.:</b> 01-002/20
	<b>Last Issued:</b> 01/23/2020

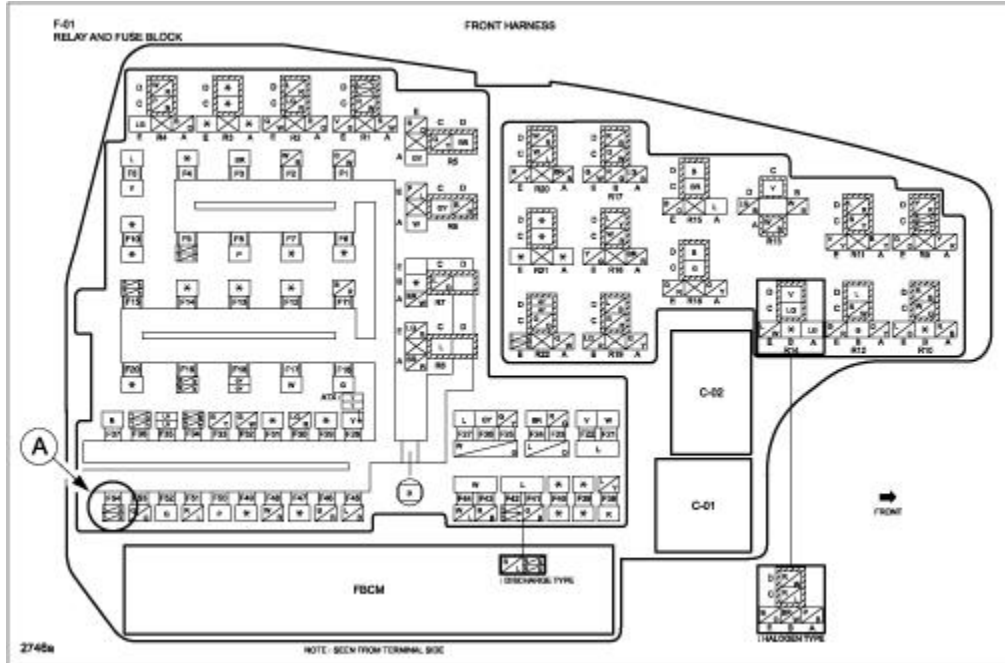
Some vehicles may experience the CHECK ENGINE LIGHT ON with DTC P2610 and P2507 stored in memory after engine start and room fuse 15A (A) removed.

As a past malfunction, the customer will not notice it (no warning light illuminated), but the DTC may be found during a vehicle service. P2507 in this situation is only applicable on 2016 and later models.

This is caused by the engine being started 3 or more times after a short duration of engine off (less than 15 seconds) with the room fuse removed.

1. Verify DTC P2610 and P2507 are stored in PCM memory.
2. Install ROOM fuse 15A with ignition OFF.
3. Start the engine and let it run for at least 10 seconds, then stop the engine.
4. Start the engine again and verify that the CHECK ENGINE LIGHT is not illuminated, then stop the engine.
5. Clear DTC P2610 and P2507 from PCM memory using IDS.
6. Verify no other DTCs are stored in memory. If so, troubleshoot them according to the MGSS online instructions or Workshop Manual.

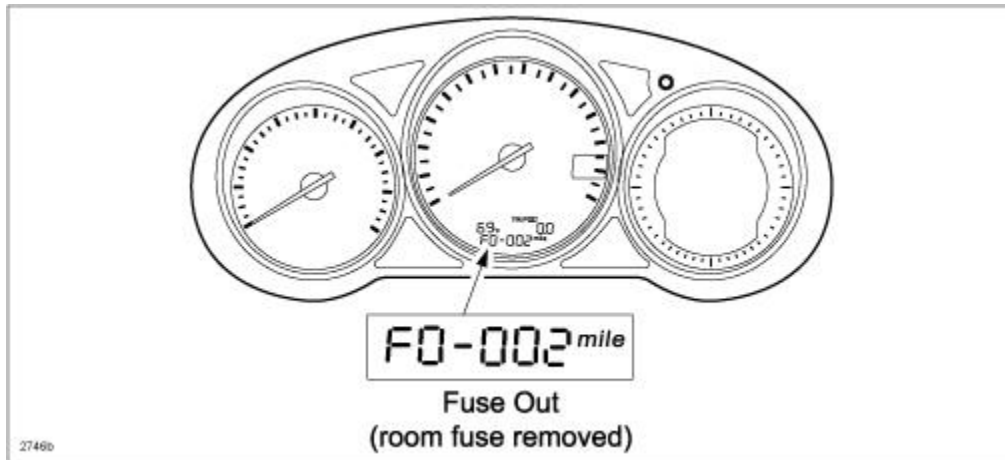
**NOTE:** The odometer will display "F0-002" during transport mode (room fuse 15A removed). Transport mode is canceled when room fuse 15A is installed or the vehicle odometer is more than 12.4mi (20km).
