Technical Service Bulletin

SUBJECT:			No: TSB-13-12-001
OIL PUMP CHAIN GUIDE ELIMINATED – SERVICE MANUAL REVISION			DATE: January, 2013
			MODEL: See below
CIRCULATE TO:	<input type="checkbox"/> GENERAL MANAGER	<input checked="" type="checkbox"/> PARTS MANAGER	<input checked="" type="checkbox"/> TECHNICIAN
<input checked="" type="checkbox"/> SERVICE ADVISOR	<input checked="" type="checkbox"/> SERVICE MANAGER	<input checked="" type="checkbox"/> WARRANTY PROCESSOR	<input type="checkbox"/> SALES MANAGER

The oil pump chain guide was eliminated in 2.0 liter (4B11) non-turbo engines effective July 1, 2012. This TSB provides updated service manual information.

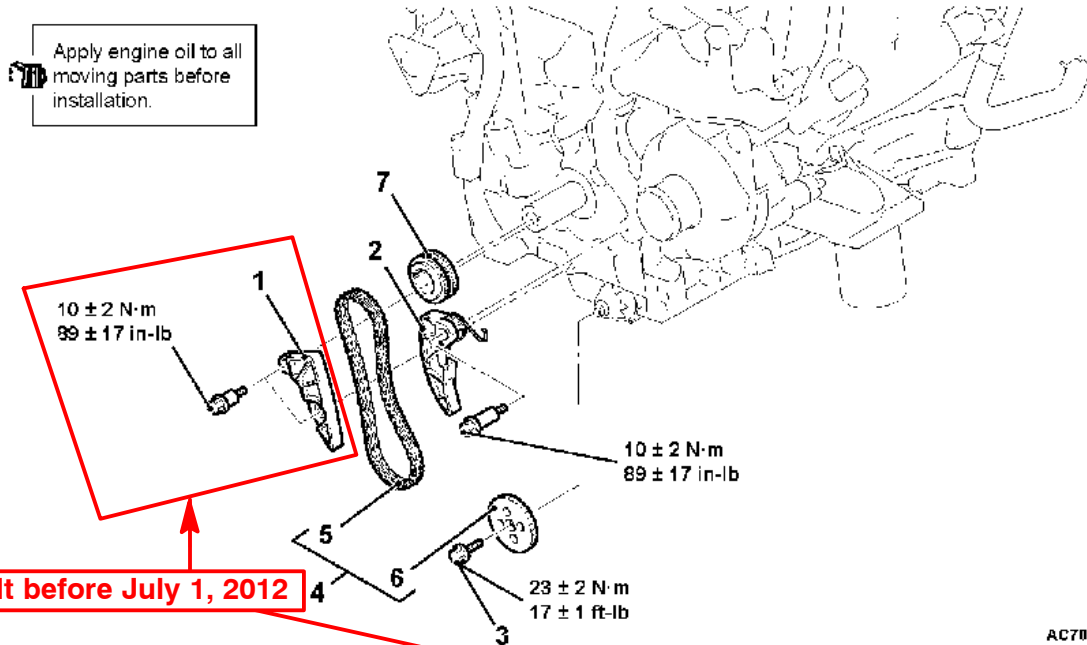
AC706643AC

Built before July 1, 2012

1. Engine oil pump chain guide >>
2. Engine oil pump chain tensioner >>B<<
3. Engine oil pump sprocket bolt >>B<<
4. Engine oil pump drive chain and engine oil pump sprocket >>A<<

Apply engine oil to all moving parts before installation.
