RYKER Exhaust Too Close OR Touching The Frame - 137241

Possible contact between the exhaust pipe and frame. Here are some ways to increase the distance between the exhaust pipe and the frame.

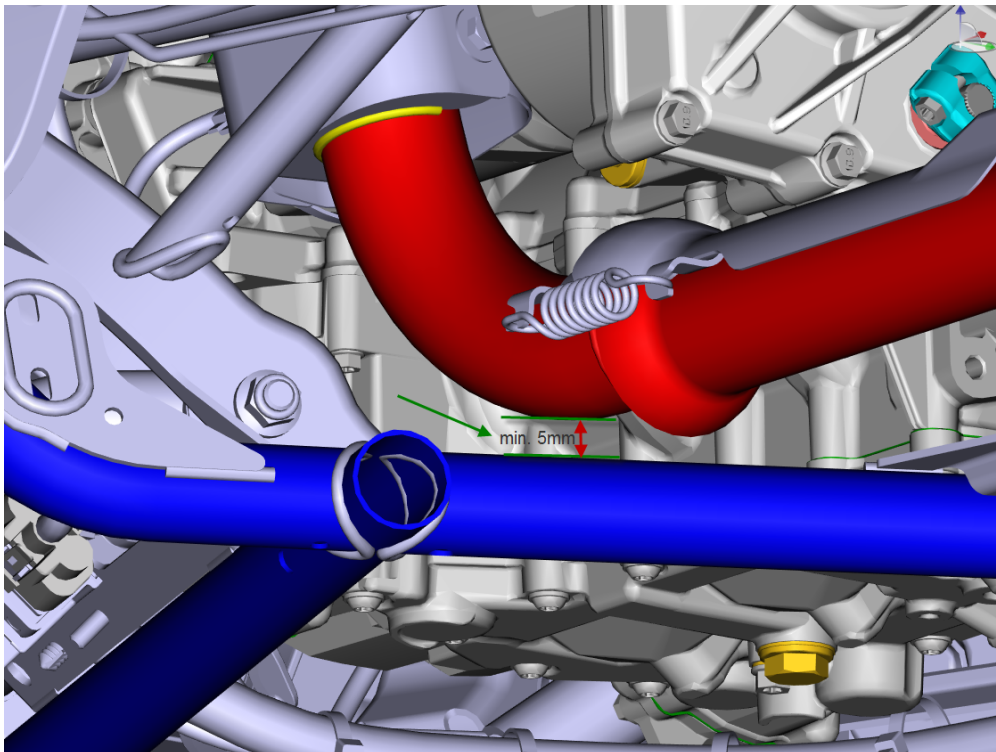
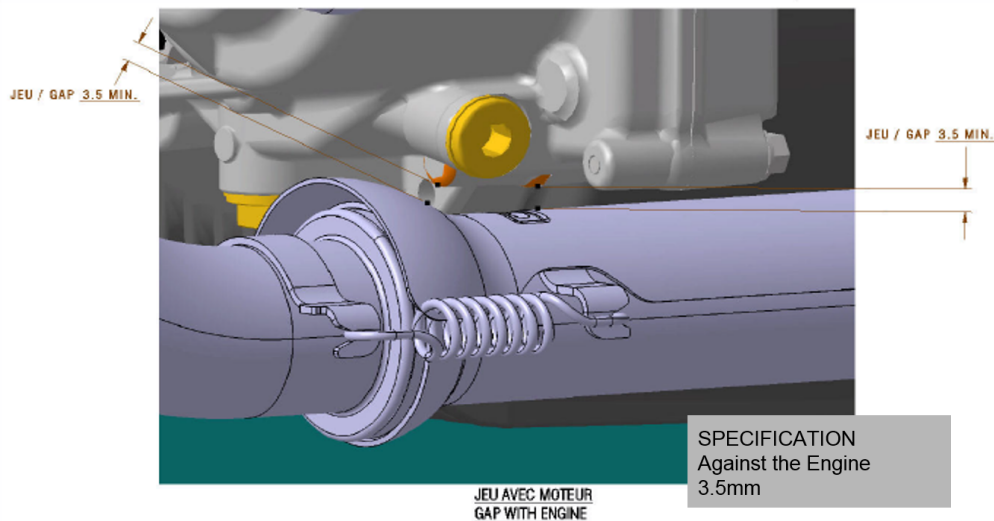
The minimal distance between the exhaust pipe and the frame should be 5mm.

- Excessive engine vibration felt
- Exhaust manifold bolts loose
- Engine rattle noise

Note the Exhaust too close will reveal marks on the frame and exhaust pipe. If no marks, the problem is possibly somewhere else.
