TECHNICAL SERVICE BULLETIN

4WD - Intermittent Grinding Noise While Driving

20-2013
17 January 2020

Ford 2013-2018 Expedition
2013-2018 F-150
Lincoln 2013-2018 Navigator

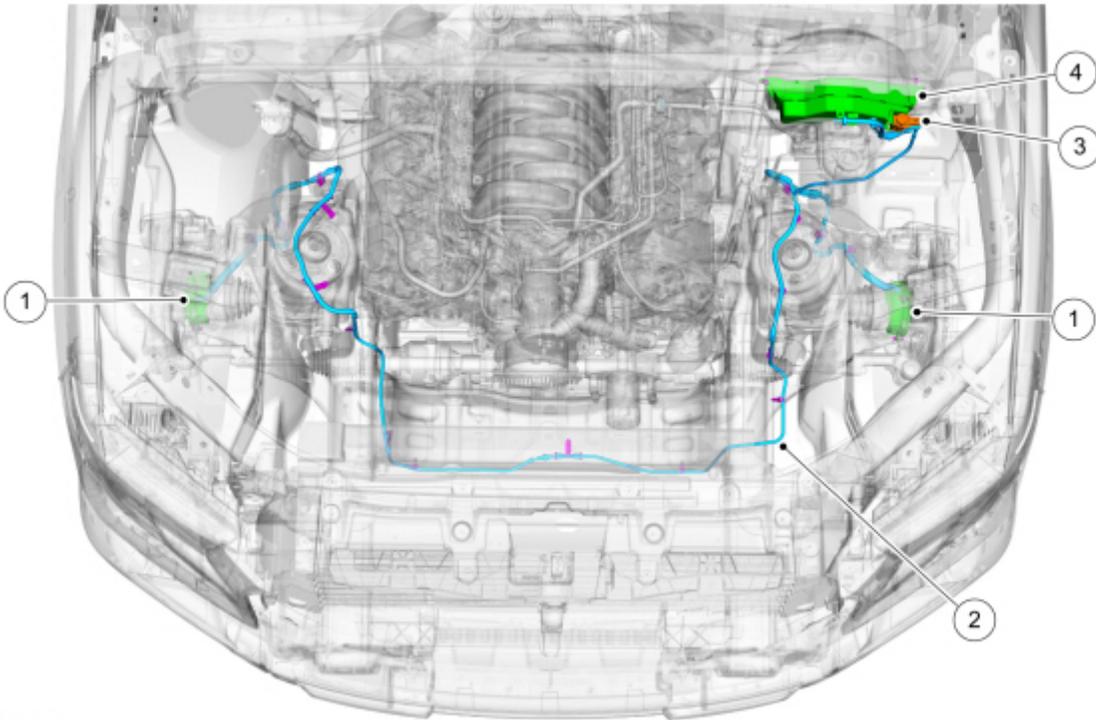
Figure 1

2. Inspect the IWE vacuum hoses. Refer to Workshop Manual (WSM), Section 308-07A. Are there any disconnected or damaged vacuum hoses? (Figure 1)

(1). Yes - reconnect or replace the vacuum hose as required. Refer to WSM, Section 308-07A.

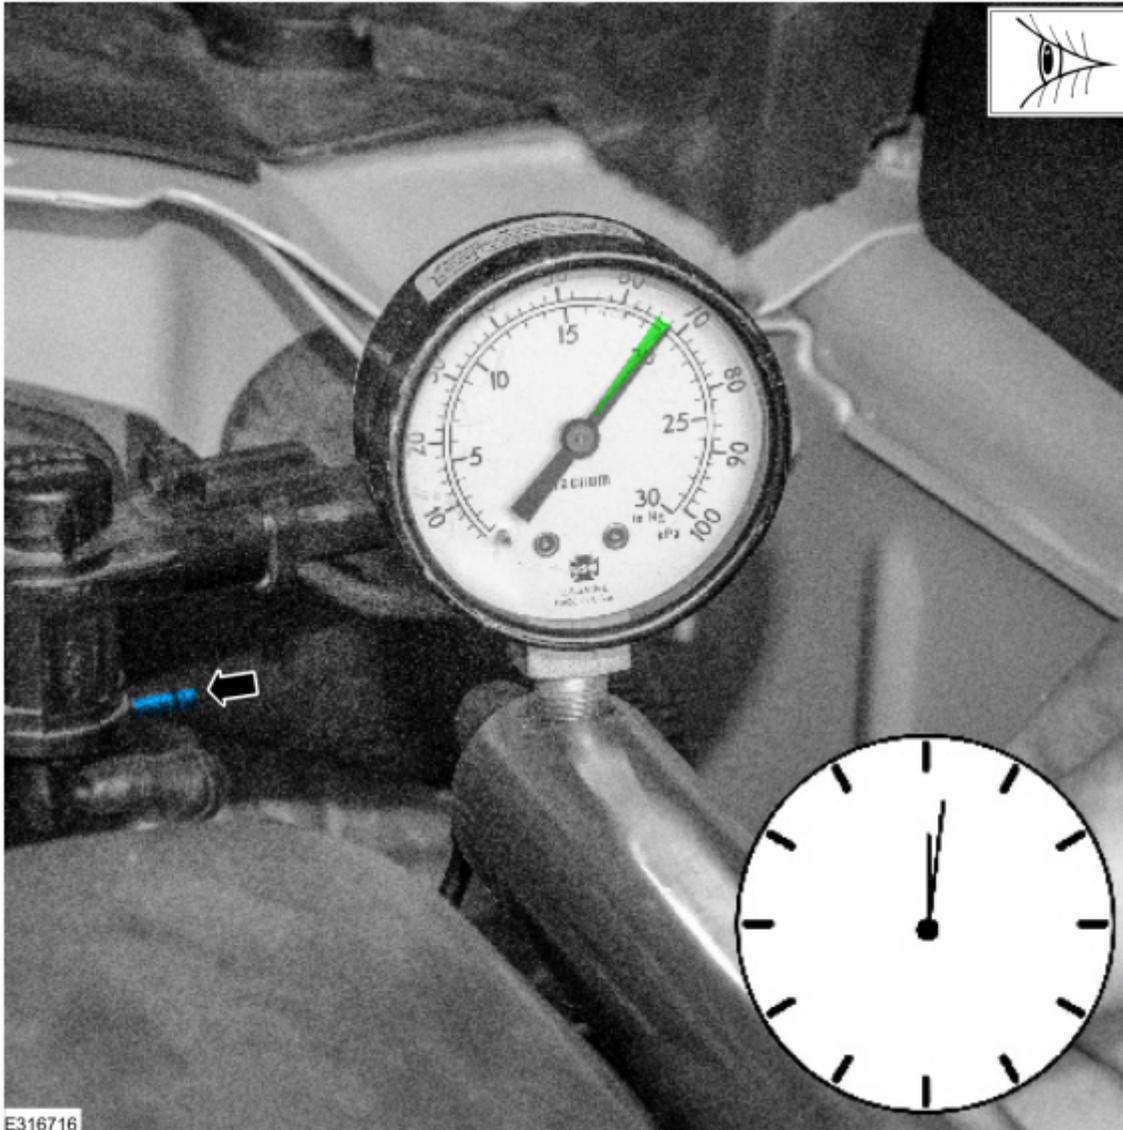
Figure 2

3. Replace the vacuum check valve located near the vacuum reservoir. Refer to WSM, Section 308-07A.
4. Disconnect the vacuum line to the IWEs at the vacuum solenoid.
5. Connect a hand vacuum pump to the IWE vacuum supply line and apply 508 mm (20 in) Hg of vacuum. Does the vacuum drop more than 12.5 mm (0.5 in) Hg per minute? (Figure 2)
 - (1). Yes - proceed to Step 6.
 - (2). No - connect the IWE vacuum supply line to the solenoid and proceed to Step 10.

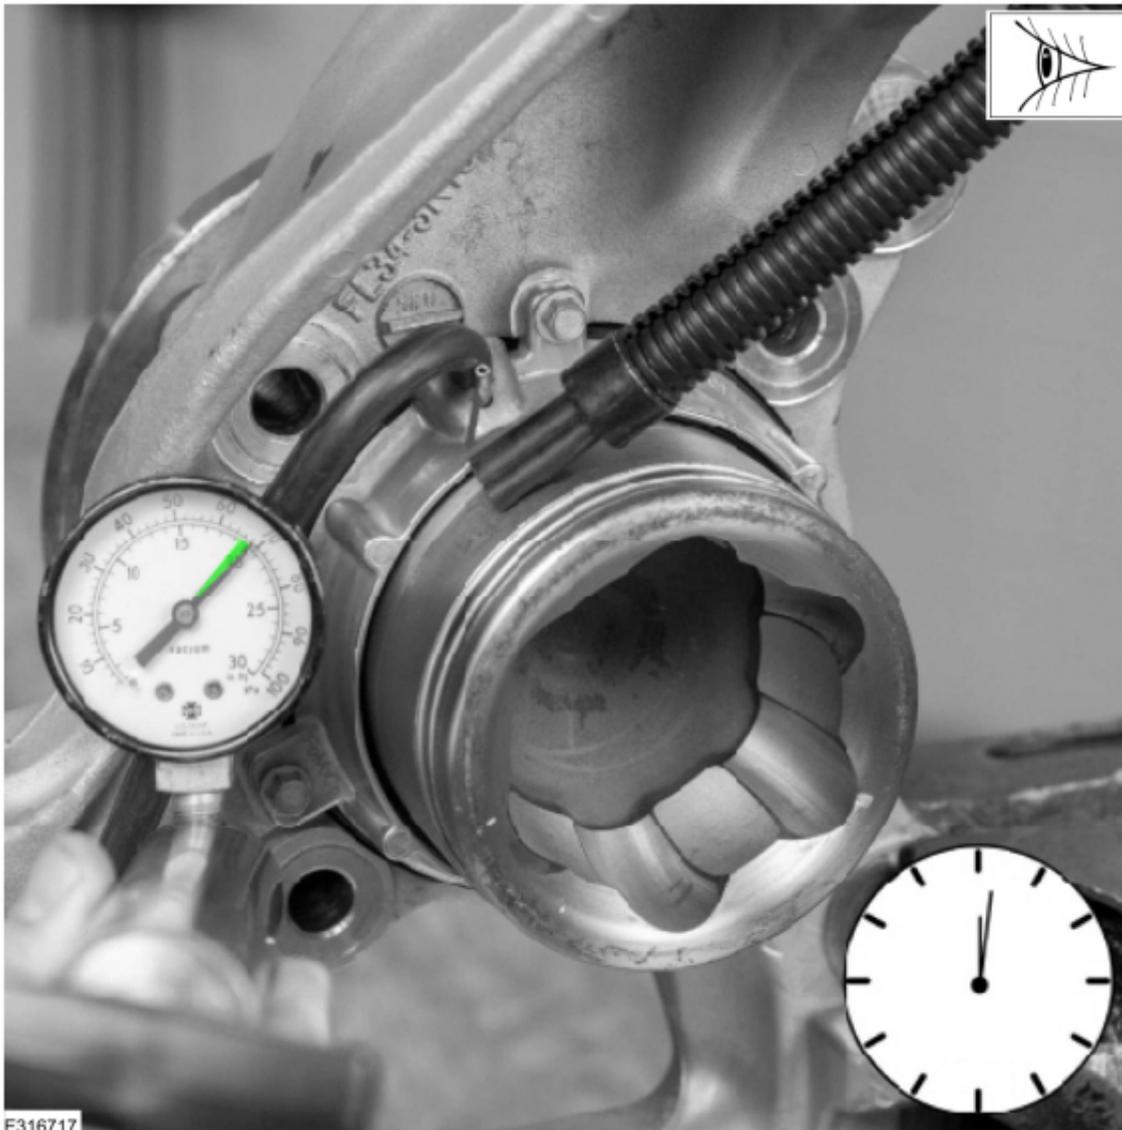
6. Using a hand vacuum pump, apply 508 mm (20 in) Hg of vacuum to each IWE, one at a time, and monitor the vacuum gauge. Does the vacuum drop more than 12 mm(0.5 in) Hg per minute? (Figure 3)

- (1). Yes - proceed to Step 8.
- (2). No - proceed to Step 7.

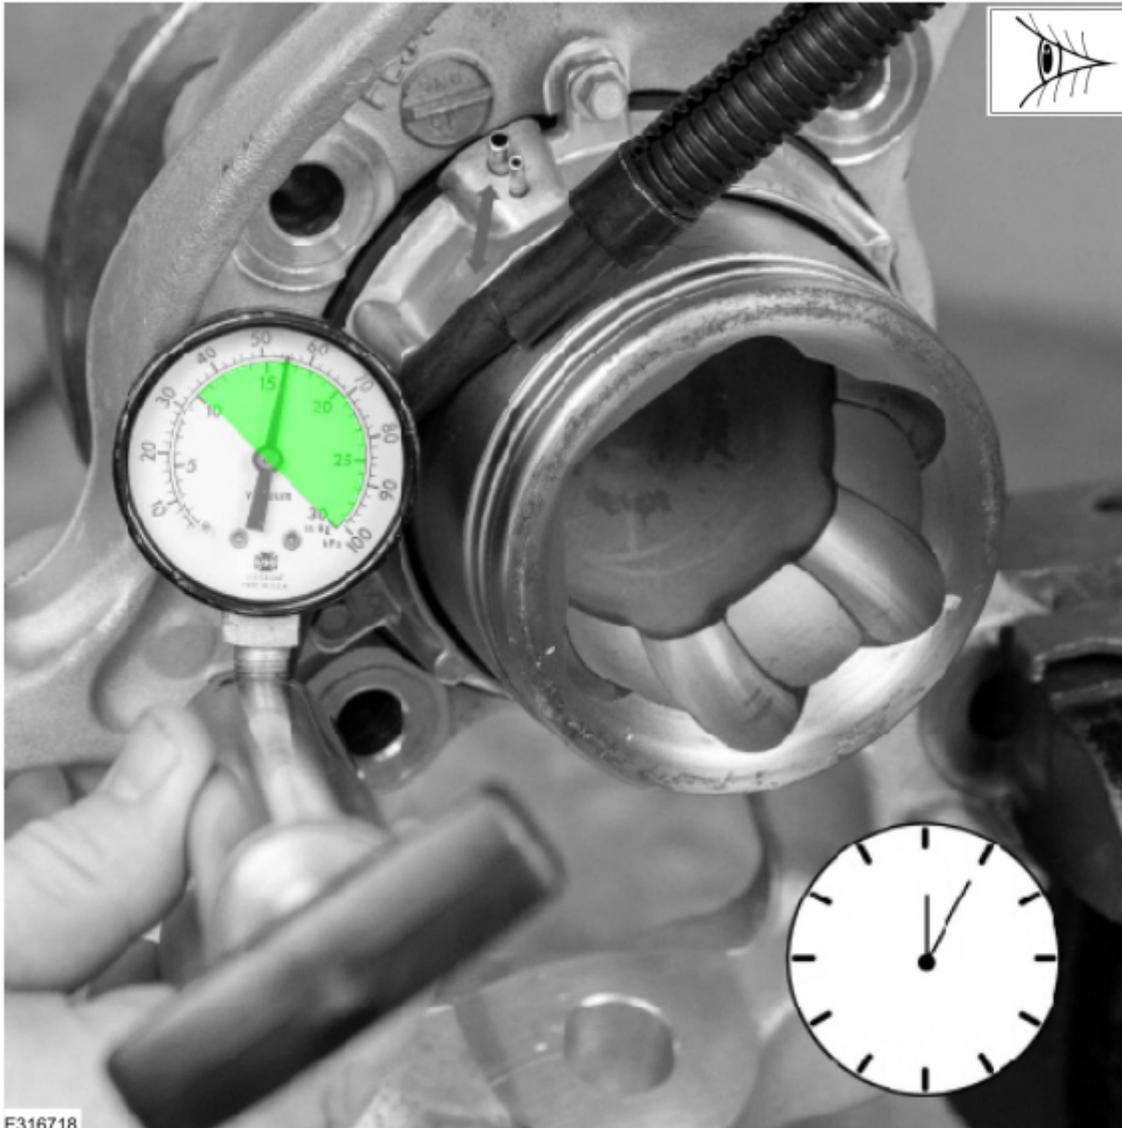
Figure 4

- (2). No - replace the IWE assembly. Refer to WSM, Section 308-07A. Proceed to Step 12.
10. Test the IWE vacuum supply lines.
 - (1). Disconnect the vacuum supply line at the left or right IWE and connect a vacuum gauge to the supply line as shown in Figure 4.

11. Is the vacuum at both left and right supply lines greater than 254 mm (10 in) Hg?

(2). No - replace the vacuum lines between the solenoid and IWEs. Refer to the WSM, Section 308-07A. Proceed to Step 12.
