## SERVICE BULLETIN

**APPLICABILITY:** 2017-18MY Impreza  
 2018MY Crosstrek  
 2018MY Legacy and Outback  
 2018MY BRZ\*

**NUMBER:** 15-211-17R  
**DATE:** 06/13/17  
**REVISED:** 01/03/20

**SUBJECT:** Reprogramming File Availability for Additional Optimization of Harman Gen 3 Audio and Navigation Head Units

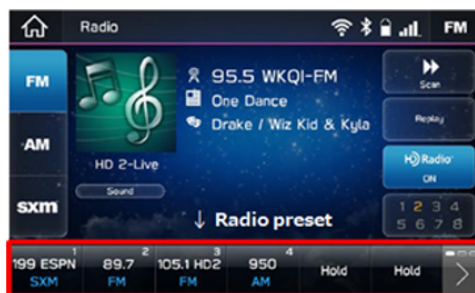
- Update to address some or all AM/FM station presets becoming lost and replaced by “**Hold**”

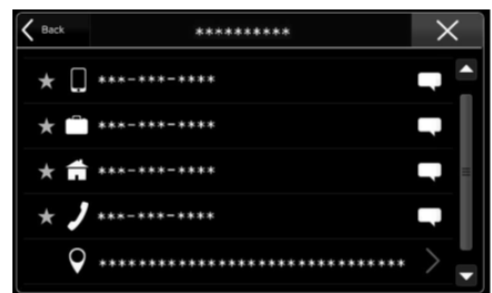
- Update to further reduce static or “noise” when listening to AM radio stations
- Update to address Navigation system “Freezing-Up” condition (gray screen / rotating loading circle)
- Update to address loss of downloaded Phone Contact list information
- Update to address music “skipping” concerns when using CarPlay
- Update to correct US State Route name pronunciations
- Update to address Hands-Free feature freezing during boot-up

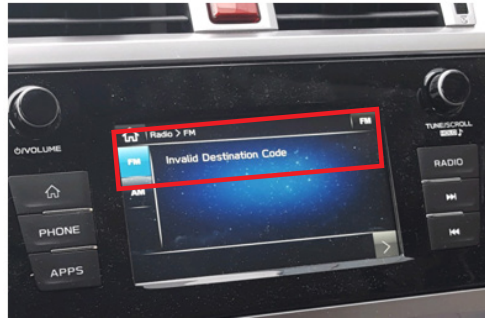
- Update to address discrepancies between Navigation unit and Multi-Function Display (MFD) and also between the Navigation unit display and actual posted Speed Limit signage  
*\*\* Since municipalities may at any time adjust speed limits of roads or sections of roads, the driver is responsible to adjust their speed according to all posted signage. The speed information supplied is the best available at the time of map production and subject to change.*
- Update to address system freezing when searching for addresses using Voice Recognition
- Update to address music not playing automatically when connecting a USB device
- Update to address display of “Invalid Destination Code” message

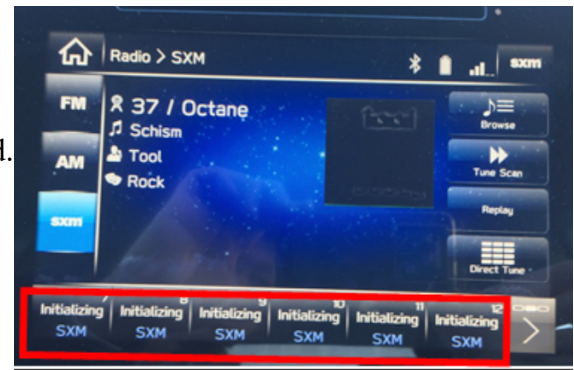
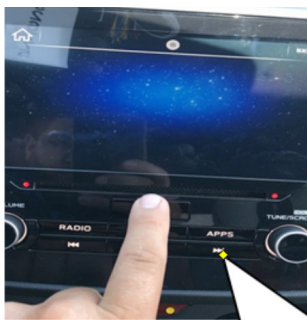
Background shown, but no icons

- On 2018MY Legacy / Outback models with Navigation (High) head units, the update corrects a condition where the head unit remains powered even after the ignition is OFF and the driver door is opened.
- Update for a condition where the SXM presets become lost and only “Initializing” appears as shown below.
- Update for condition where only the star field background is displayed (without icons) after the HOME button is pressed.

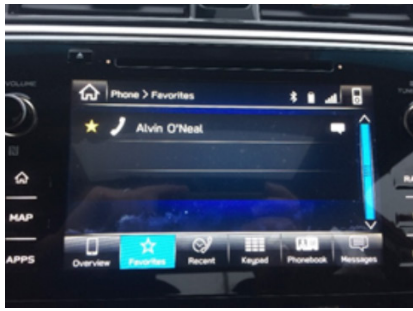
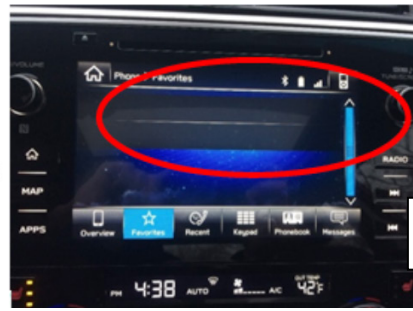
List is blank

- Update for a concern of after selecting a contact to be a “Favorite” and the “Favorite” list display is blank.

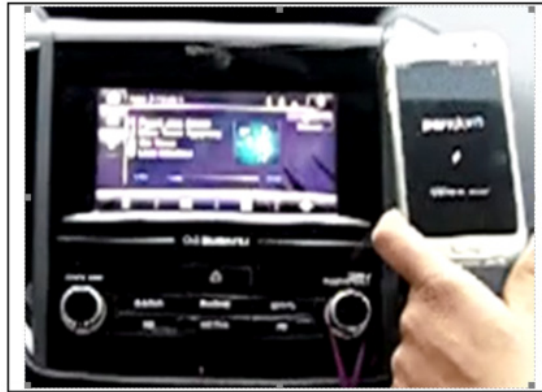
- 1- No streaming audio; when using the Pandora® app, there is no audio output.

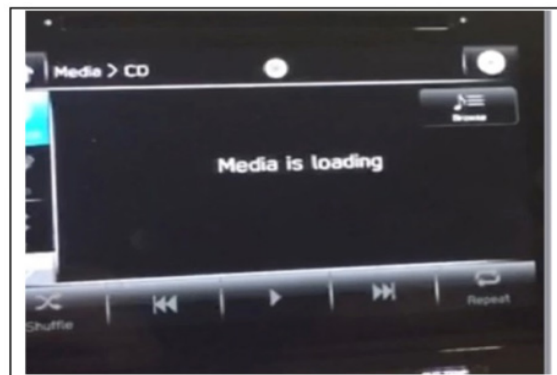
- 2- “Media is loading” is displayed on the screen but, the media never completes loading.

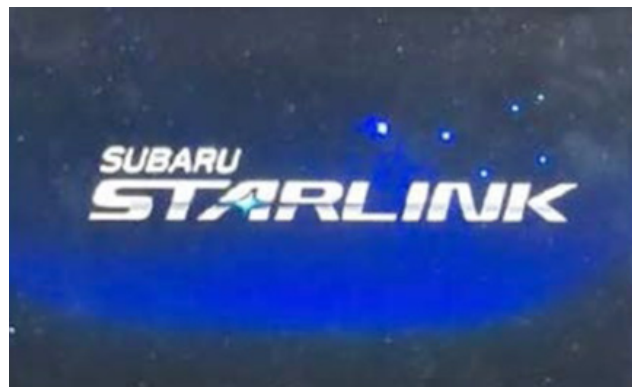
- 3- The screen freezes when the STARLINK screen is displayed.

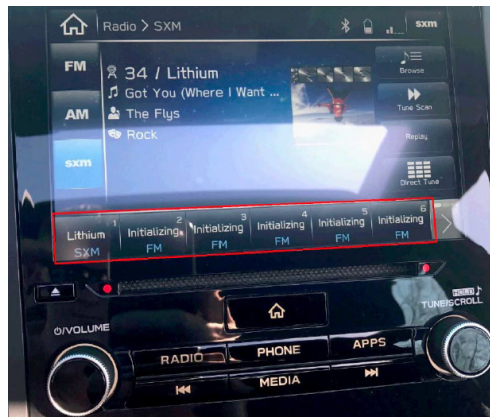
- 1- Radio station presets disappear (touch screen buttons return to “Initializing”).

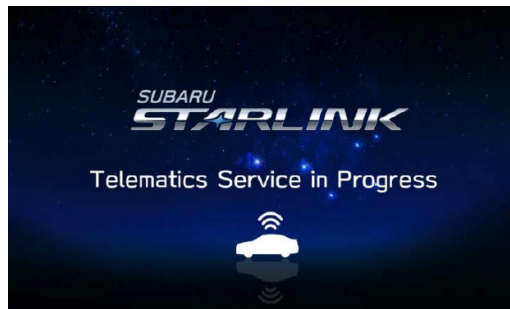
- 2- STARLINK “Telematics Service in Progress” screen freezes.

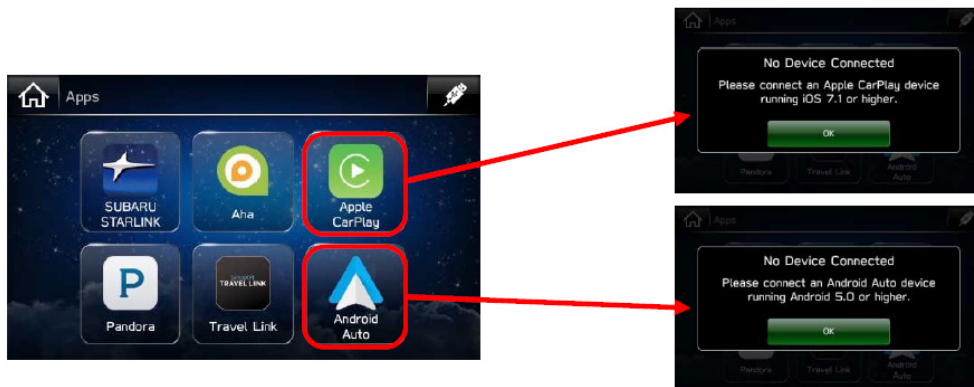
- 3- Apple Car Play / Android Auto function does not operate (“No Device Connected”).

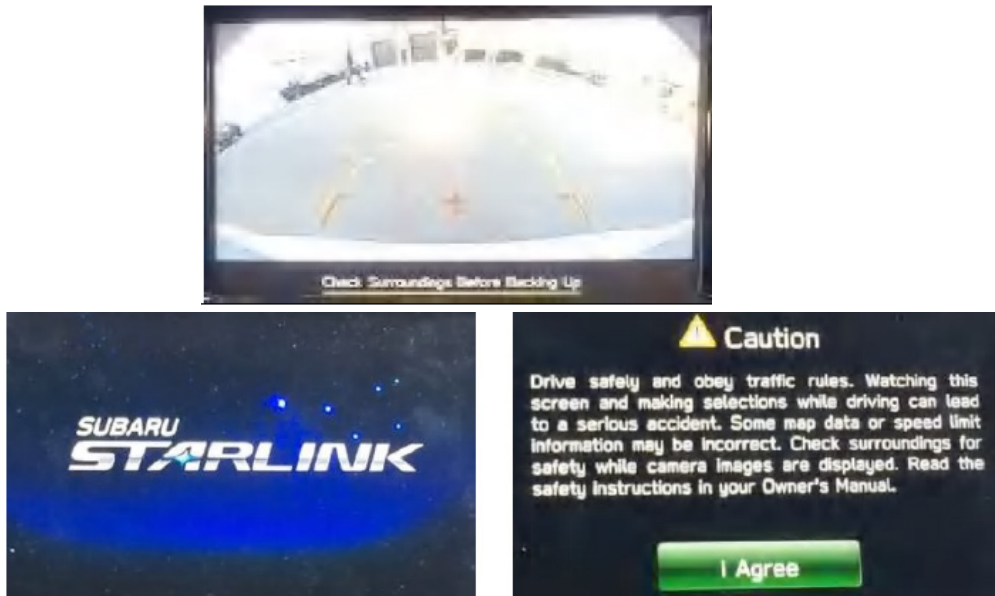
For reference, the previously released WTN-74R symptoms are also provided below. The main purpose of WTN-74R was to address display screen freeze-up during Back-Up Camera display (when the shifter is in “R”). In addition, the screen may also freeze when either the Subaru STARLINK or Disclaimer Caution / I Agree screen is displayed.

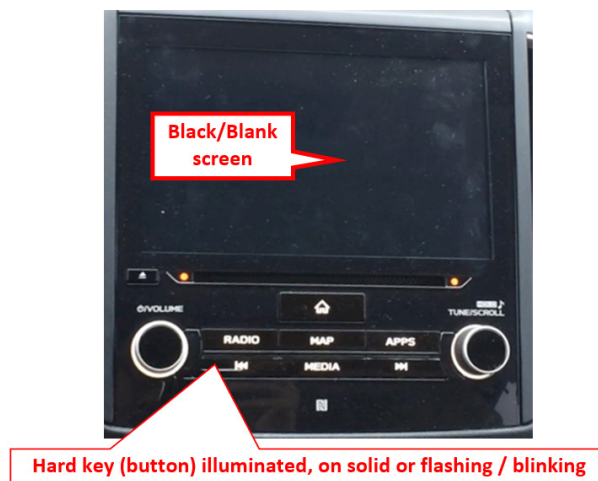
- 1) After switching the vehicle (ACC or IGN) on, the display screen goes black with no audio output and the hard key buttons are illuminated (on solid, or flashing / blinking).

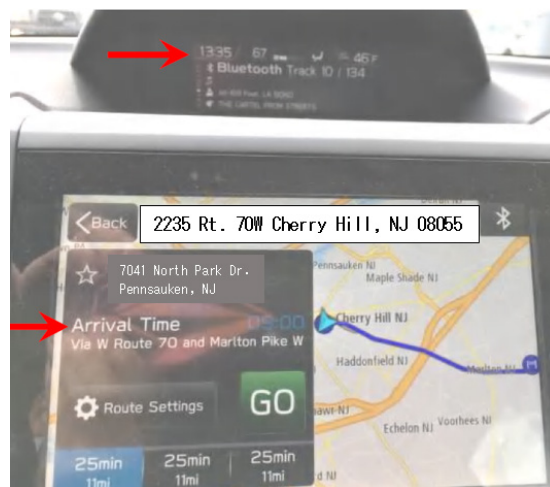
- 2) Time of day displayed in the MFD is incorrect and the arrival time displayed in Navigation unit is also incorrect.

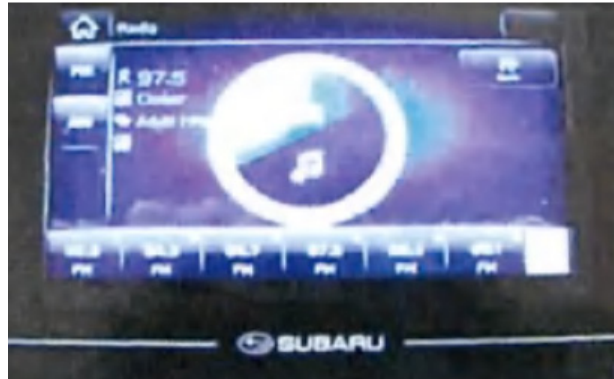
- 3) The time in the MFD automatically reverts to a “default” setting, even after setting the time using “Manual” mode.
- 4) Audio volume goes to maximum automatically after one click of the volume up button on the steering wheel. In some cases, this condition may also occur without input from the operator. Maximum volume is also displayed on the screen.
