SERVICE INFORMATION BULLETIN

APPLICABILITY: 2018MY Legacy and Outback w/8-inch Navi System
 2017-18MY Impreza with 8-inch Navi System
 2018MY Crosstrek with 8-inch Navi System
 2018MY BRZ with 7-inch Navi System

NUMBER: 15-254-19R

SUBJECT: Map Data Update Procedure for Harman Gen 3.0 Navigation Equipped Head Units (H/U)

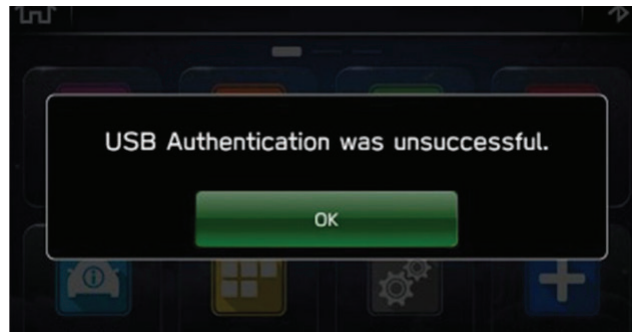
CAUTION: NEVER attempt to install this software update on any 2019 or 2020 MY vehicles as they are equipped with Gen 3.1 Navigation systems. This update is **ONLY** for models equipped with **Gen 3.0** Navigation systems. Should an attempt be made to install any of these files into a Gen 3.1 H/U, the USB Authentication error screen below will be displayed.

- The USB Authentication error screen will also be displayed when attempting to install the map data bundled with a software version older than the version already installed in the H/U.
- Move the vehicle to an outside location where the engine can be safely started and kept idling during the update process.
- Never idle the vehicle in a closed space such as a garage, even if the garage door is open.
- Once the vehicle is in a safe location, be sure the vehicle is in Park if CVT or Neutral if MT and the parking brake is fully engaged.
- Unplug any cables or devices from the USB ports.
