LTB01208NAS4

# TECHNICAL BULLETIN

501-14

Hood Release Inoperative

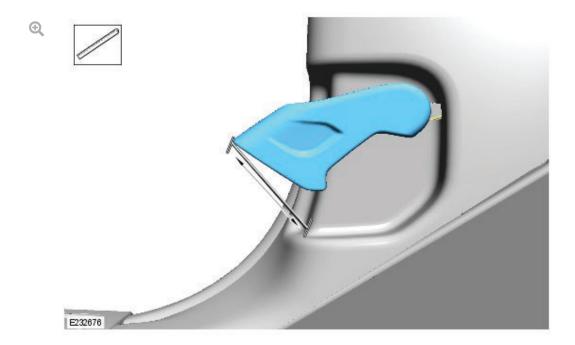
Open the hood and use a steel rule or similar engineer's scale to record the distance the interior release lever travels to operate the hood latches.

- If the hood interior release lever does operate the hood latches, the hood can be opened, and the distance is less than 120mm, release the vehicle.
  - No further action required.
- If the hood interior release lever does operate the hood latches, the hood can be opened, and the distance is more than 120mm, go to Step 5.
- If the hood interior release lever does not operate the hood latches and the hood cannot be opened, go to Step 2.
