H268NAS1

TECHNICAL BULLETIN

Service Action: Startup Battery Cable - Install Retaining Clip

MODEL:	MODEL YEAR:	VIN:	APPLICABILITY:
XE (X760)	2019	487656-487797	V8 S/C 5.0L Petrol

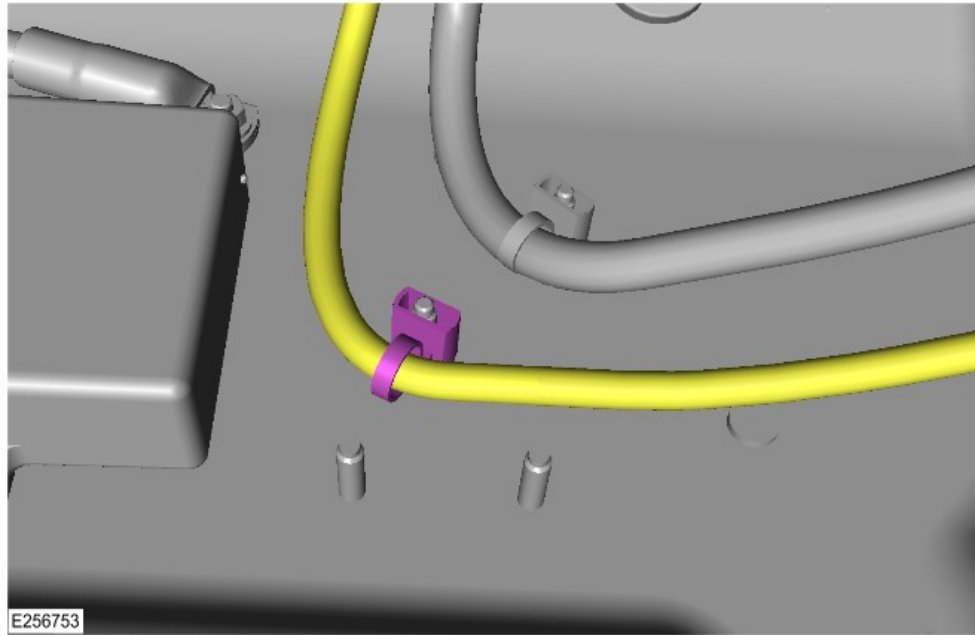
7.

A potential issue has been identified on certain Jaguar vehicles within the listed Affected Vehicle Range have been manufactured without an additional vehicle startup battery cable retaining clip. Without the retaining clip, there is potential for a touch condition between the vehicle startup battery positive cable and a loadspace floor stud.

Make sure the excess cable tie is removed at the base of the retaining clip.

Install the new retaining clip and secure to the vehicle startup battery positive (+) cable to the loadspace floor stud as shown.
