SERVICE BULLETIN

EL19-069

January 17, 2020

2019 SENTRA; STEERING WHEEL AUDIO SWITCHES INTERMITTENTLY INOPERATIVE

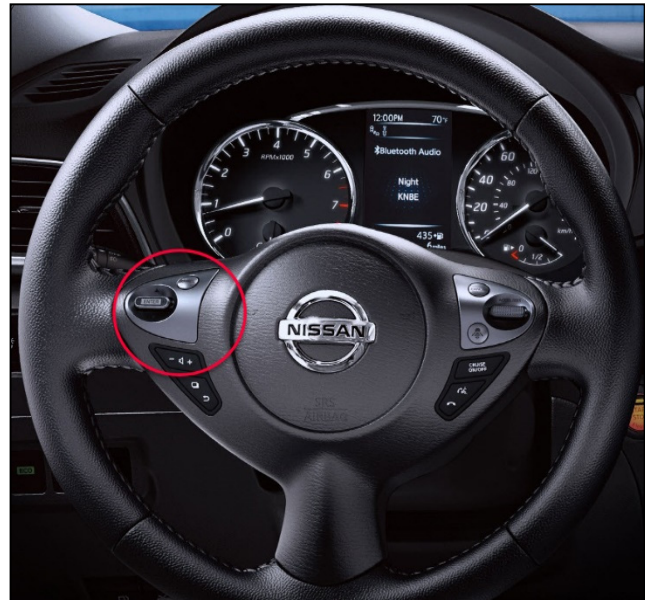
Figure 1

The steering wheel audio switches (Figure 1) are intermittently inoperative.

Update the AV control unit software. Refer to **SERVICE PROCEDURE** on page 2.
