# SERVICE BULLETIN

Classification: EL19-069a	Reference: NTB20-002a	Date: January 31, 2020
------------------------------	--------------------------	---------------------------

## 2019 SENTRA; STEERING WHEEL AUDIO SWITCHES INTERMITTENTLY INOPERATIVE

**APPLIED VEHICLE:** 2019 Sentra (B17) – S model only  
**APPLIED VIN:** Vehicles Built before 3N1(\*)B7AP(\*)K(\*)432870  
**APPLIED DATE:** Vehicles Built before October 10, 2019

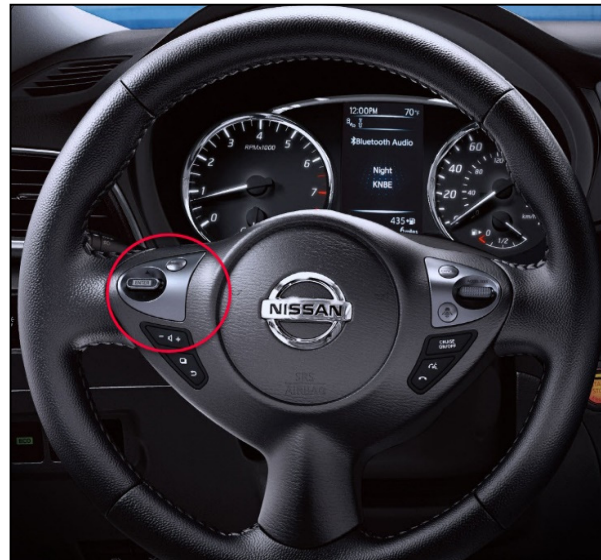
Figure 1

The steering wheel audio switches (Figure 1) are intermittently inoperative.

Update the AV control unit software. Refer to **SERVICE PROCEDURE** on page 2.

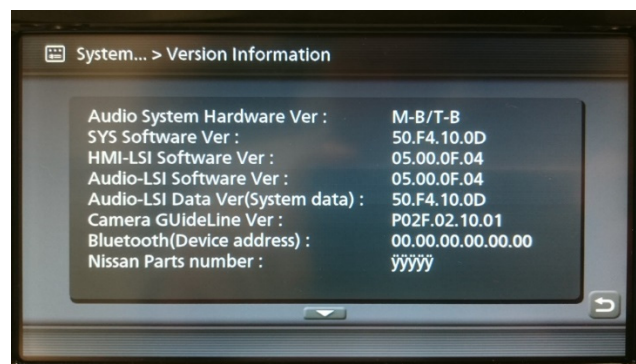
Figure 7

- If the SYS Software Version is **NOT 80836034 or higher**, turn the ignition OFF and continue to step 7 on page 4.
- If the SYS Software Version is **80836034 or higher**, this bulletin does not apply. Go to ASIST for further diagnostic and repair information.

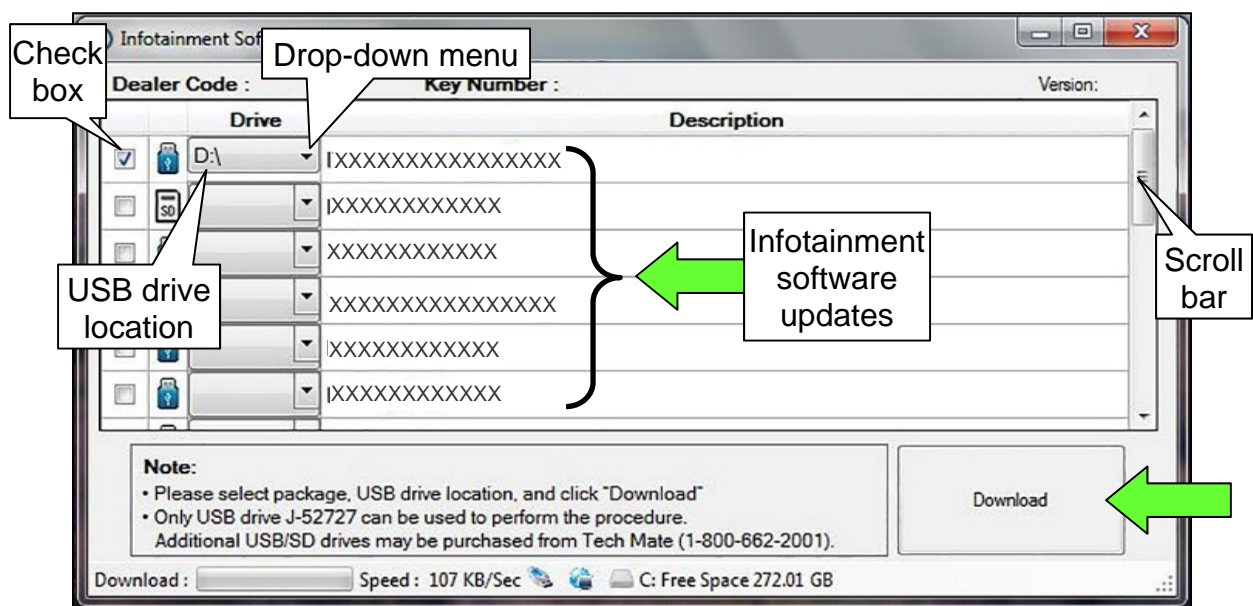
Figure 9

To avoid damage to the vehicle, ensure the correct update software package is selected. Failure to select the correct update software package may result in needing to replace the AV control unit.

10. Select the check box next to the correct update software package (Figure 9).
  - Locate Update #1 (LD001) and Update #2 (LD002).
  - Only one (1) update will be loaded at a time, starting with Update #1 (LD001).

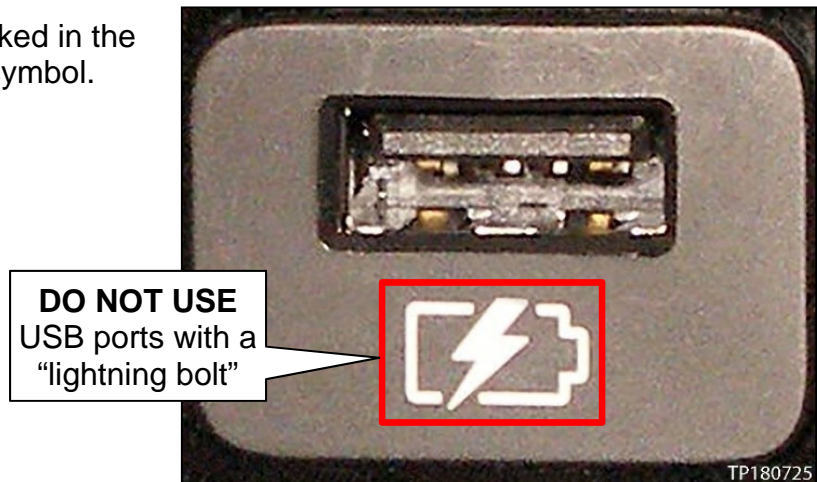
Figure 13

Do not insert the USB drive into a charging port (Figure 13). If used, the update software and/or USB drive may become damaged. Only insert the USB drive in a USB media port.

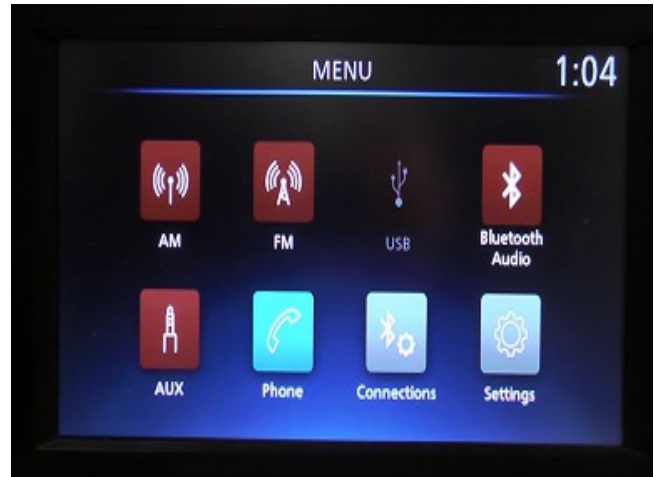
To prevent damage to the AV control unit, do NOT remove the USB drive unless the audio unit has rebooted and the main MENU screen as shown in Figure 15 is displayed.
