Technical Service Bulletin

40 Rumbling/creaking noises from front of the vehicle when driving - Q7, Q8, A8, and Audi e-tron quattro

40 20 01 2058489/1 February 6, 2020.

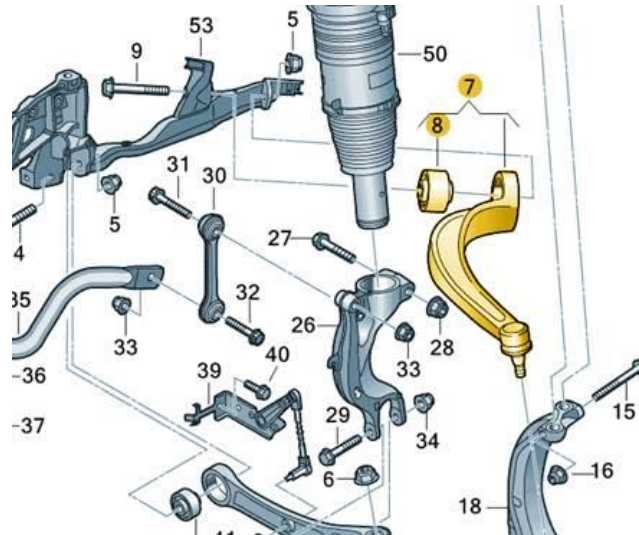
Figure 1. Hydro-bush.

The noises can be generated on the lower left guide in the area of the hydro-bush. (Figure 1 – Position 7 and 8).

The noises from the guide link can be transmitted into the vehicle interior by the connection of the sub frame on the body and are noticeable in the foot well.

1. Replace the hydro-bush on the guide link in pairs (Figure 1 – Position 8) according to the instructions in Elsa at Repair Manual, *Chassis >> Suspension, Wheels, Steering >> 40 Front Axle >> Lower Control Arm and Ball Joint >> Guide link bonded rubber bushing, Removing and Installing*.
2. Before installation, ensure that the new parts of the hydro-bush have a parts version of **03S** or higher (Figure 3).

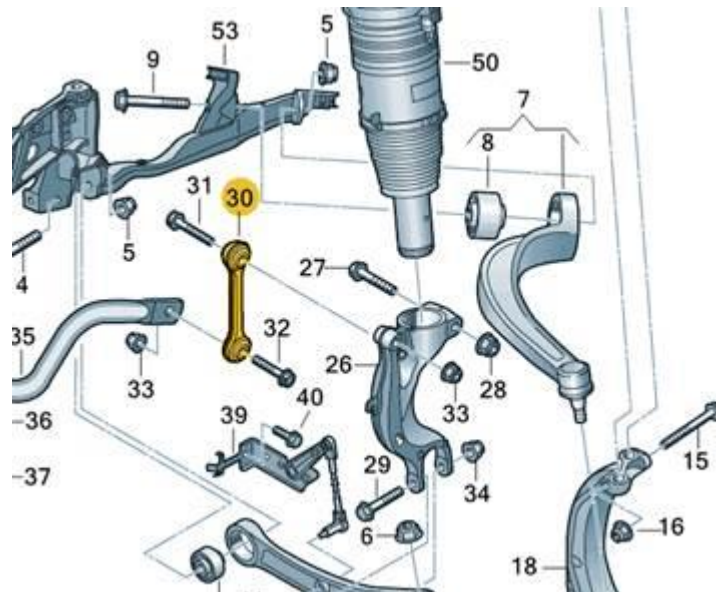
Figure 2. Coupling rod.

Parts such as the coupling rod (Figure 2 – Position 30) are usually replaced by mistake, presenting no problems.
