# Technical Service Bulletin

## 91 MIB3: Features grayed out, Audi connect has no function, SOS LED is off or red, and SOS warning message in the FPK

91 20 35 2058096/2 February 6, 2020. Supersedes Technical Service Bulletin Group 91 number 19-21 dated December 19, 2019 for reasons listed below.

Model(s)	Year	VIN Range	Vehicle-Specific Equipment
A4, A5	2020	All	Not Applicable

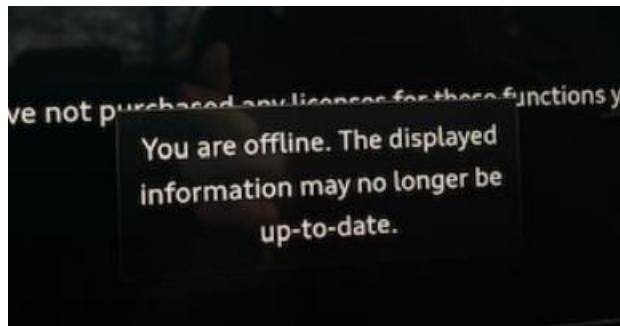
- Audi connect services do not function (Figure 1).
- SOS LED is off or red, or the Roadside button does not function.
- There are missing MMI icons on the main menu.
- The Settings Menu cannot be accessed.
- Some MMI features are grayed out.

**Figure 1.** Audi connect offline.

This new MIB3 system initially comes from the factory with Cluster 32 software which has a concern that can create one or all of the conditions previously mentioned above, when transport mode is deactivated.

For all listed conditions, the service solution is to perform a full factory reset of the MMI menu settings using ODIS. The manual factory reset using the settings menu in the MMI will not resolve this concern (manual method via *Settings >> System Maintenance >> Restore Factory Settings*).

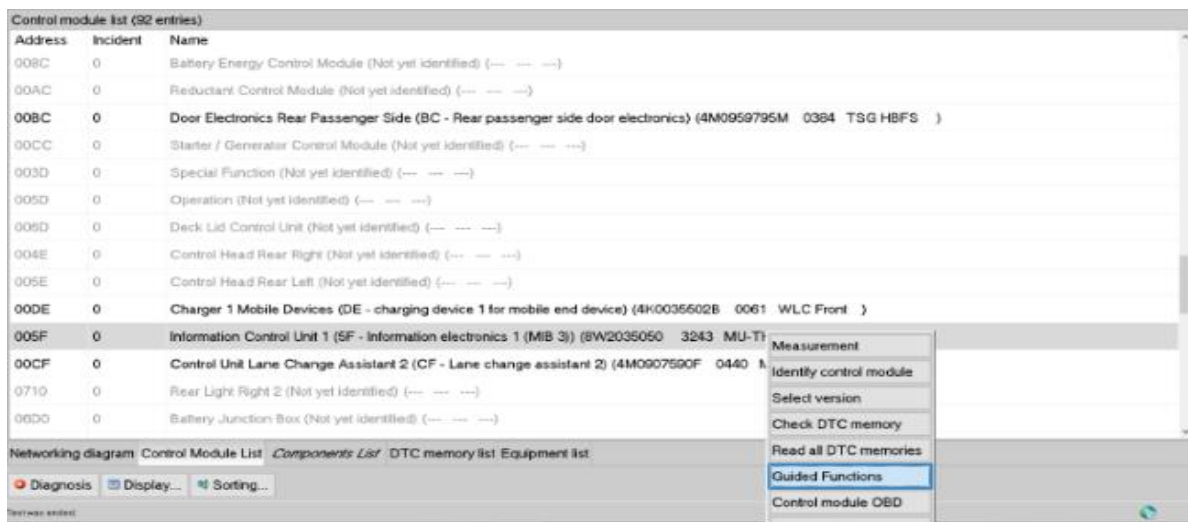
Figure 2. Information Control Unit 1 - Guided Functions.

1. Using ODIS start Guided Fault Finding.
2. Navigate to Address 005F – Information Control Unit 1 (5F-Information electronics (MIB3)) and right click Address 005F and select Guided Functions (Figure 2).

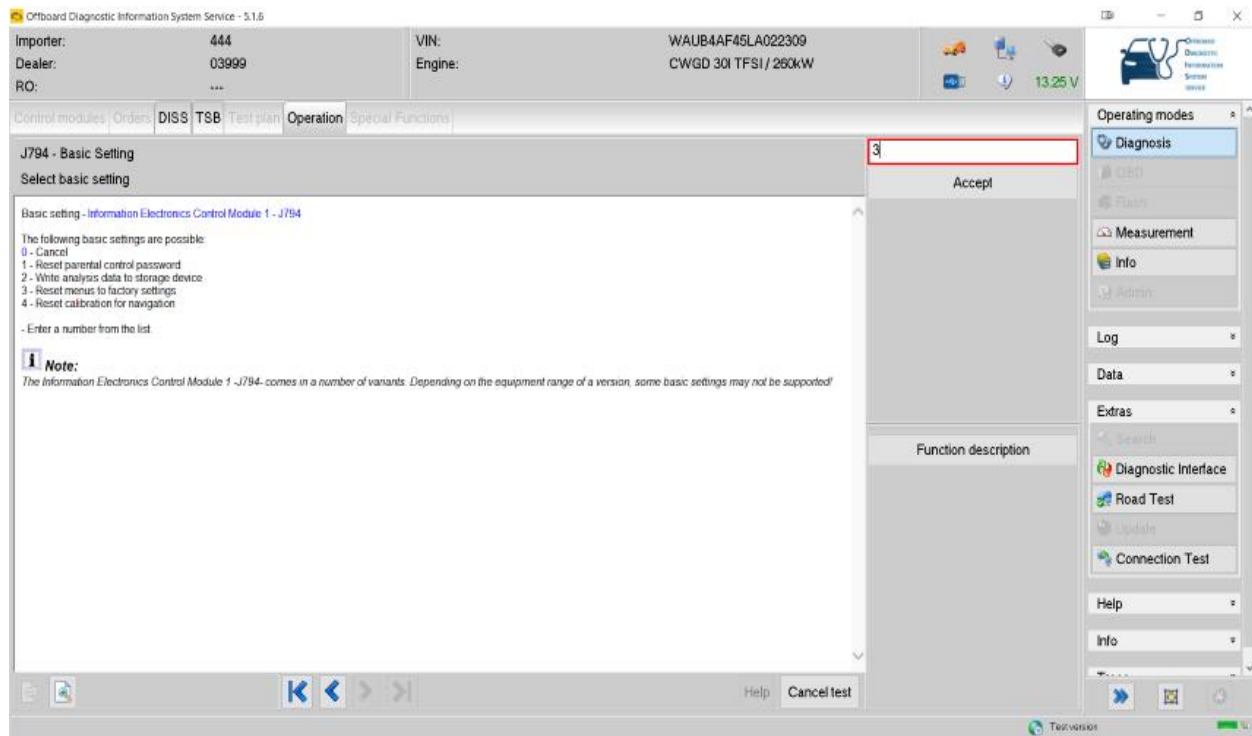
**Figure 3.** Reset Menus to factory settings.

3. Select “Basic Setting”
4. Select “3-Reset Menus to Factory Settings” (Figure 3).

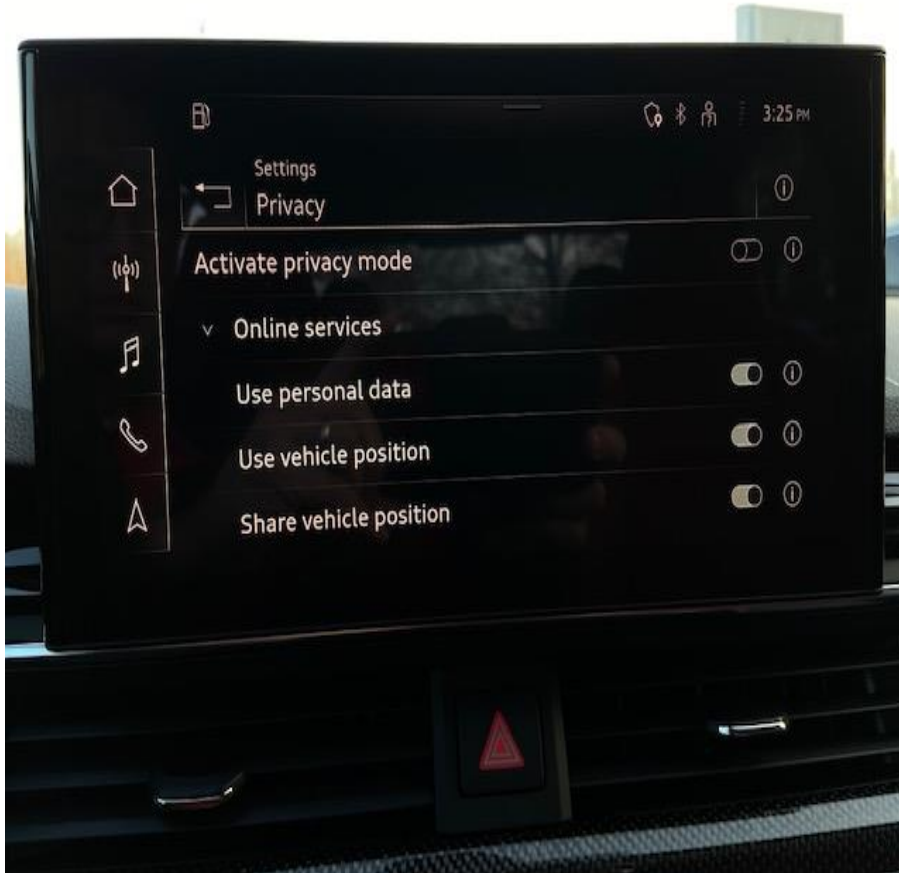
**Figure 4.** Privacy Mode deactivated.

5. Progress forward through the remaining prompts to complete the MMI factory reset. Once the reset is complete in the MMI, GFF can be ended.
6. Next, go to the main MMI Settings menu and swipe to the right and select Privacy. Then turn OFF Privacy Mode by deselecting “Activate Privacy Mode,” (Figure 4).
