SIB 01 13 19

2020-01-15

SIDE PANEL REAR LIGHT HOUSINGS: LTD WTY EXT TO 10 YEARS
WITHOUT MILEAGE LIMIT

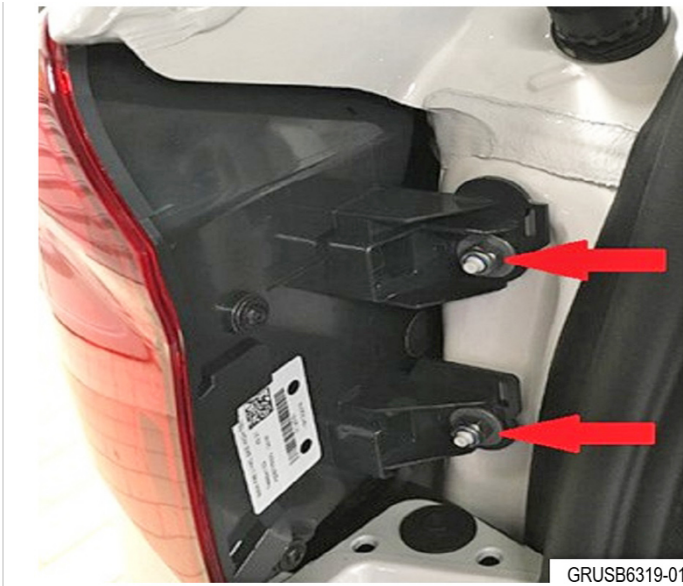
The rear light housing(s) can loosen/detach at the mounting tabs, this can cause a clacking sound in the rear of the vehicle while driving.

The plastic mounting tabs for the rear tail light assembly housing(s) may become too brittle and crack to the point where the hold down nut(s) can no longer keep the housing(s) in place.

Replace the rear tail light assembly (left, right or both) that are found to have cracked and broken Housing Mounting Tabs.
